K4 Area Tank Inspection Status

November 28, 2024

Tokyo Electric Power Company Holdings, Inc.

1. K4 area tank overview

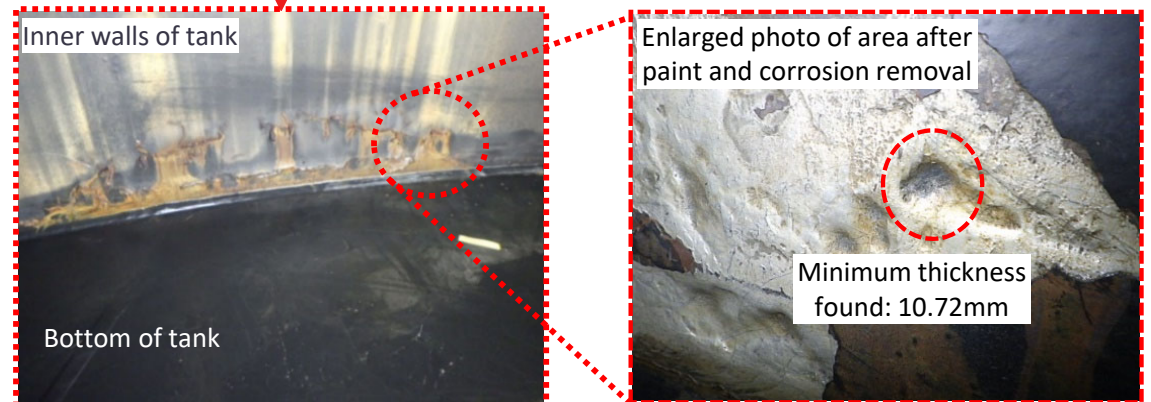
K4 area: Tank E1 plan view

- The transfer of ALPS-treated water being stored in the Group E tanks (E1~E5) to the measurement/confirmation facility was completed on November 21, 2023, and an internal inspection of the tanks was implemented between March and July 2024.
- Localized paint peeling and wall thinning due to corrosion was found in tanks E1, E2, and E5.
- A simulation was used to perform a stress assessment of the tanks (Reference 1) to ascertain the impact of the thinning, and it was confirmed that there has been no impact on the structural strength of the tanks.
- The locations of thinning in the group E tanks were repaired using overlay welding that was then repainted (Reference 2).

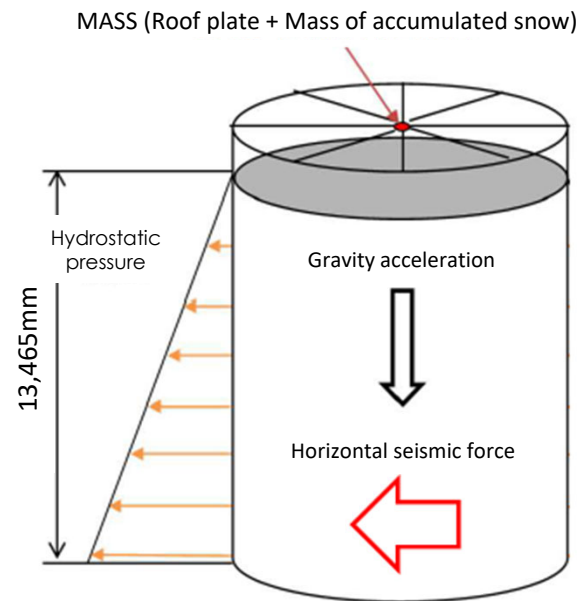
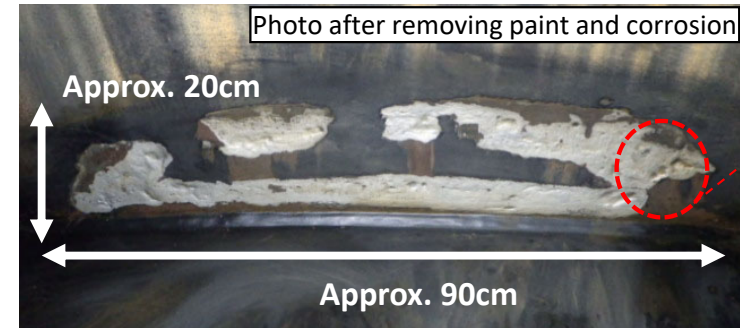
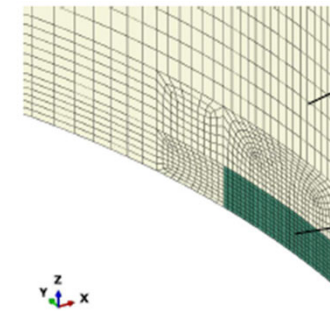
[Reference 1] Structural integrity assessment (stress assessment)

- A stress analysis was performed using FEM analysis that considers thinning since there was concern over a decrease in integrity due to the thinning. (Amount of thinning: 14.5mm (General thickness measurement) – 10.72mm (Minimum thickness found) ≐ 3.8mm)
- To be conservative, a 20cm X 90cm concave section of wall with a uniform thickness of 10.7mm was modeled and a stress assessment was performed. Results found that the maximum stress to the concave section was 93MPa, thereby indicating a seismic resistance margin of approximately 2.5 considering the threshold of 236MPa.

- Analysis code: ABAQUS
- Analysis model: 3-dimensional model
- Elements
 - Material: SS400
 - Thickness: 14.5[mm] (Actual measurement)
 - Inner diameter: 10,000[mm]
- Constraint conditions: Bottom of the tank is totally secured
- Load conditions
 - Deadweight: 86,000kg (Specific gravity of liquid: 1.1)
 - Hydrostatic pressure: 13,465mm
 - Horizontal seismic force: 0.36G (Seismic resistance class B)

Assessed component	Generated stress [MPa]	Threshold [MPa]	Seismic resistance margin	Result
Body plates※	93	236	2.54	○

※ To be conservative, a 20cm X 90cm concave section of wall with a uniform thickness of 10.7mm was modeled for assessment

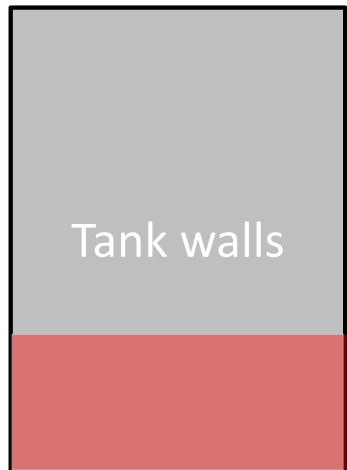
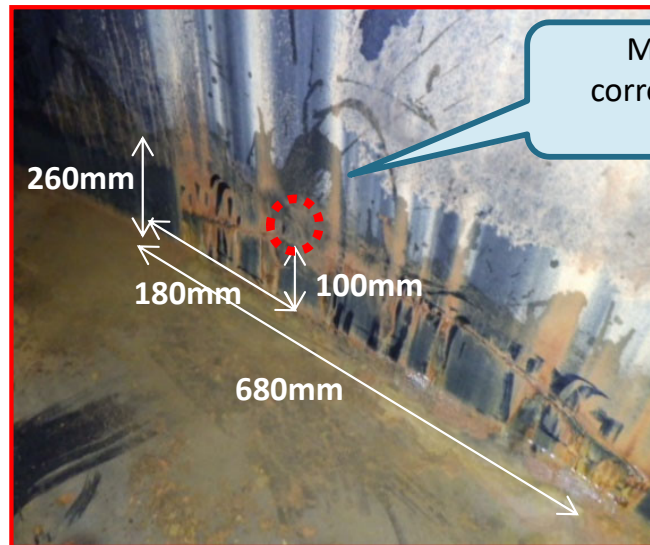
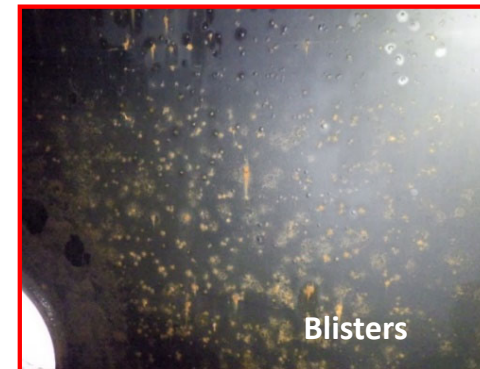
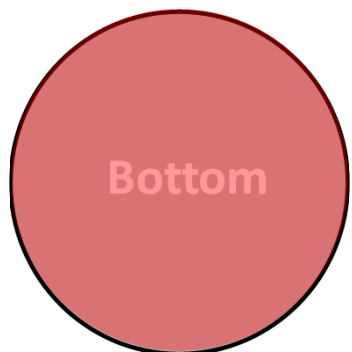
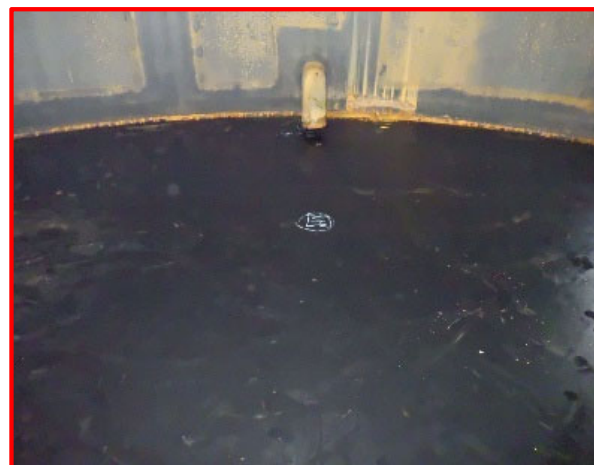
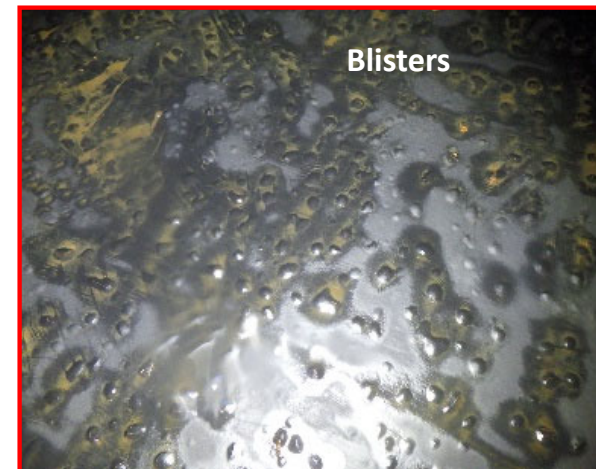
- Between September~October 2024, the tanks were drained and an internal inspection was performed
- Some paint peeling, rust, and slight corrosion was found at the bottom of the walls of the tanks, but there was no thinning as seen in K4-Group E, and ultrasonic thickness measurements of the tank walls confirmed that thickness exceeds requirements. ※
- Group C has been repainted and repaired. (Reference 3)

Minimum thickness at the place where the most corrosion/thinning was found in K4 (group C) tank C5:
12.89mm (required thickness: 10.2mm)

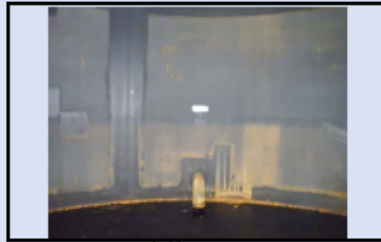
Tank walls 0°

Prior to repainting

➤ Paint cracks and base material rust was removed and the areas were repainted. (Target paint thickness: 500μm)
