# Results of an In-House Investigation Performed in the Vicinity of the Unit 1 X-25 Penetration to Confirm Accessibility

November 28, 2024

Tokyo Electric Power Company Holdings, Inc.

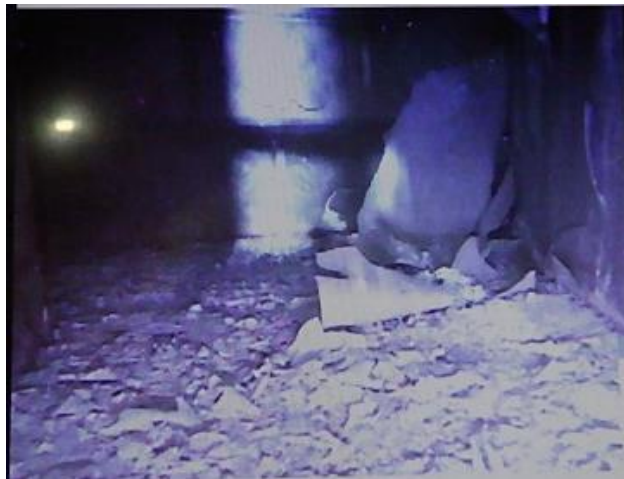
Photo 1 : Location A ☆ (Location A direction)

- It was confirmed that there are no large obstacles and the crawler robot can move.

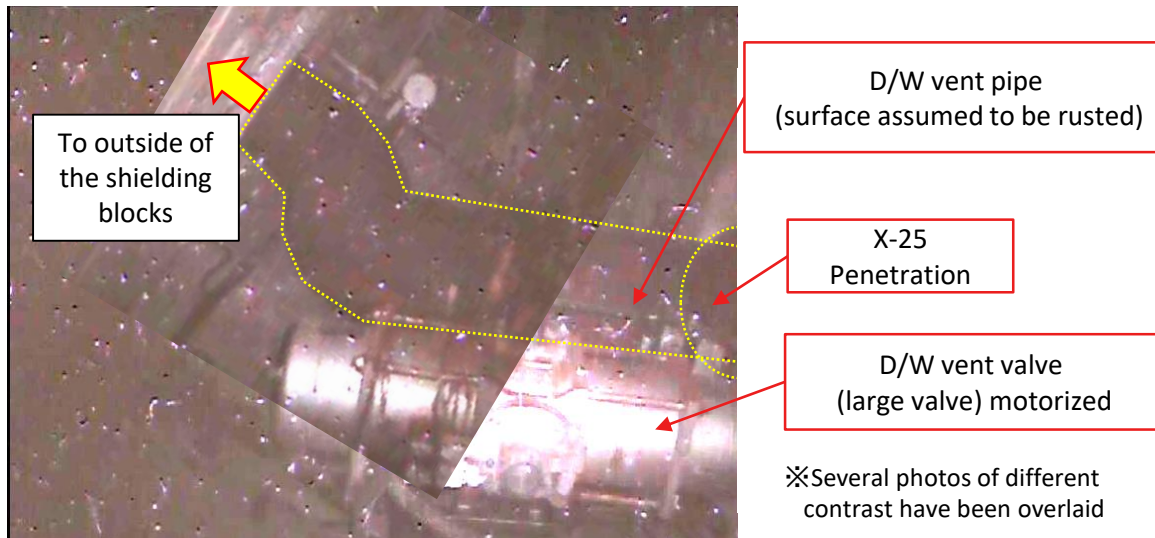
Photo 4 : Location C (Approximately 3m from the floor around the D/W vent pipe/valve)

- It was confirmed that there are no obstacles that would hinder drone flight
- A step ladder that would hinder crawler robot movement was found

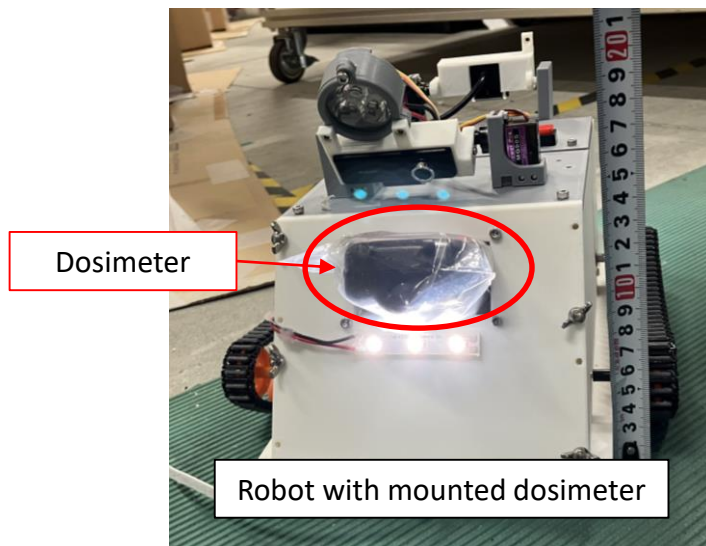
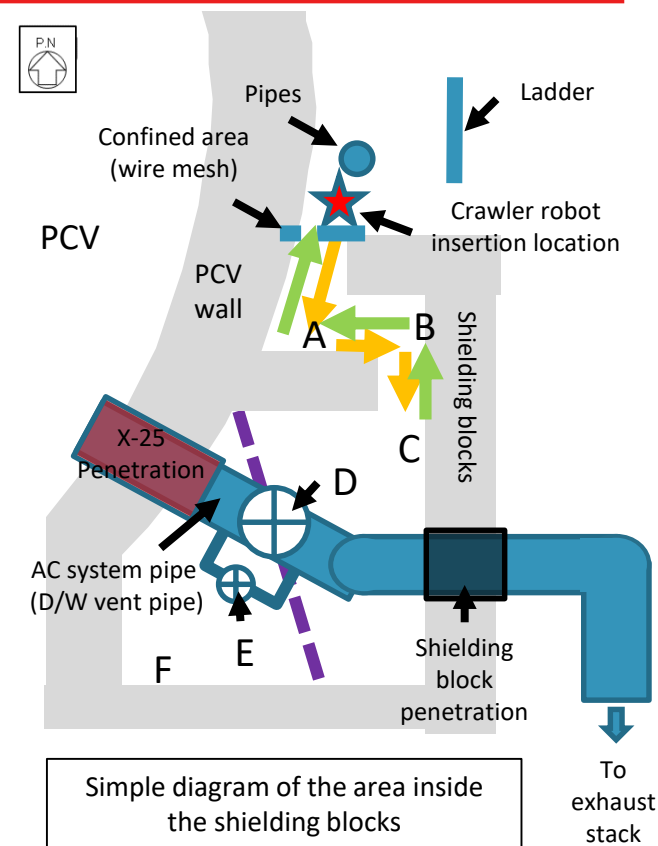
- Approximately 2,900mSv/h was measured at the location just past the labyrinth structure (Location C)
- Over 3,000mSv/h was measured as the robot moved in the direction of the D/W pipe

Measurement Location ※	Air dose rate[mSv/h]
☆	570
A	1,620
B	1,100
C	2,900
Moving south from C	Over 3,000
D,E,F	Step ladder prevents crawler robot entry

※ Measured approximately 12cm from the floor

- In light of the results of STEP 1~3 investigations, we will deliberate how to use a combination of the crawler robot and the drone to perform an investigation and move forward with preparations.

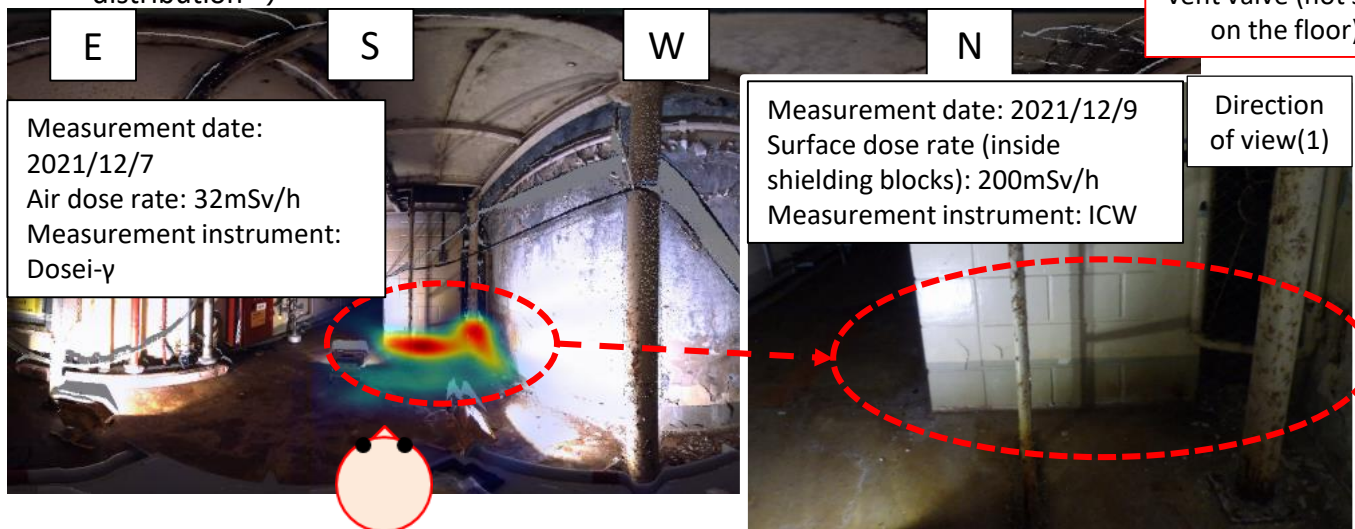
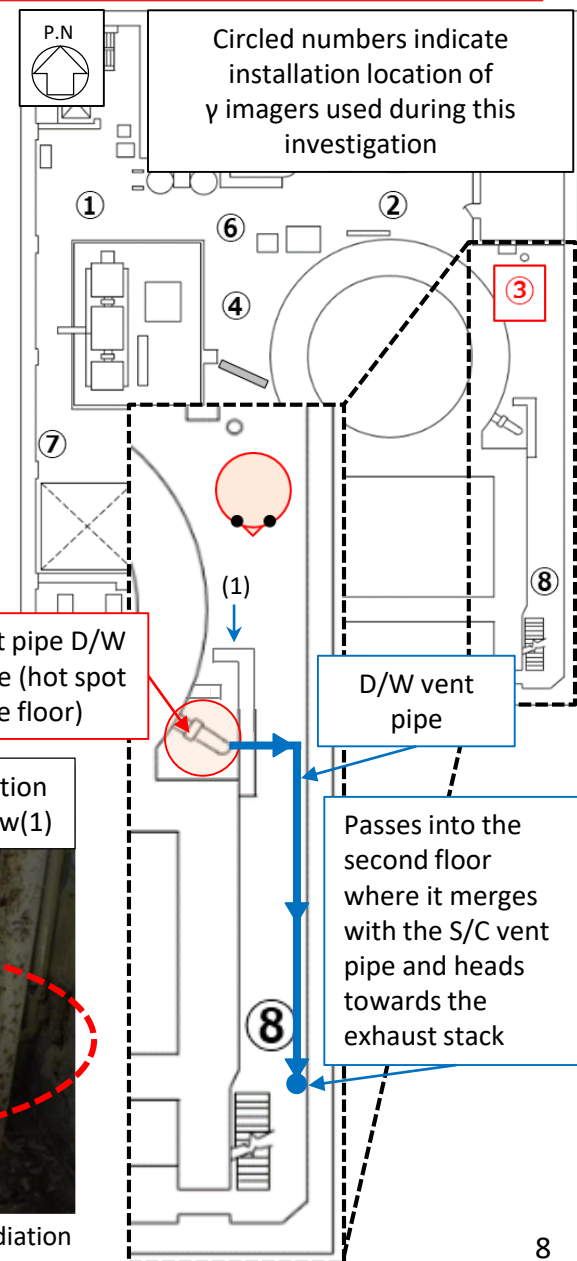
- $\gamma$  imager installation location ③ on east side of 3<sup>rd</sup> floor
- Identified hotspots:
  - Floor inside the shielding blocks where the AC system pipes (D/W vent pipe), and D/W vent valve exist (D/W venting was not performed during the accident)
    - The hotspot overlaid on the photo shows the direction of the high-dose location and indicates the high possibility that there is an actual hotspot inside the shielding blocks
- Assumed cause of the hotspot:
  - D/W pressure and temperature rose in conjunction with the generation of hydrogen. It is possible that this caused gases inside the D/W to leak outside the building via the penetration and the D/W vent valve, thereby concentrating within the shielding blocks and allowing radioactive substances to adhere to the floor.
- Overlay Photo (360° panoramic photo+  $\gamma$  radiation source intensity distribution※)

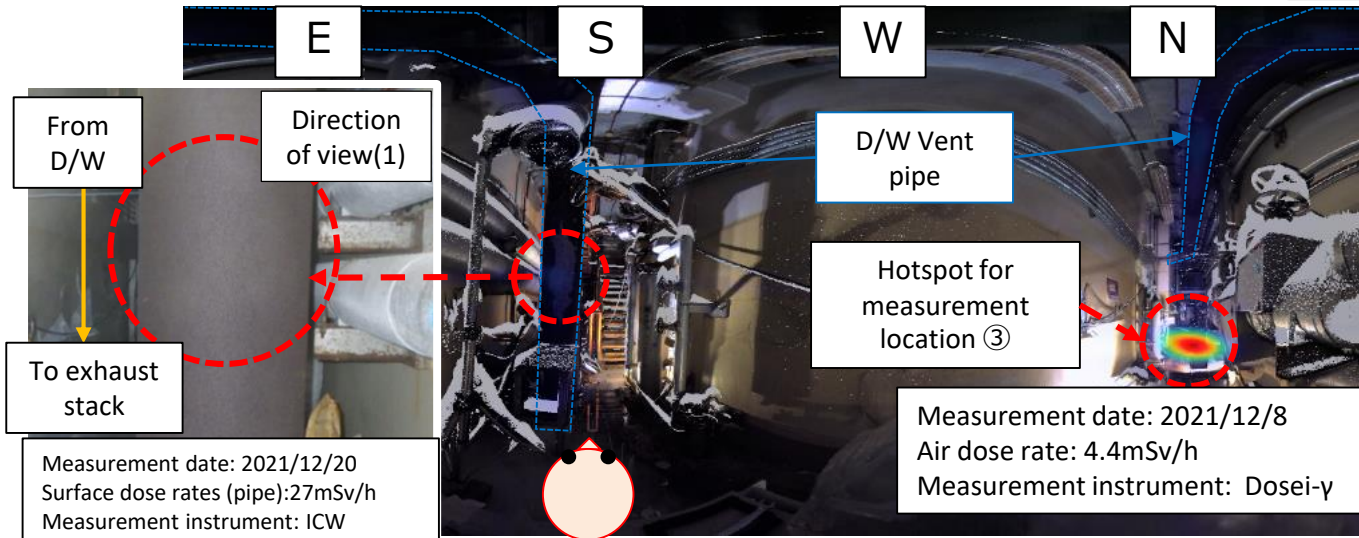
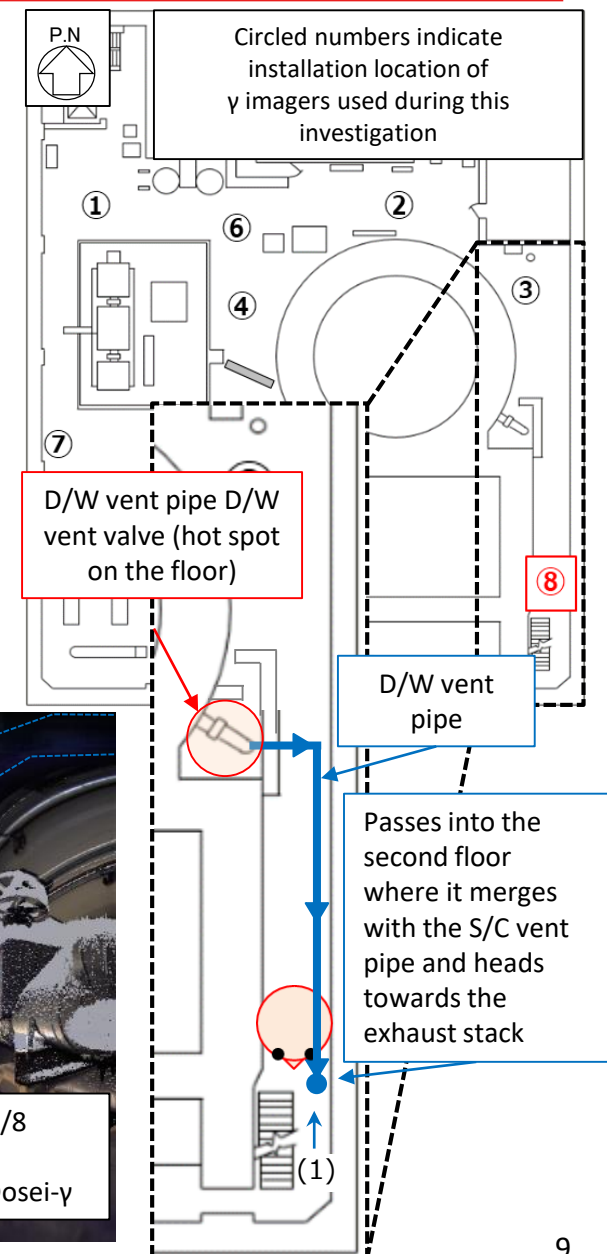
- Investigation results:
  - Since high dose rates were measured along the length of the pipe, it is assumed that the inside of the pipe is contaminated

- Even though the D/W vent valve was closed, the high pressure and high temperature of the D/W might have caused some of the gases inside the D/W to leak downstream via the valve

- It is possible that some of the S/C event gases flowed into the pipes
  - Rust was found along the entire surface of the pipe, which is different from other pipes in the area

- It is possible that the paint on the pipe degraded due to hot gases passing through it and the heat given off by a radioactive substances adhered to the inner side of the pipes thereby allowing rust to form

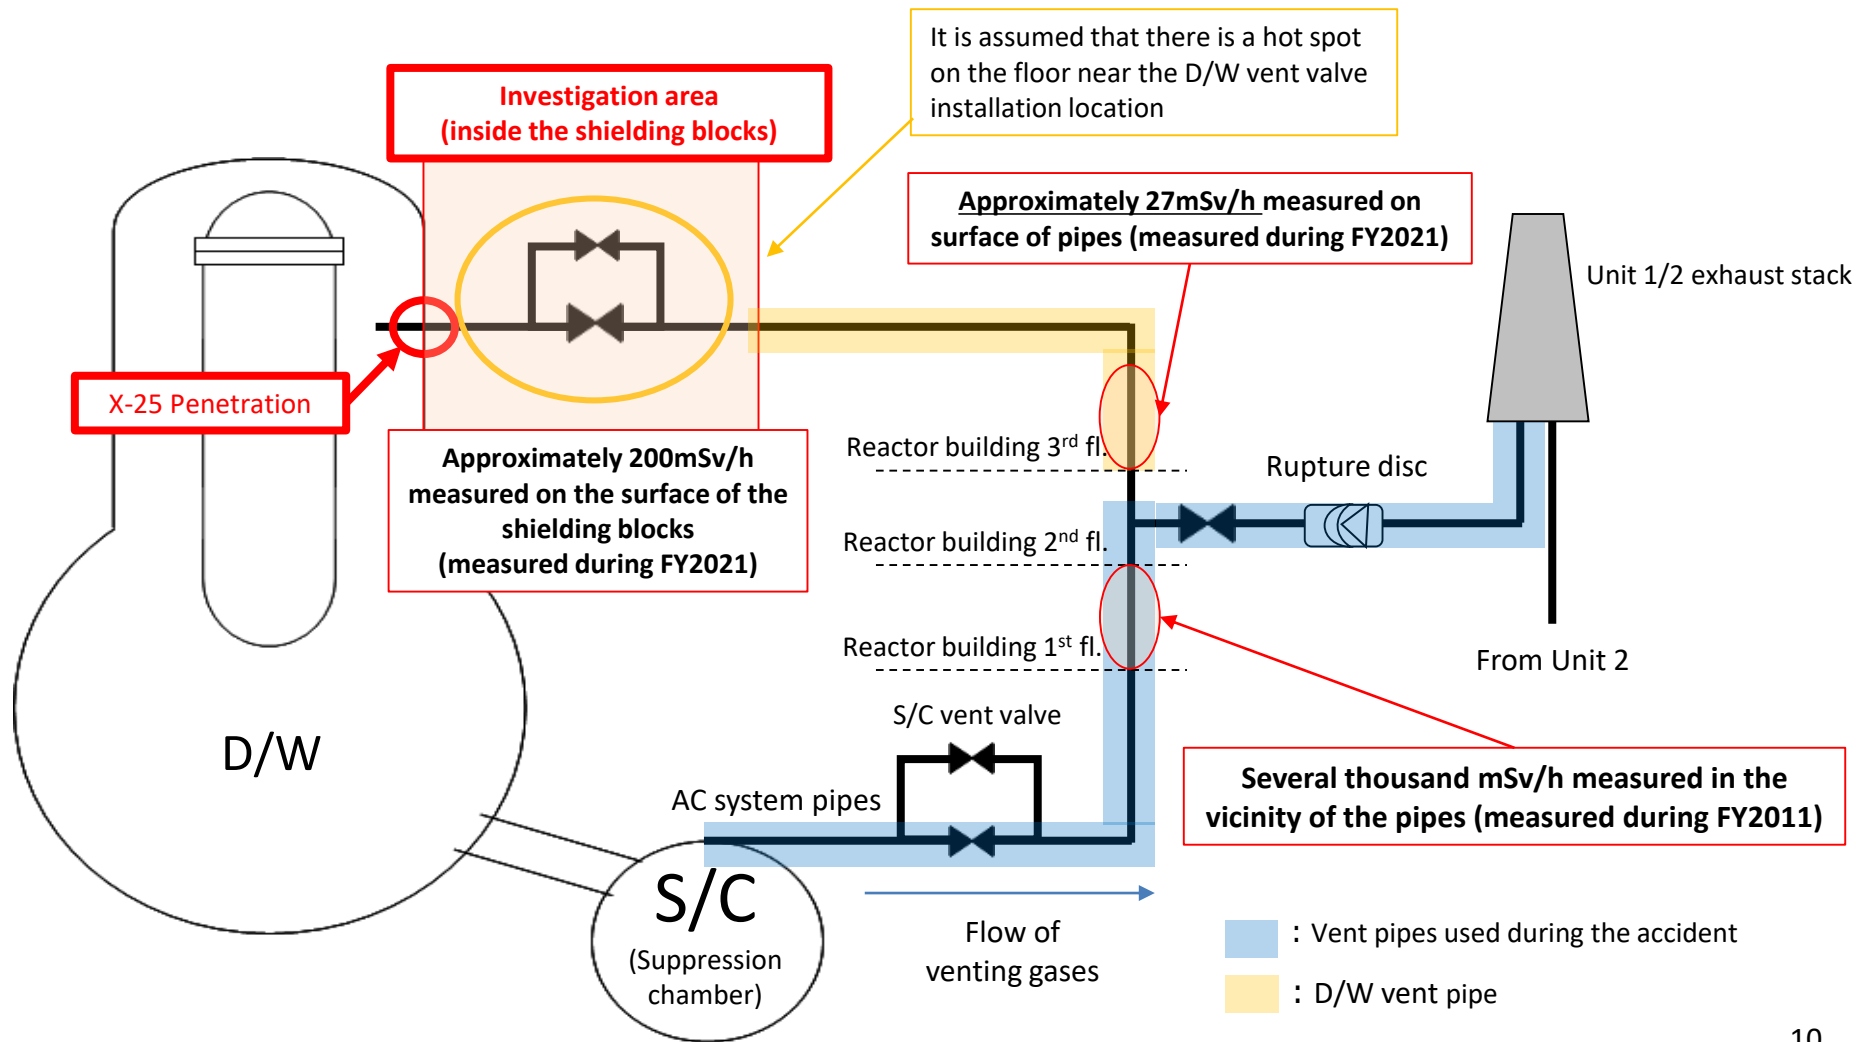
- The D/W vent pipe branches off from the vent lines used during the accident but dose rates in the vicinity of the investigation area (approximately 200mSv/h) are higher than the dose rates at the entrance to the branching pipe (approximately 27mSv/h), so it is assumed that the source of the high dose rates is something other than the vents.
