Causes and Countermeasures for the Decrease in Water Level of the Unit 2 SFP Skimmer Surge Tank and Going Forward Measures

November 28, 2024

Tokyo Electric Power Company Holdings, Inc.

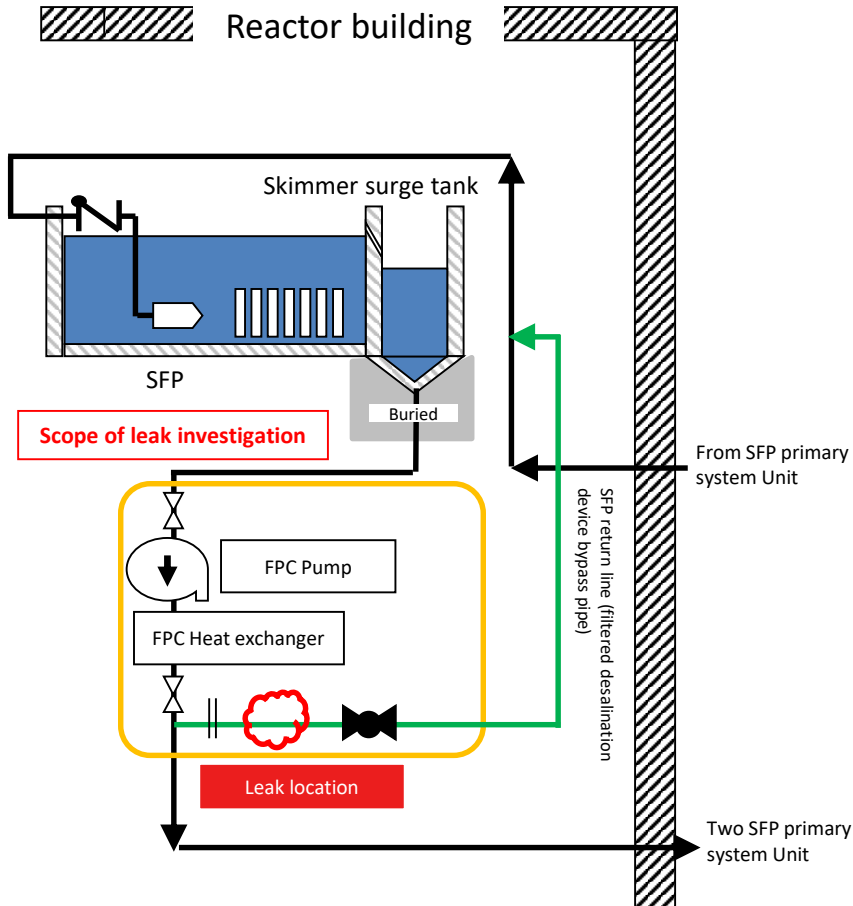
Simplified diagram of Unit 2 SFP system (leak location)

- One leak was found from the line returning directly to the SFP from the FPC heat exchanger (filtered desalination device bypass pipe ※)
- ※ Line that bypasses the existing FPC system filtered desalination device. It was used during inspection of the filtered desalination device but is not being used now. The filtered desalination device purifies and desalinates system water using filters and resin

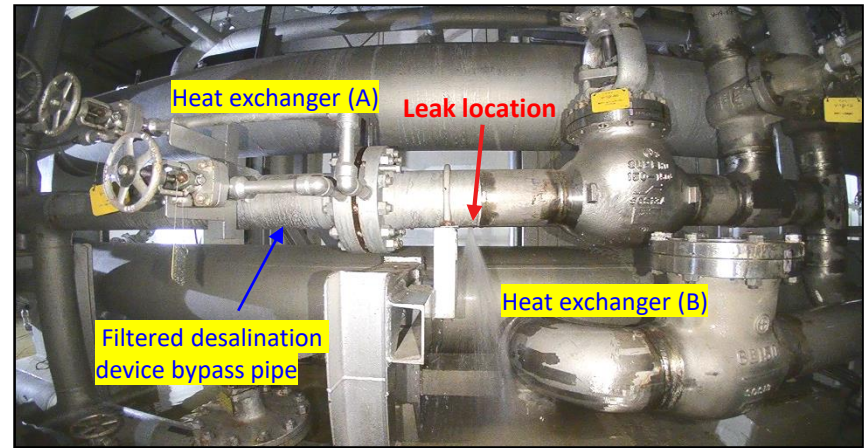
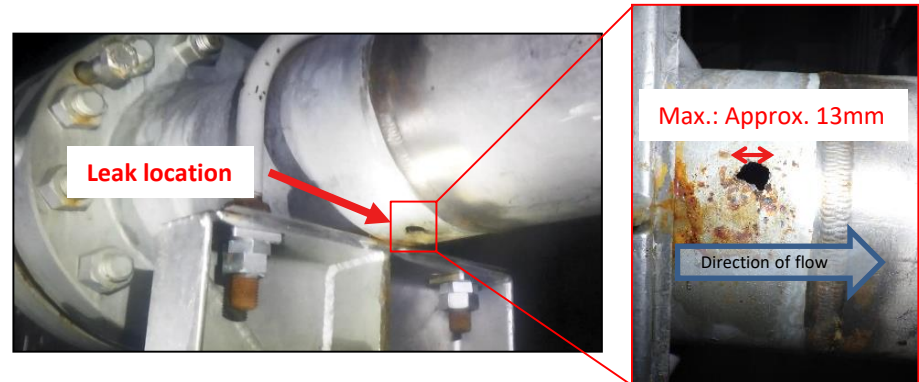
The location (for FPC heat exchanger room)

Specifications of pipe at leak location
Pipe material	Carbon steel used for pressurized pipes (STPG370)
Pipe diameter	150A
Pipe thickness (nominal)	7.1mm

Leak location conditions
Dimensions of leak hole	Max: Approximately 13mm
Location of leak hole	Underneath the pipe (directly underneath and extending for a width of approximately 10mm in the circumferential direction) Stretches for approximately 18mm in the axial direction from the weld
Inside the pipe	Deposits found inside the pipes
Pipe configuration	<ul style="list-style-type: none"> The material used from the weld line to the motorized valve side is stainless steel for pipes (SUS304TP), and the dissimilar metal joint consists of carbon steel (STPG370) and stainless steel A flow adjustment orifice is installed on the heat exchanger side

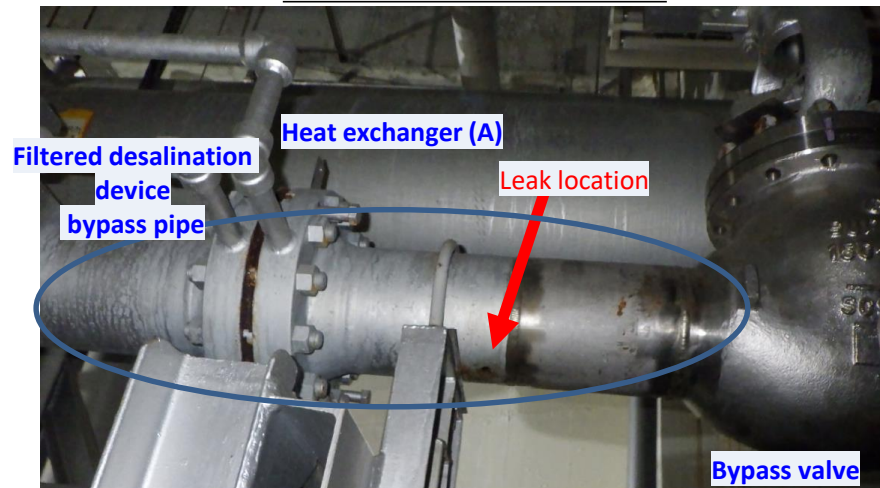
Area around the leak location

- ✓ The outside surface of the pipe was examined using drone cameras as well as via direct inspection by personnel.
- ✓ Discoloration thought to be rust was found around the hole causing the leak, but no significant corrosion was found on the outer surface of the pipe of the same line.

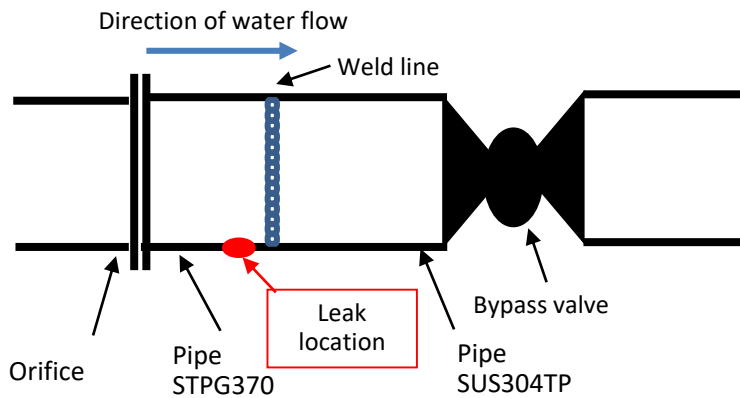
Pipe outer surface adhesion

- ✓ Adhesions on the outside of the pipe near the leak location were sampled and subjected to SEM – EDX analysis (elemental analysis).
- ✓ As a result of the elemental analysis, 0.6% chloride was detected.
- ✓ It is assumed that system water leaking from the leak location caused chloride to adhere to the outer surface of the pipe.

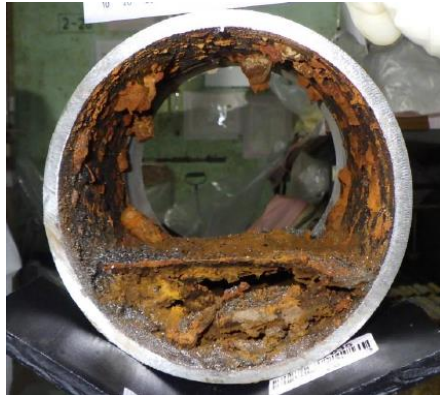
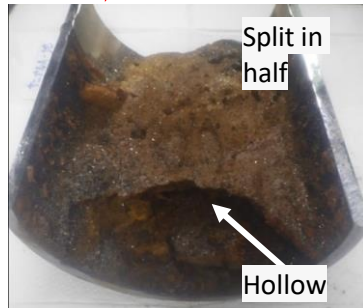
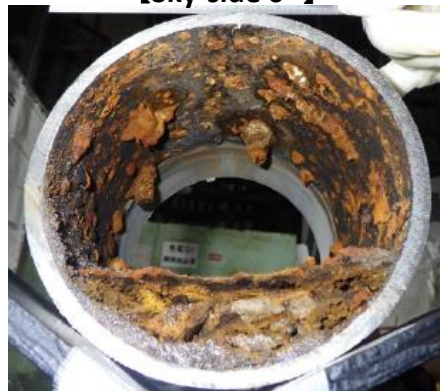
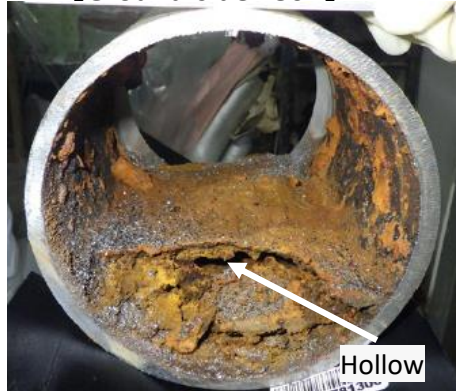
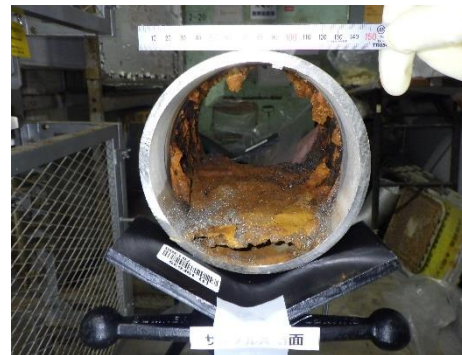
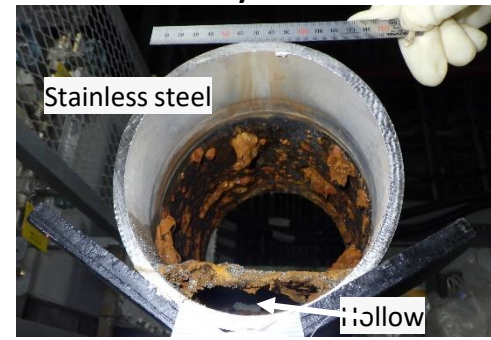
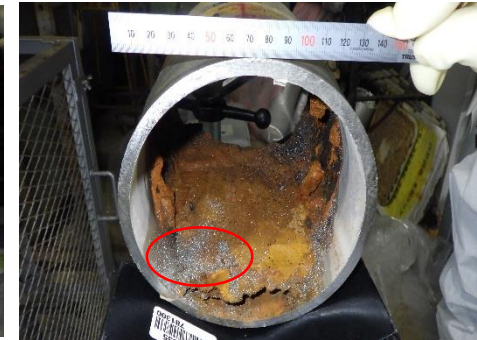
Reddish-brown adhesions were observed along the entire circumference of the inner surface of the carbon steel, and some clump-like adhesions were seen on the sky-side. There were bridge-like deposits on the ground-side, and the area below it was hollow. There were deposits on the ground-side on the stainless steel pipe side, and the area below it was hollow, but no deposits were found on the sky-side side.

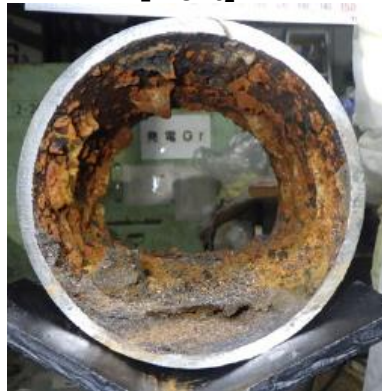
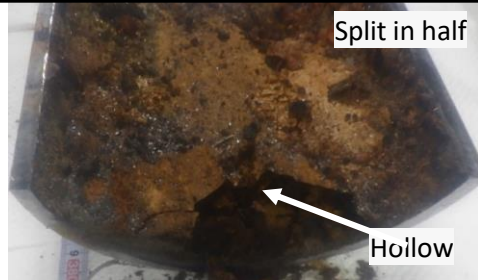
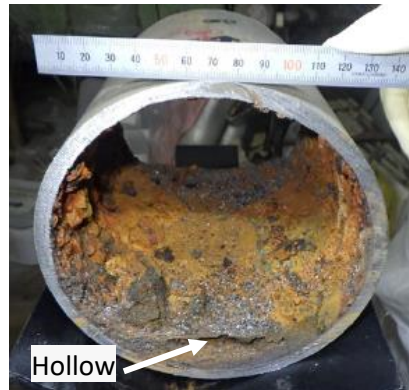
[Sample C f cross-section]

[Confirmation results]
 Reddish-brown adhesions were observed along the entire circumference of the inner surface, and some clump-like adhesions were seen on the sky-side. There were bridge-like deposits on the ground-side, and soil-like (gray) deposits were found below them. This area below was hollow.

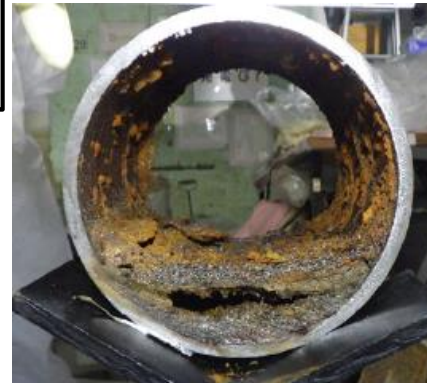
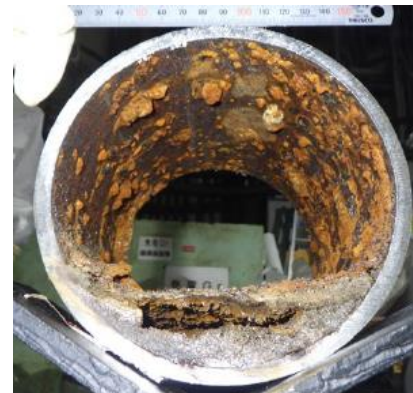
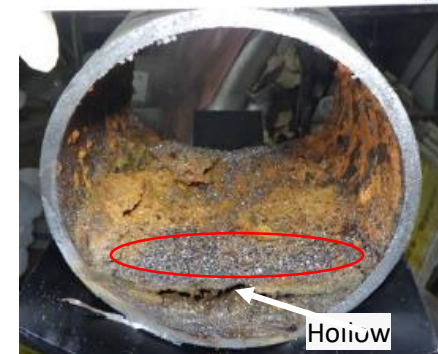
[Sample B cross-section]

[Confirmation results]
 Reddish-brown adhesions were observed along the entire circumference of the inner surface, and some clump-like adhesions were seen on the sky-side. There were bridge-like deposits on the ground-side, and soil-like (gray) deposits were found below them. This area below was hollow.

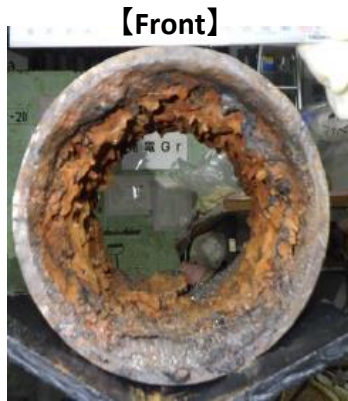
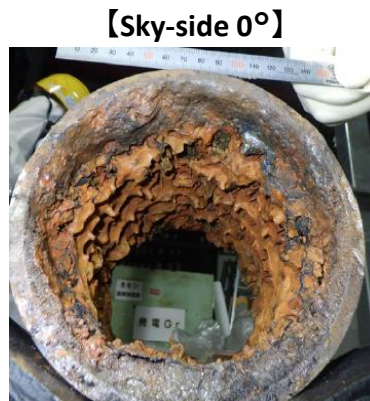
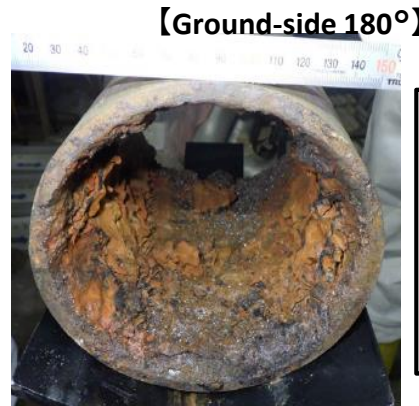
【Sample D h cross-section】

Reddish-brown adhesions were observed along the entire circumference of the inner surface, and some clump-like adhesions were seen on the sky-side. There were deposits on the ground-side (surface is reddish-brown, with gray deposits underneath)

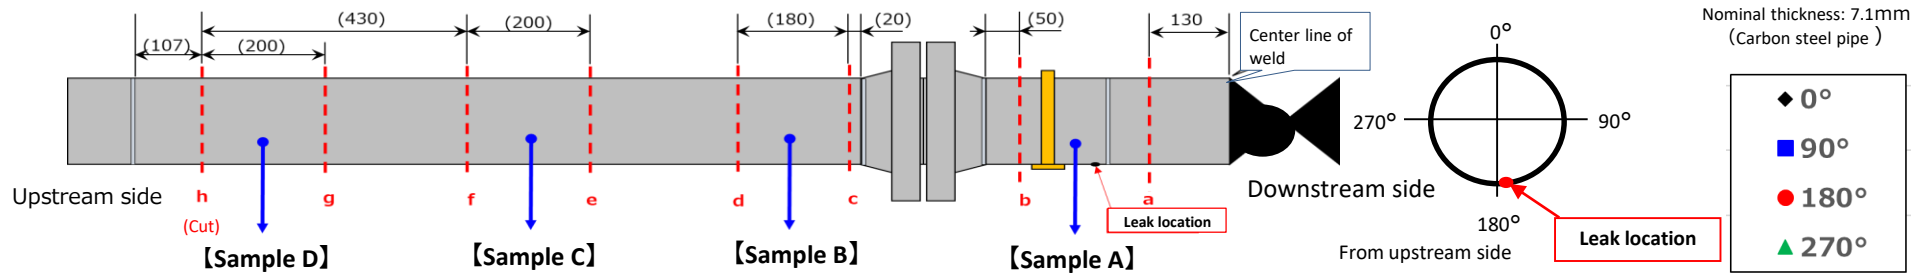
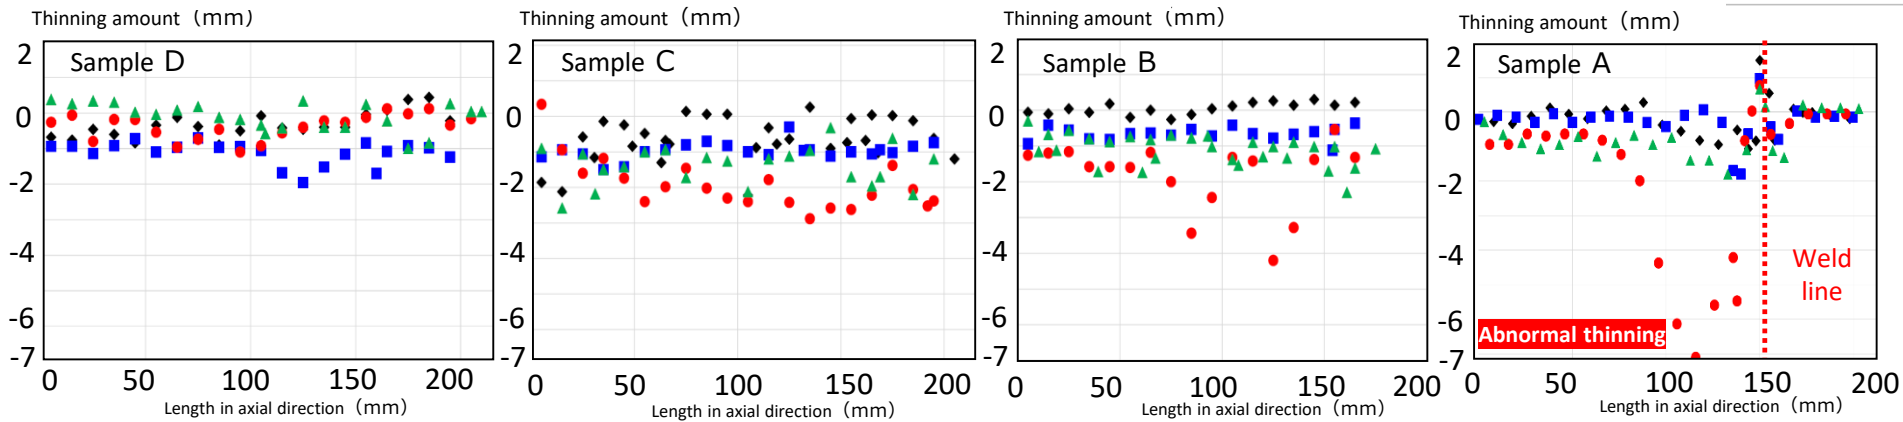
- ✓ Sample A : Thinning on the sky-side 0° and 90° was minimal, but other thinning was observed. The amount of thinning on the ground-side 180° was relatively large, and an abnormally large amount of thinning was found on the carbon steel side approximately 100mm from the weld line. No significant thinning of the stainless steel pipe was observed.
- ✓ Sample B : Thinning on the sky-side 0° was minimal, but other thinning was observed. The amount of thinning on the ground-side 180° was relatively large, and fairly uniform.
- ✓ Sample C : Thinning on the sky-side 0° was minimal, but other thinning was observed. The amount of thinning on the ground-side 180° was relatively large
- ✓ Sample D : Thinning was observed around the entire circumference, and there was little non-uniformity in each direction.

1.9	2.2	1.5
1.8	aperture	2.0
1.9	1.2	2.4

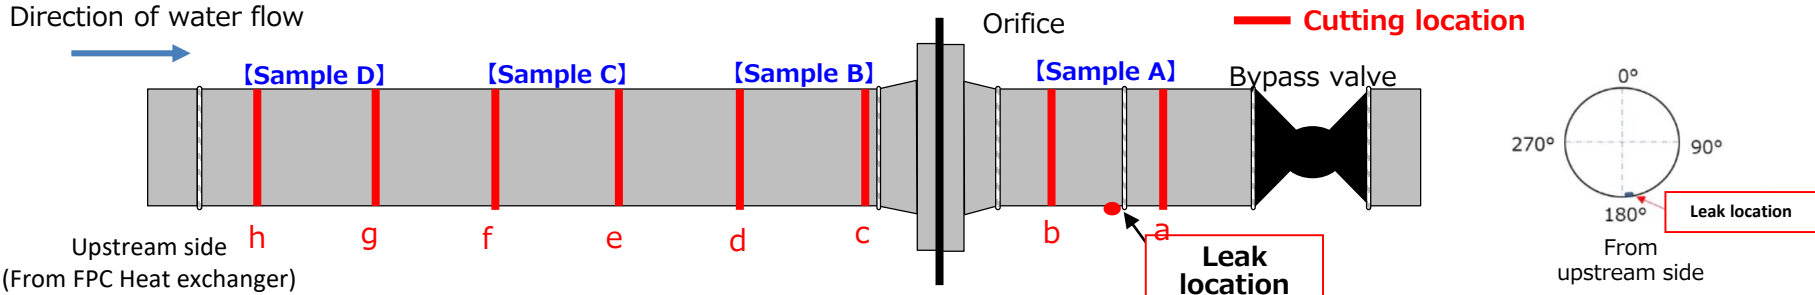
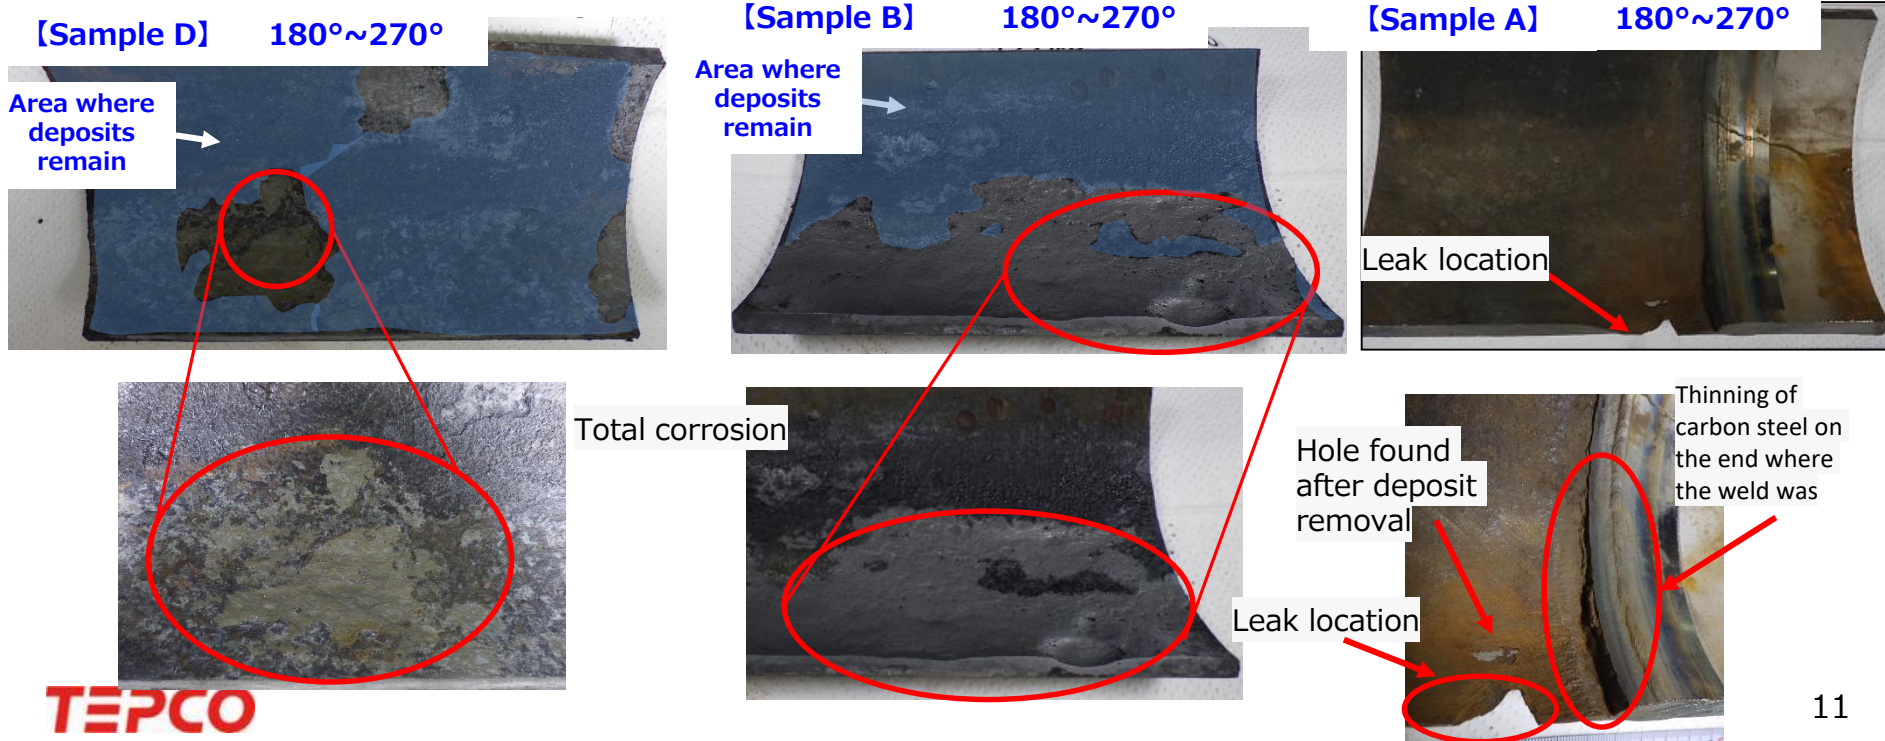
- ✓ The internal surface of the pipe was observed after removing the deposits.
- ✓ The internal surface of pipe samples A, B, D confirmed corrosion throughout.
 - 【Sample A】 Abnormally large thinning was confirmed approximately 100mm from the weld line on the 180° side
 - 【Sample B】 Thinning on the 180° side was uniform with localized deeper thinning
 - 【Sample D】 Corrosion confirmed throughout

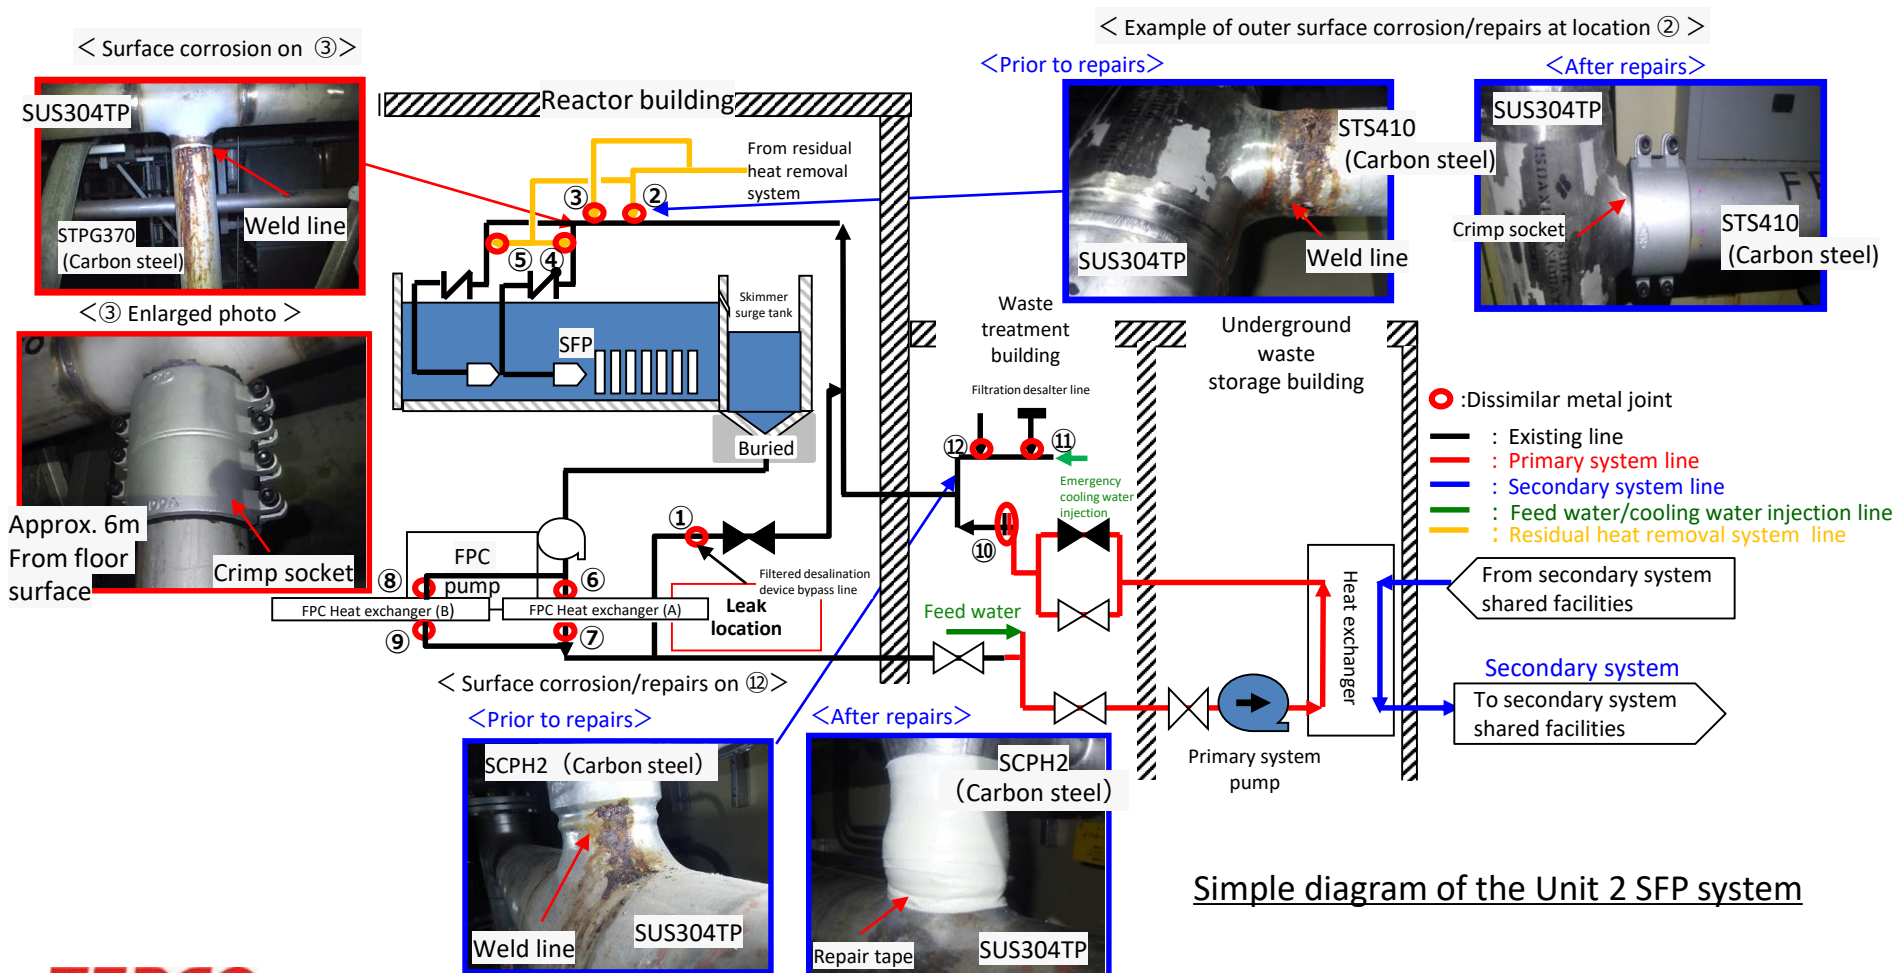
- ✓ Including the leak location, 12 joints similar to the pipe where the leak was found (dissimilar metal welds) were confirmed
- ✓ Corrosive elements were found adhered to the outer surface of welds ②, ③, and ⑫ so repairs were made.
- ✓ Since welds ④ and ⑤ are buried in the concrete of the operating floor, the state of corrosion of the outer surface of the pipes could not be observed. (Skimmer surge tank water level monitoring and stagnant water level monitoring will be employed to determine if there is a leak since the leaking water would flow through the floor funnel into the stagnant water in the building)
- ✓ A visual inspection of the outside of the pipes and thickness measurements were conducted for welds ⑥~⑪ and no significant thinning was found.

- ✓ Pipes where leaks were found have been removed/sealed.
- ✓ A substitute cooling line (FPC pump/Heat exchanger bypass line) has been configured.
- ✓ The adhesion of corrosive materials was found on the outer surface of three other similar welds (dissimilar metal welds) and repairs have been made.
- ✓ A leak check was conducted utilizing the operating pressure of the substitute cooling line, and it was confirmed that there are no abnormalities.

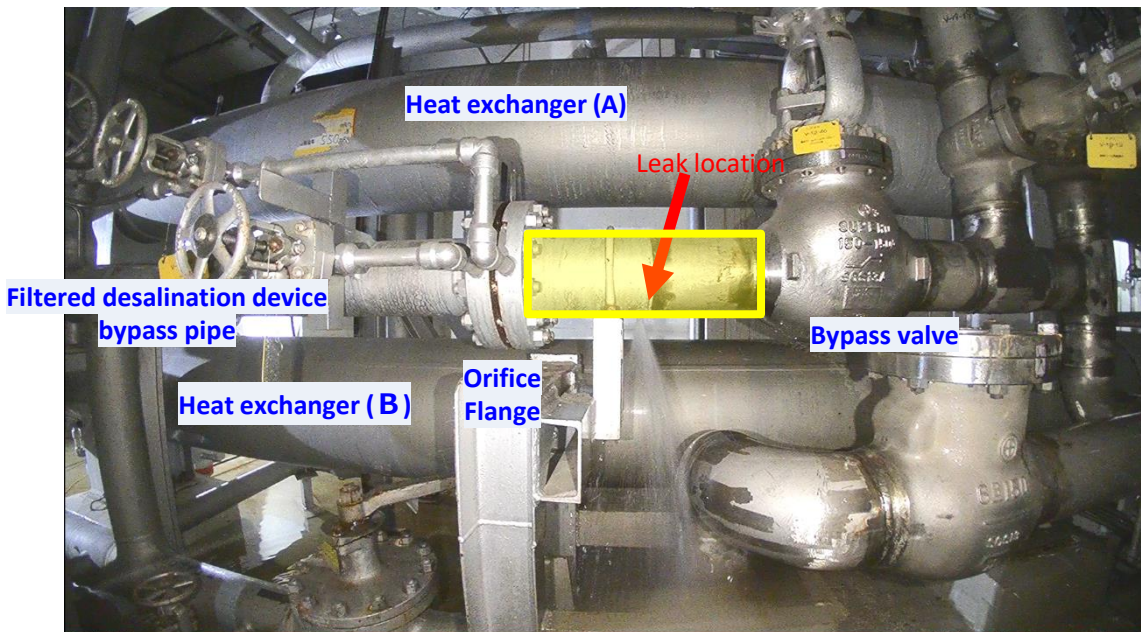
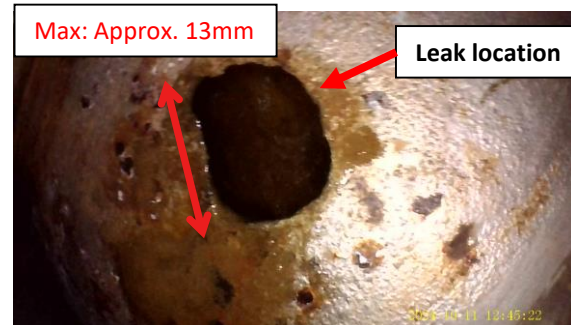
【Examining the leak location with a fiber scope】

- : The top of the pipes cannot be examined due to deposits
- : Deposits

The top of the pipes cannot be examined due to deposits

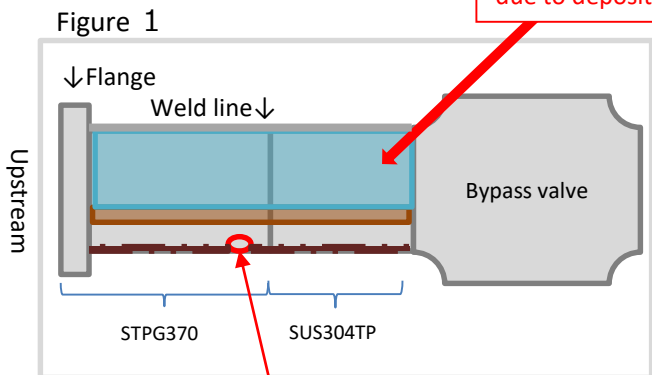
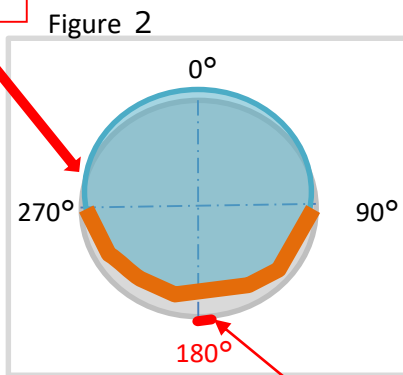
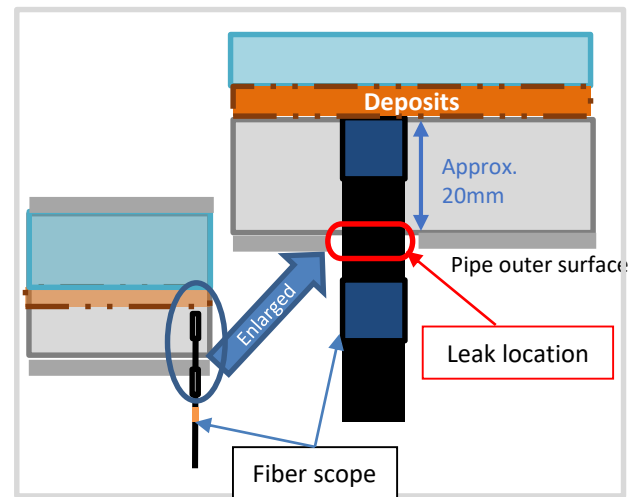
Fiber scope cannot be inserted upwards due to deposits
