# Unit 3 X-6 Penetration Front Chamber Investigation Results

December 26, 2024

Tokyo Electric Power Company Holdings, Inc.

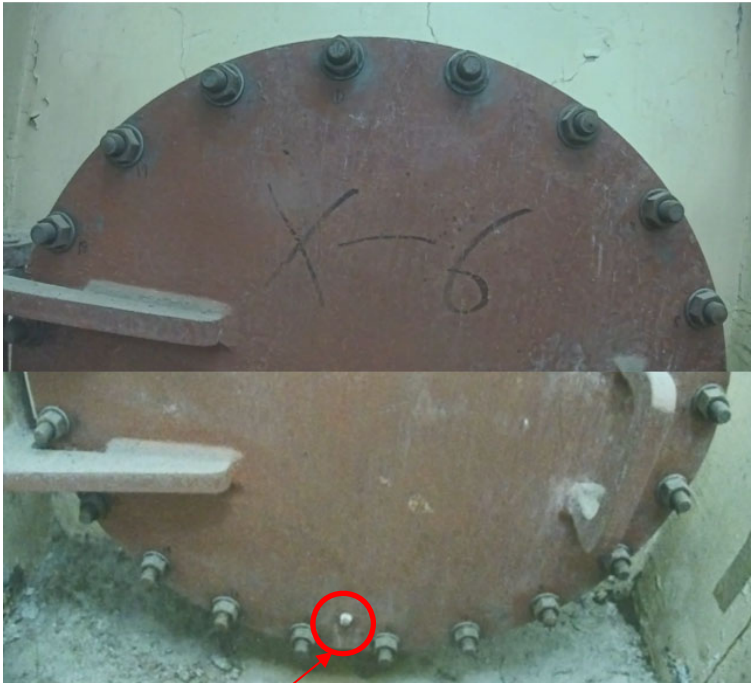
### 1. Front (flange face)

- No adhesions of molten material were found on the flange face of X-6 penetration like those seen at Unit 2, and the external conditions are not very different compared to prior to the disaster.
- There are no deposits on the front chamber floor like those confirmed at Unit 2, and small diameter clumps of what is assumed to be concrete can be seen.

N<sub>2</sub> injection insertion line for flange leak tests

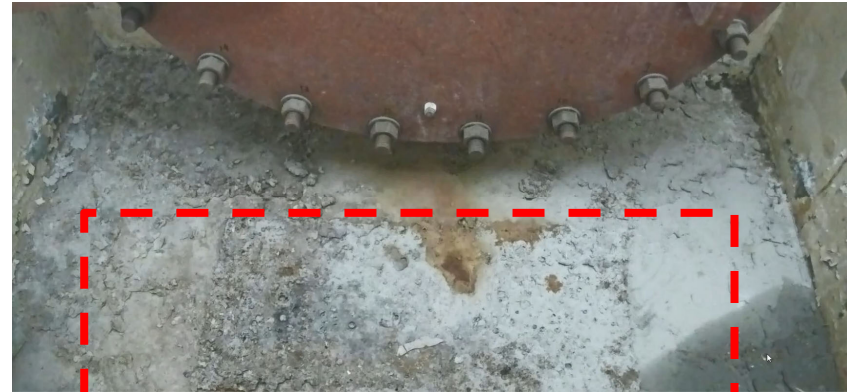
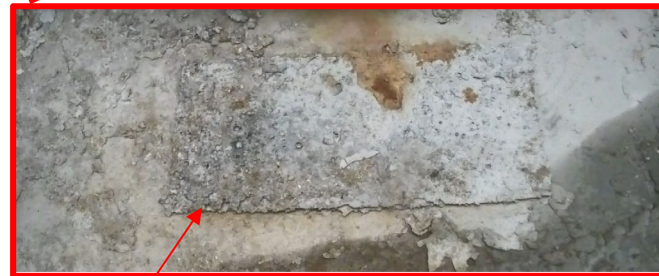
### 2. Front chamber floor

Embedded metal fixture that serves as a base for the CRD replacement rails

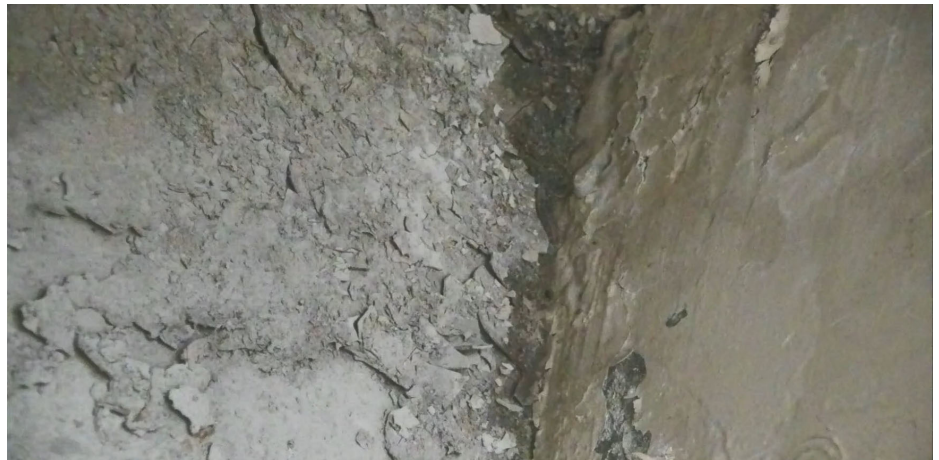
4. Floor (back right)

External frame of shielding that fell when the hole was bored

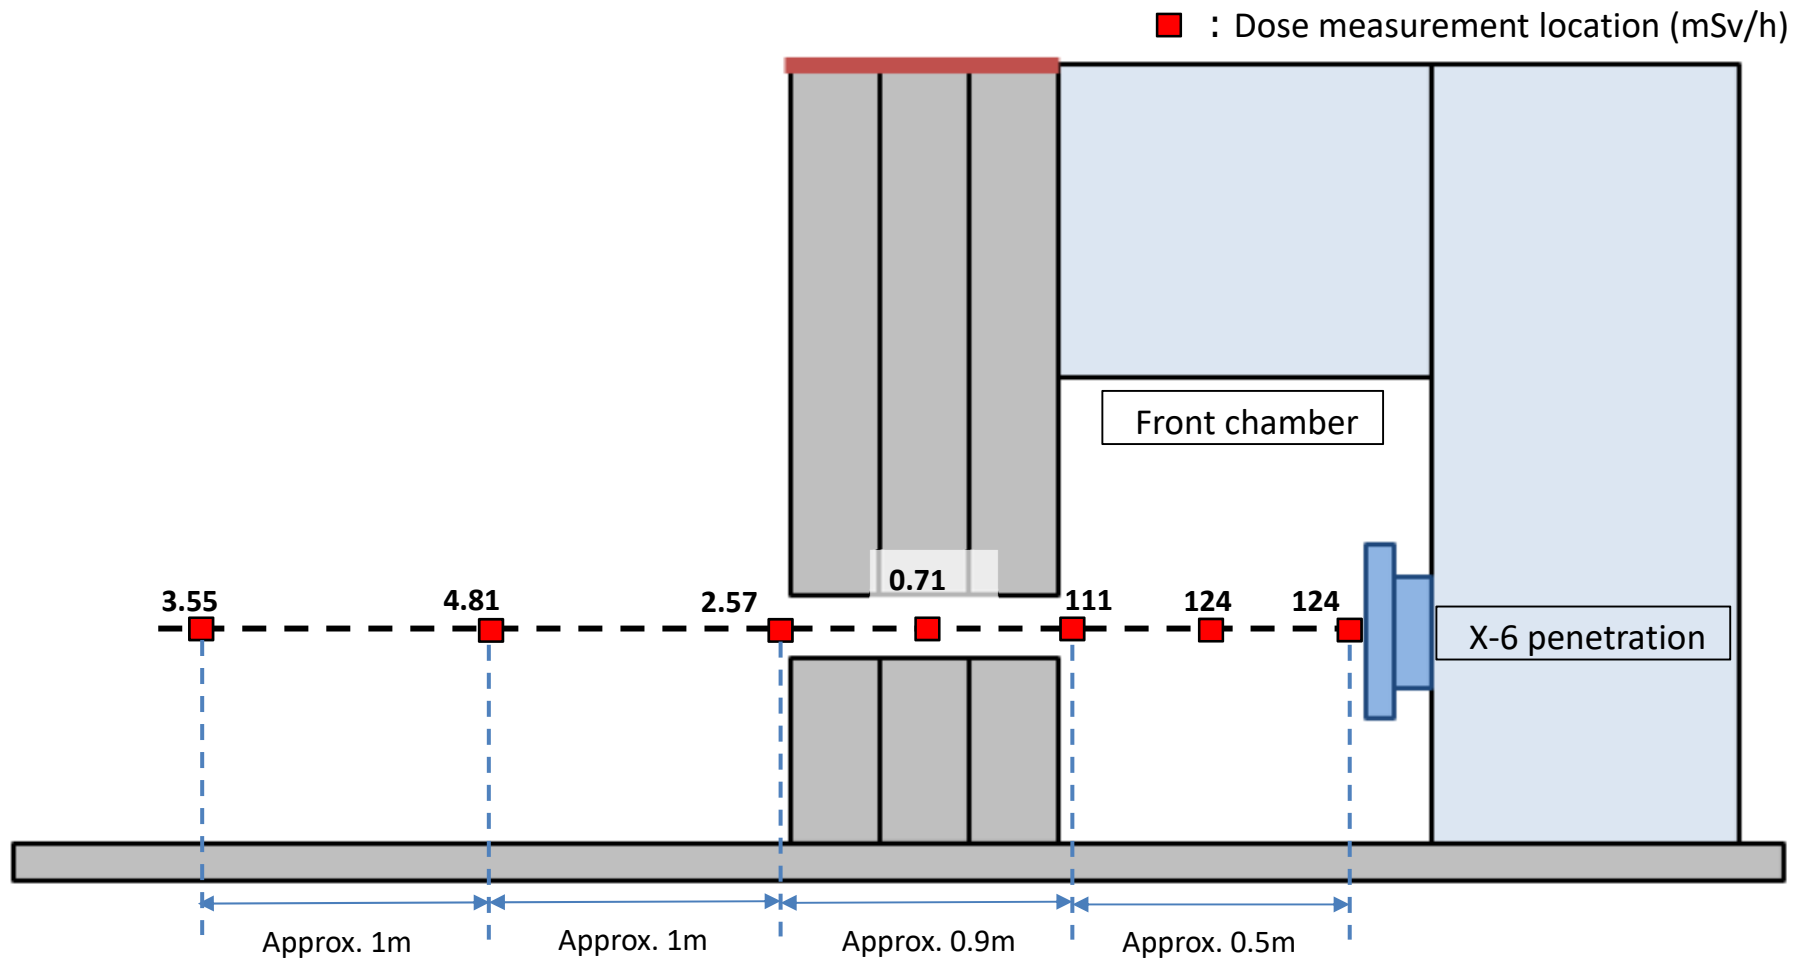
### 3. Unit 3 X-6 penetration front chamber interior dose measurement results

- A maximum dose of 124mSv/h was measured inside the X-6 penetration front chamber.

- Furthermore, air dose rates inside the front chamber were high at maximum 124mSv/h, but compared to inside the Unit 2 front chamber, the air dose rate is low, and no molten materials were found on the floor.

- Going forward, we shall deliberate methods for reducing the dose rates inside the front chamber and removing the shield walls based on these results. And, after doing so, we shall decide whether or not additional investigations are needed and plan them accordingly.

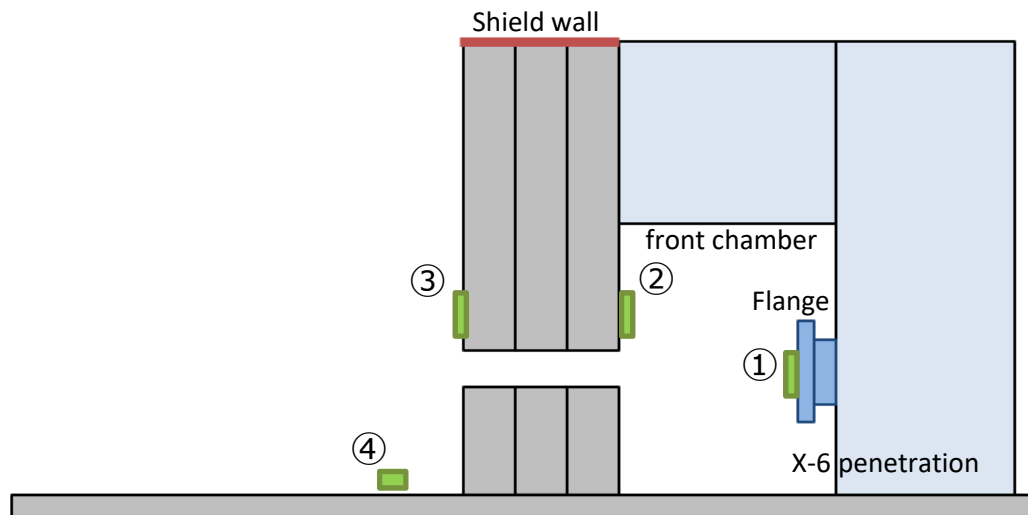
X-6penetration front chamber

No.	Smear sampling location	Unit	Cs-134	Cs-137	Gross $\beta$	Gross $\alpha$
①	Flange surface	Bq/cm <sup>2</sup>	4.2E-01	4.2E+01	3.1E+01	<1.5E-03
②	Inner wall of the shielding	Bq/cm <sup>2</sup>	1.8E+02	1.4E+04	9.4E+03	<2.0E-01
③	(Reference) Outside surface of shielding wall	Bq/cm <sup>2</sup>	8.4E+00	6.6E+02	5.1E+02	6.0E-03
④	(Reference) Floor on the northwest side of the first floor of the R/B	Bq/cm <sup>2</sup>	1.5E+02	1.1E+04	7.2E+03	<2.0E-01

※ Assumed reason why contamination is higher at ② than ①

In addition to the flange, it is possible that radioactive substances could find their way into the X-6 penetration front chamber through gaps in the ceiling of the front chamber and shield walls. Since the top of the shield walls were showered with water to decontaminate them after the disaster, it is possible that radioactive substances found their way in through these gaps.

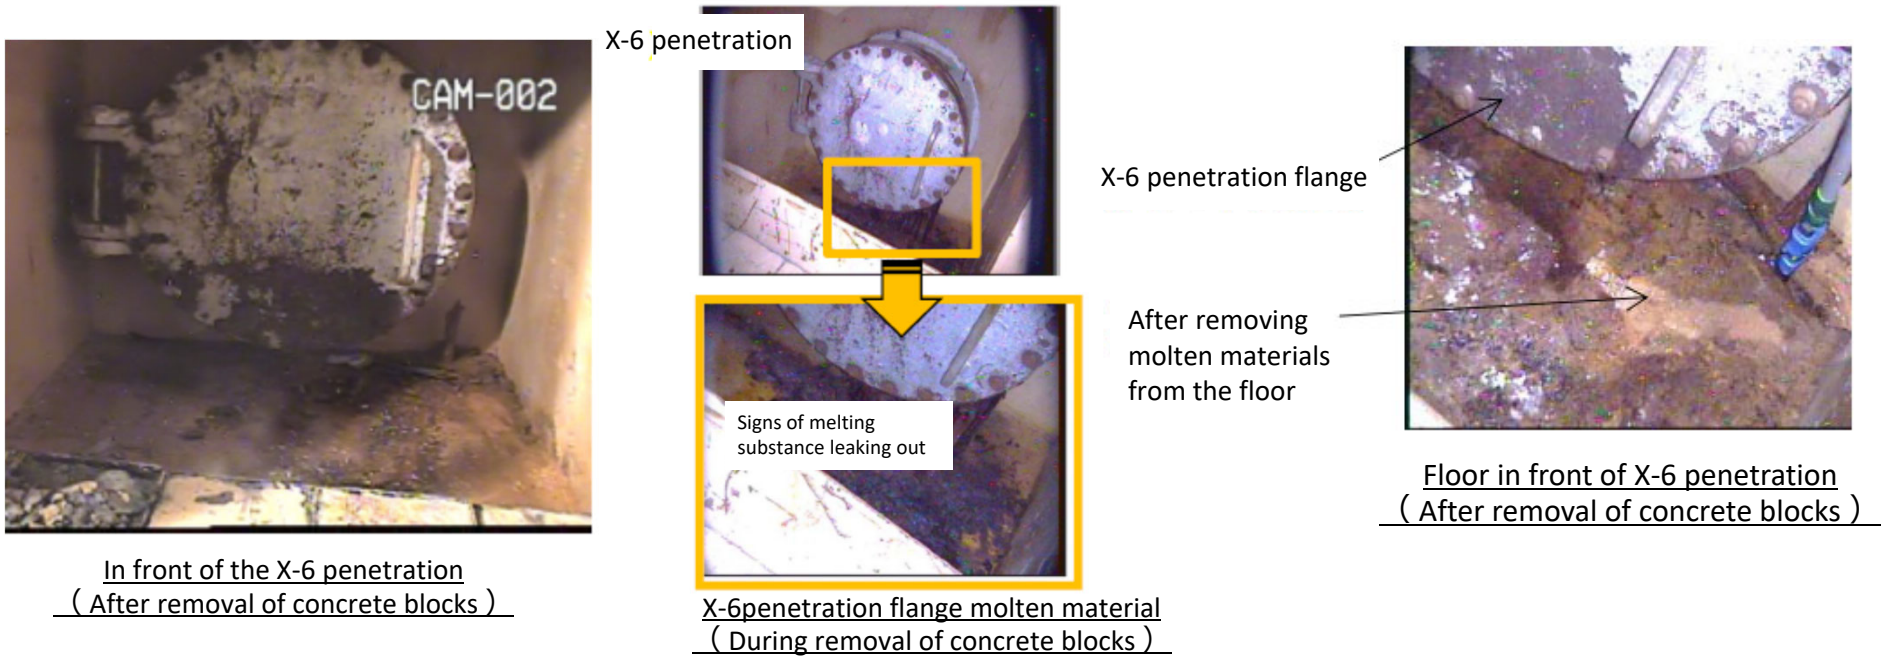
In front of the X-6 penetration  
( After removal of concrete blocks )

X-6penetration flange molten material  
( During removal of concrete blocks )

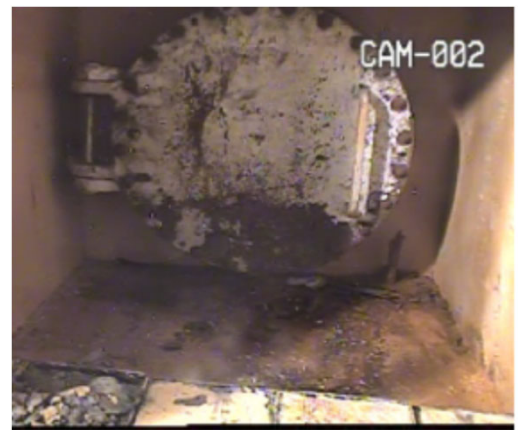
In front of the X-6 penetration  
( After concrete block removal )

- The area around the X-6 penetration was photographed, dose measurements were taken, and the following were confirmed:
  - Molten material and signs of molten material were found on the floor of the X-6 penetration flange.
  - Dose levels exceeded 1000mSv/hour at the center of the X-6 penetration flange.

- Concrete blocks were piled up to shield the front of the Unit 2 X-6 penetration.
- A remote operated device and forklift were used to remove the concrete blocks.
