ALPS Treated Water Discharge Status Update

January 30, 2025

Tokyo Electric Power Company Holdings, Inc.

2. Facility inspection status

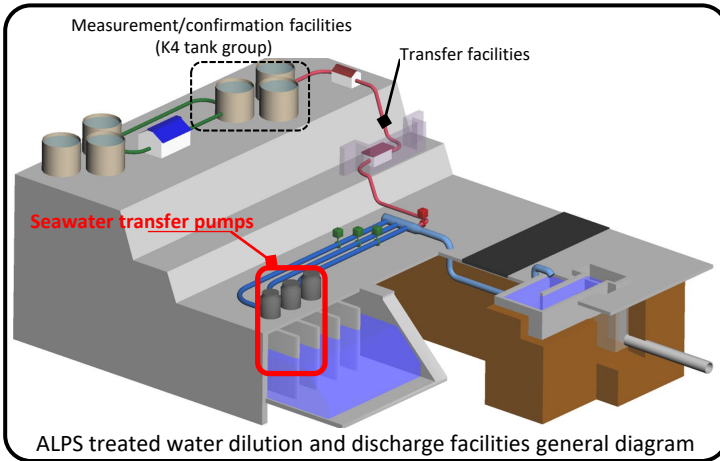
Impeller

- A disassembly inspection was conducted for seawater transfer pump system C and no abnormalities were found. The system will be reassembled, brought back online and subjected to test operation.

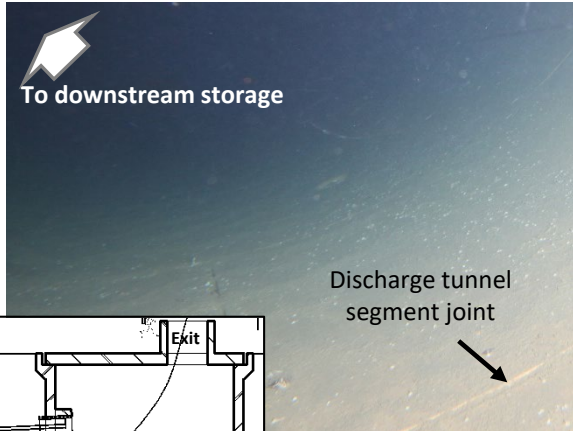
Discharge tunnel wall surface conditions
(Approx. 350m from the exit)

- An internal inspection of the discharge tunnel and discharge outlet were conducted and no abnormalities were confirmed.

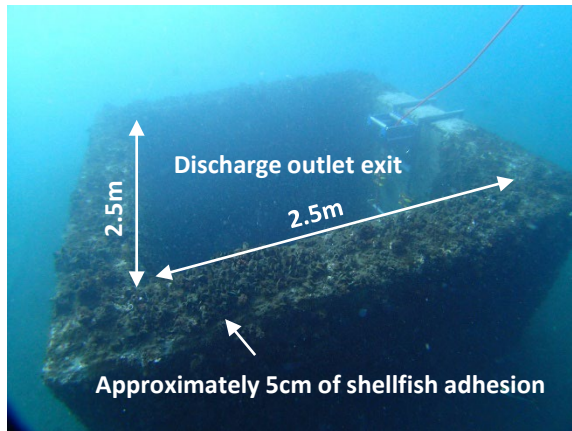
Discharge outlet exit

| Inspection item | Results of this inspection (January 2025) | Results of previous inspection (June 2024) |
|---|---|---|
| Marine organism adhesion | Outside surface of the discharge outlet: Approximately 5cm of adhesion Inside surface of the discharge outlet: Approximately 5cm of adhesion centering around the top No seaweed on the seafloor around the discharge outlet Inside the discharge tunnel: some adhesion of marine organism (until approximately 20m into the tunnel) <u>marine organism adhesion gradually decreases as you get more than 20m inside the title with no adhesion at around the 350m mark.</u> | Outside surface of the discharge outlet: Approximately 5cm of adhesion Inside surface of the discharge outlet: approximately 5cm of adhesion centering around the top No seaweed on the seafloor around the discharge outlet Inside of the discharge tunnel ^{※1} : Some adhesion of marine life |

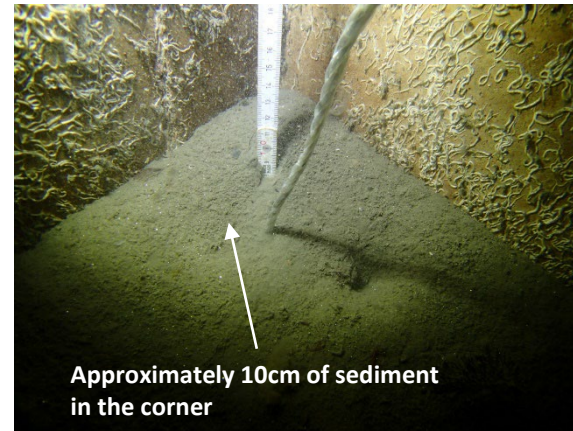
Bottom of discharge outlet (east side)

| Inspection item | Results of this inspection (January 2025) | Results of previous inspection (June 2024) |
|---|---|---|
| Sediment conditions | Approximately 20cm on average on the bottom of the discharge outlet Sediments inside the discharge tunnel are sparse and <u>only several centimeters thick, there is sediment several centimeters thick at the vertical alignment change point.(no sediments more than 300 m from the exit)</u> | Approximately 20cm on average on the bottom of the discharge outlet Approximately several centimeters of sediment inside the discharge tunnel ^{※1} |
