# ALPS Treated Water Discharge Status Update

February 27, 2025

Tokyo Electric Power Company Holdings, Inc.

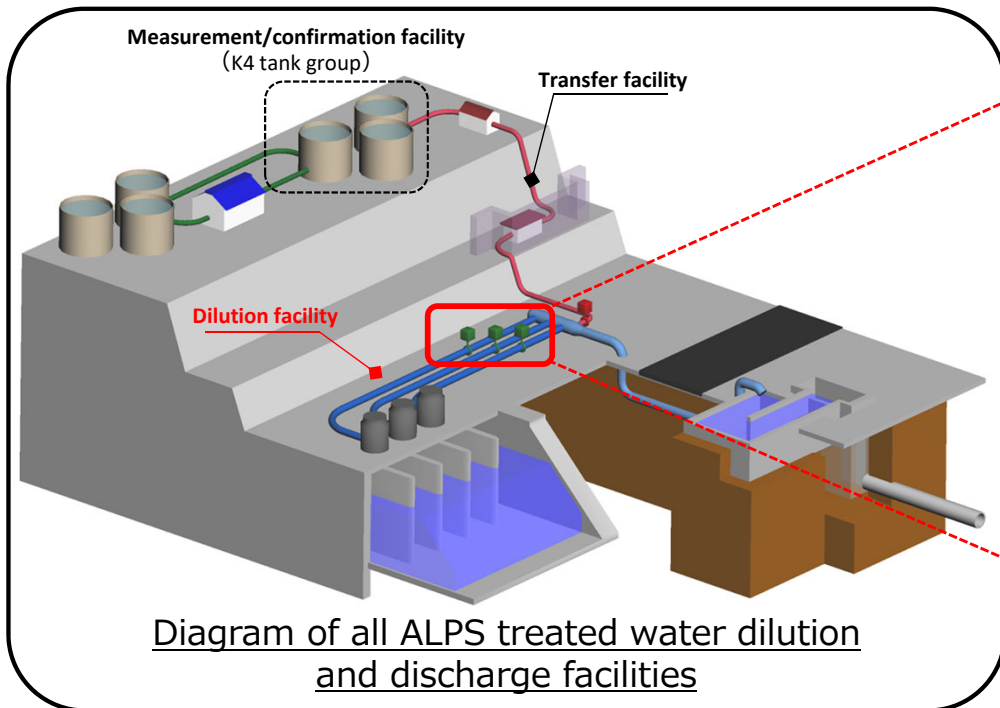
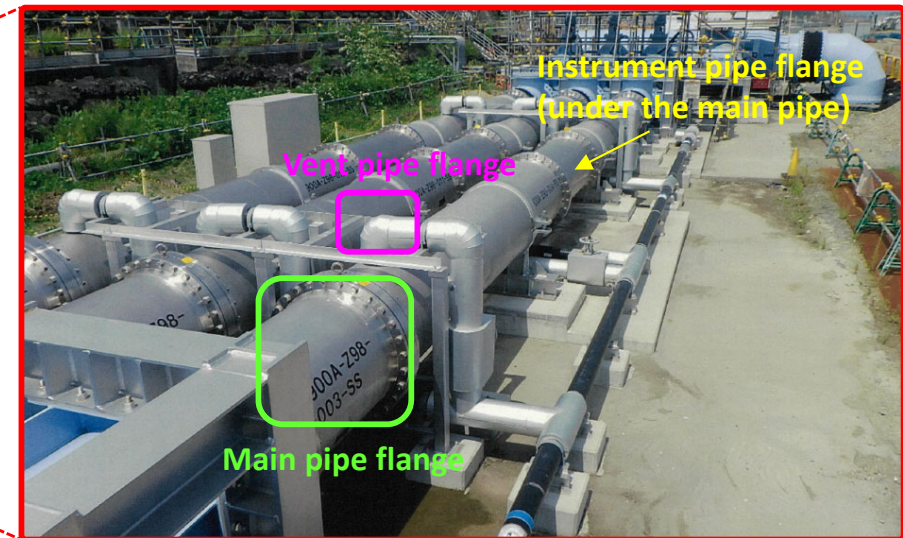
Seawater transfer pipes

- The internal surface of the seawater transfer pipes (900A, duplex stainless steel) is in good condition and we confirmed that there are no problems with the dilution of ALPS treated water with seawater (already reported).
- Corrosion was found on the vent pipes (6 locations, 50A) and instrument pipe (6 locations, 15A) flanges (duplex stainless steel) which are attached to the seawater transfer pipes (already reported), then they were replaced.

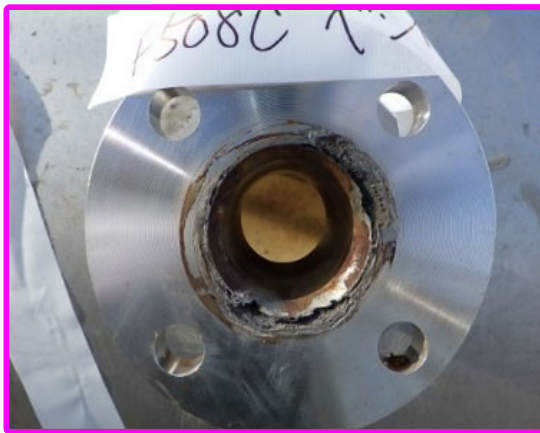
- Trial operation of seawater transfer pump systems A, B, and C were implemented on February 14 and 17, 2025. Leak checks were also performed and it was confirmed that there are no abnormalities.
- The cause of the corrosion found in the ancillary pipes for the seawater transfer pipes during this inspection is gap corrosion that could be prevented by implementing the following countermeasures.
  - Since the corrosion occurred after 18 months, we will regularly flush the vent pipes, etc., to prevent an increase in localized concentrations of chloride ions caused by stagnant water and implement inspections/check conditions 10 months later.
  - We will continue to ascertain the cause in detail and deliberate other effective countermeasures.

Vent pipe flange  
(prior to replacement)

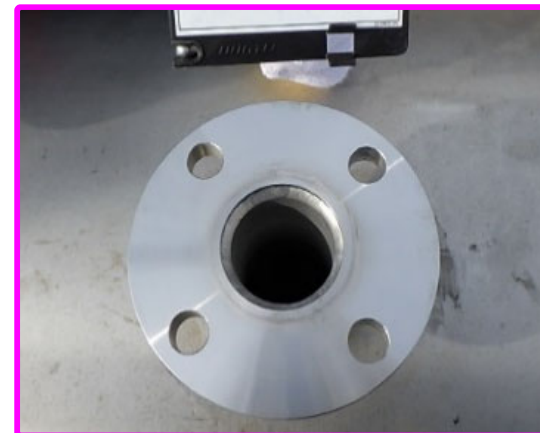
Vent pipe flange  
(after replacement)

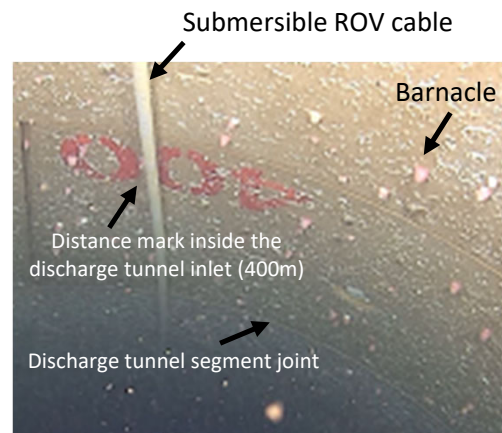
Inspection item	Results of this inspection (February 2025)	Results of previous inspection (February 2024※)
Marine organism adhesion	Inside the discharge tunnel: Some adhesion of marine life (barnacles) have adhered themselves Inside the down-stream storage: <u>A small amount of marine life has adhered itself to the wall</u>	Barnacles (few)
Sediment conditions	Inside the discharge tunnel: <u>Approximately 1~2cm of sediment exists until about 50m into the tunnel</u> Inside the down-stream storage: <u>Approximately 10cm of sediment exists at the bottom</u>	Almost none (some floating mud)
Issues that may impact discharge, such as cross-sectional closure (foreign objects, etc.)	None	None

**Discharge tunnel wall conditions**  
(400m from the discharge tunnel inlet)

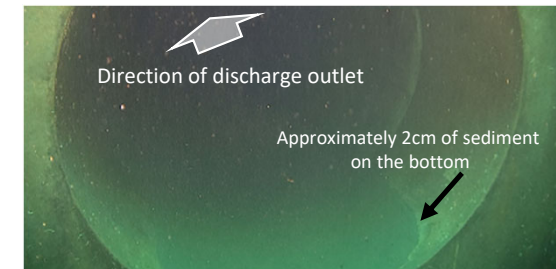
**Discharge tunnel inlet conditions**

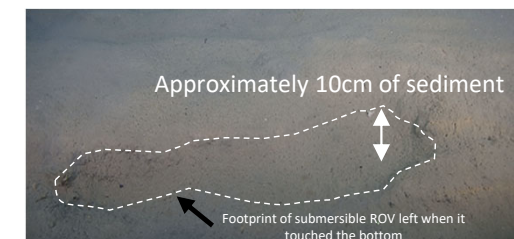
**Sediment conditions at the bottom of the down-stream storage**
