# **Fukushima Daiichi Nuclear Power Station Unit 2 PCV Internal Investigation/ Status of Fuel Debris Trial Retrieval**

August 28, 2025

International Research Institute for Nuclear Decommissioning  
Tokyo Electric Power Company Holdings, Inc.

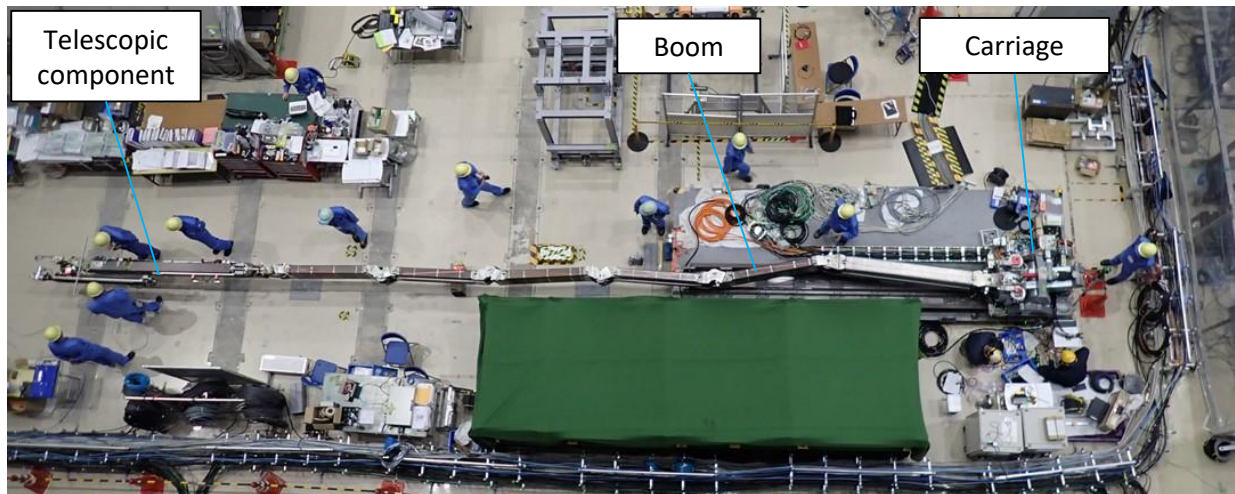
- Cables inside the arm had been replaced and a comprehensive inspection (maintenance) of the robotic arm has been completed as scheduled.
- Movement checks after the comprehensive inspection (maintenance) are underway.

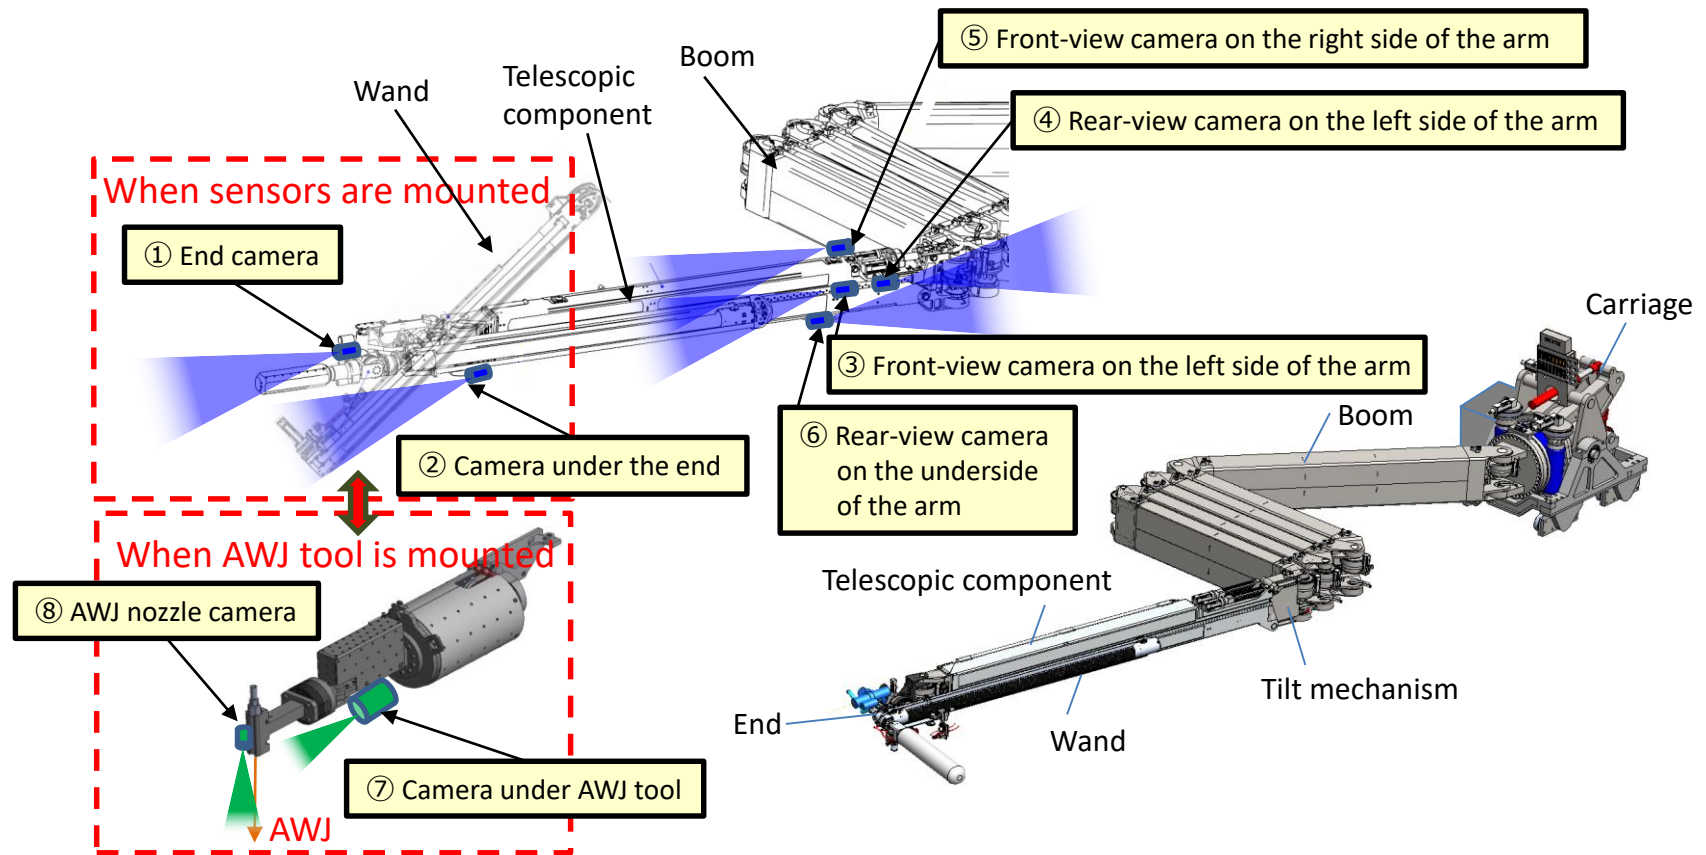
Cameras mounted on the robotic arm

- In light of the camera malfunctions on the telescopic device, irradiation tests of the cameras mounted on the robotic arm are being implemented and the radiation resistance as noted in the manufacturer's specifications could not be confirmed under conditions more severe than that of the field environment in some cases. Irradiation tests of the cameras will be continued as we deliberate countermeasures, and the work schedule will be subject to a detailed review.

- In light of the camera malfunctions on the telescopic device, irradiation tests of the cameras mounted on the robotic arm are being implemented and the radiation resistance as noted in the manufacturer's specifications could not be confirmed under conditions more severe than that of the field environment in some cases. Irradiation tests of the cameras will be continued as we deliberate countermeasures.

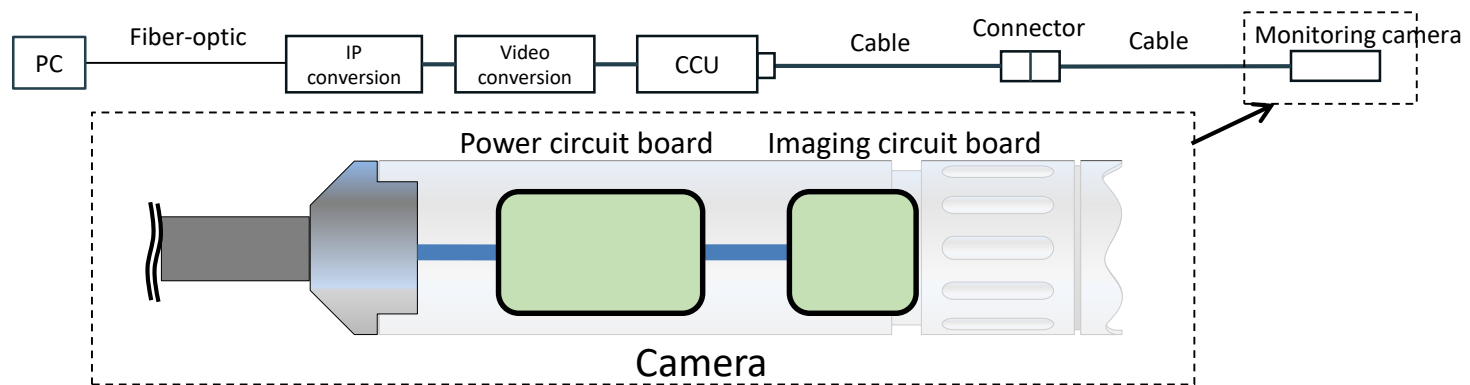
Position of circuit boards inside the monitoring camera

- The two cameras from which the video feeds were lost were decontaminated, removed from the site and disassembled. It was confirmed that there are two circuit boards inside each camera.
- The circuit boards were replaced with working spare parts and it was checked that the video signal could be received. In other words, we tested that the video signal can be received if using either a working power circuit board or a working imaging circuit board.
- Test results found that the imaging circuit boards in both of the cameras were not working properly.

- The two cameras from which the video feeds were lost were subjected to high levels of radiation inside the PCV. It is assumed that as a result, a charge was created on the imaging circuit boards inside the cameras and that charge affected the circuit boards.
- After the confirmation by the camera manufacturer, it was found that during the camera startup sequence, there were cases in which the power could not be turned on after the power was turned off due to high levels of radiation.
- As a countermeasure, it was decided to keep the cameras on at all times during fuel debris retrieval, and both two fuel debris retrieval attempts were completed without issue.
- Furthermore, the camera manufacturer has confirmed that this problem does not occur by improving the durability of the camera startup sequence, and these countermeasures have already been applied to products of the same model.
