Fukushima Daiichi Nuclear Power Station Unit 3 PCV Internal Investigation (non-submerged area) using Micro-drones

December 25, 2025

Tokyo Electric Power Company Holdings, Inc.

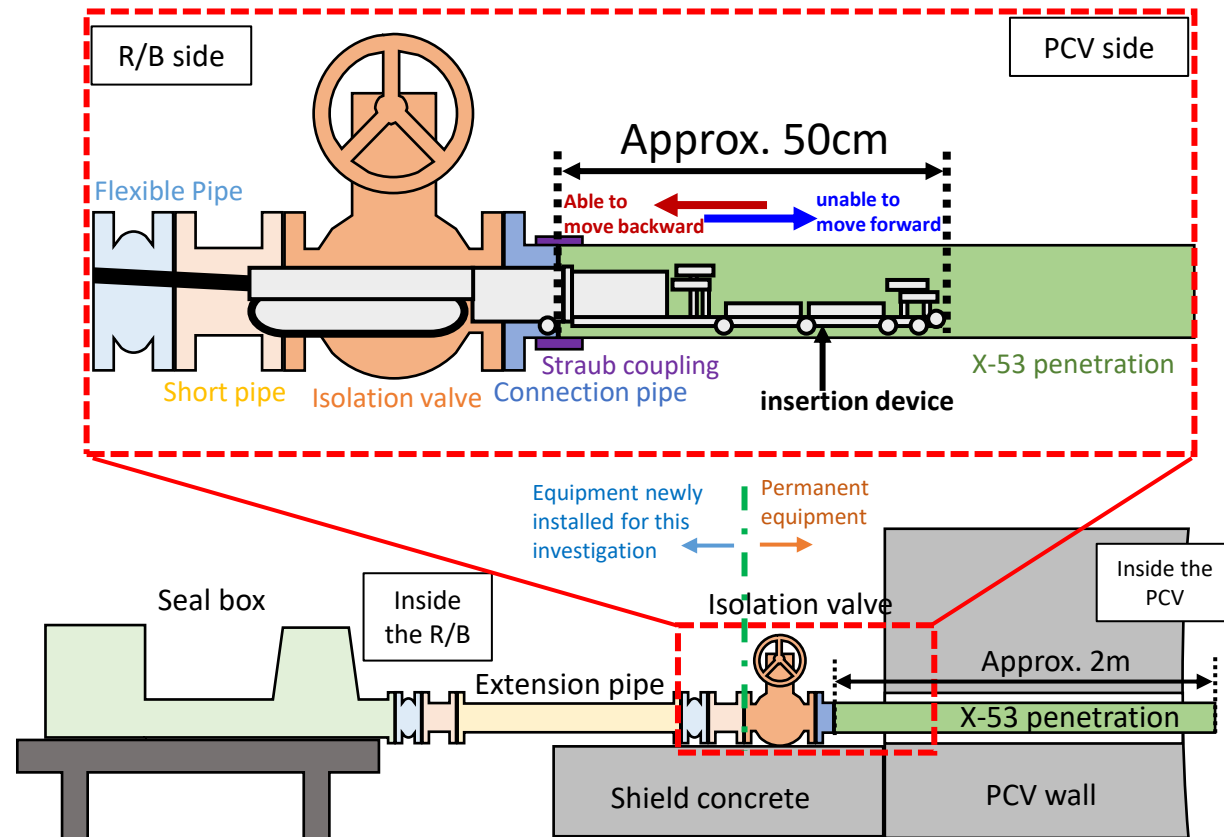
Diagram showing the unable to move the insertion device forward

- When conducting function tests of the investigation device it suddenly became impossible to move the insertion device forward inside the X-53 penetration.
- Several attempts were made at insertion, but the device was unable to move forward past a certain point (approximately 50cm into the X-53 penetration).
- The device could be moved backwards, so normal procedures for withdrawal were conducted and the insertion device was returned to the seal box (Since the device was withdrawn to the seal box, the isolation valve, which is the PCV boundary, did not have to be opened or closed).

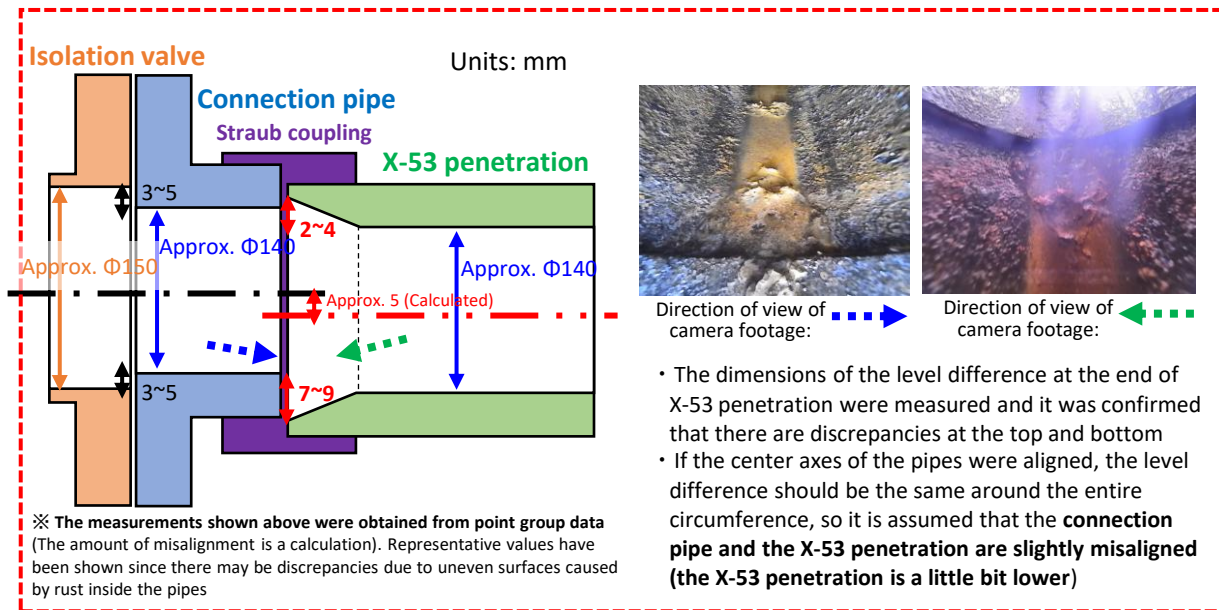
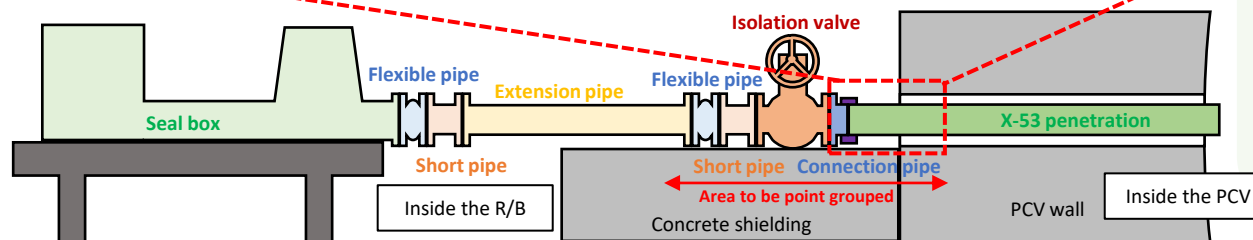
Diagram of confirmed conditions inside the insertion pipe

- Analysis of obtained footage (footage from point grouping) shows that the center axes of the **connection pipe and X-53 penetration are slightly misaligned.**※1
- From these results we assume that the reasons why the insertion device cannot move passed this point is because the **cross-sectional area of the pathway becomes smaller and the crawler loses grip.** ※2
- Going forward, the obtained data will be further analyzed in detail and countermeasures deliberated.

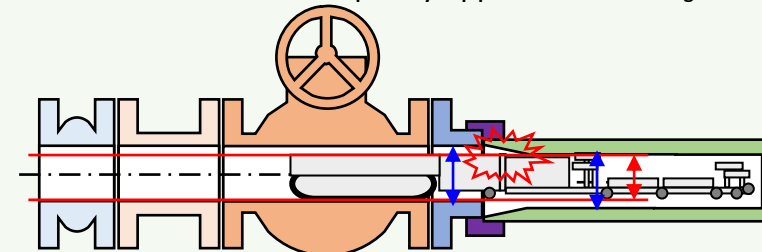
Reduction in cross-sectional area of pathway as pipe core becomes misaligned

- Reduction in cross-sectional area in longitudinal direction as pipe center axes becomes misaligned (red arrow)
- If the system is designed based on the minimum pipe diameter (blue arrow) then the device will not be able to pass the point where the cross-sectional area becomes narrower

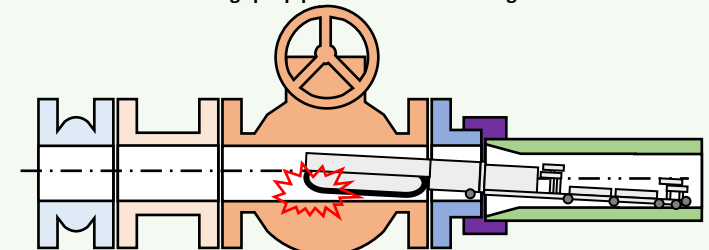
Crawler loses grip a pipe core becomes misaligned

- The entire X-53 penetration is lower, relatively, due to the misalignment
- After the front of the device passes through the X-53 penetration, it tilts downward forcing the crawler to lift and lose grip thereby making it unable to move forward any further

Diagram illustrating why the insertion device cannot be moved forward (assumptions)

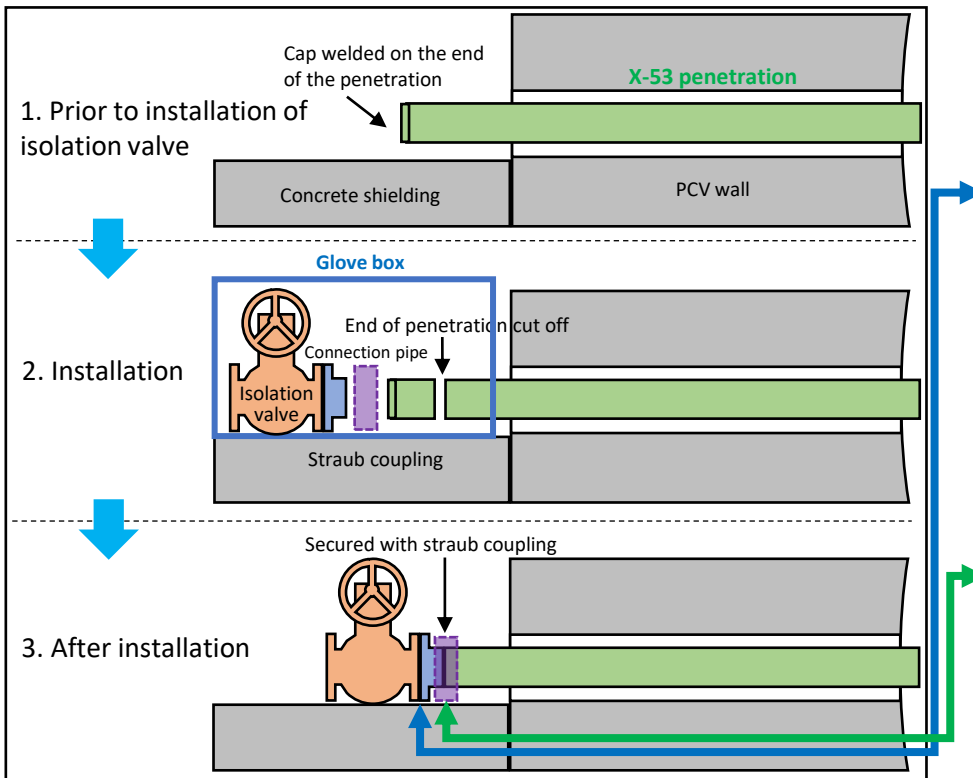
Isolation valve installation diagram (2015)

- The X-53 penetration was used to access the inside of Unit 3 during the PCV internal investigation conducted in 2015, and an isolation valve was manually installed using a glove box.
- At the time, the area around X-53 penetration still showed the impact of the accident and field dose rates were high, so the cut end of the X53 penetration was secured to the isolation valve connection pipe using a straub coupling that did not require a lot of time to be installed.
- The straub coupling can be affixed even if the joint is slightly misaligned, so footage from recent PCV internal investigation (2017) were checked to see if we could see a level difference. However, we could not discern such things from the footage. ※1

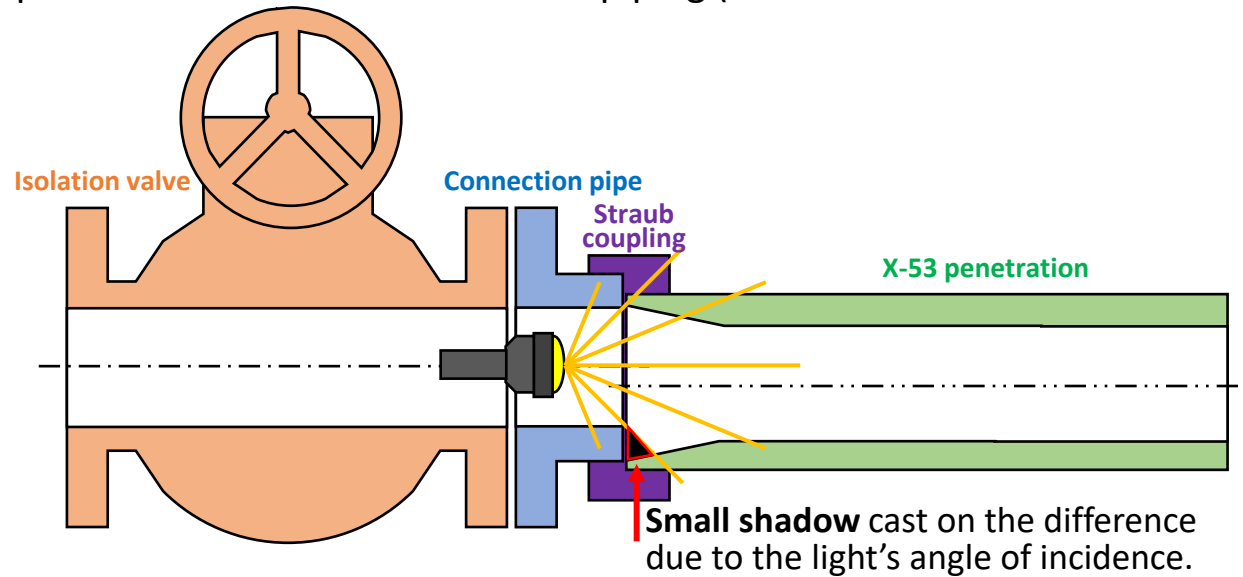
- When the lighting is positioned near the center of the piping (similar to the PCV internal investigations in 2015 and 2017).

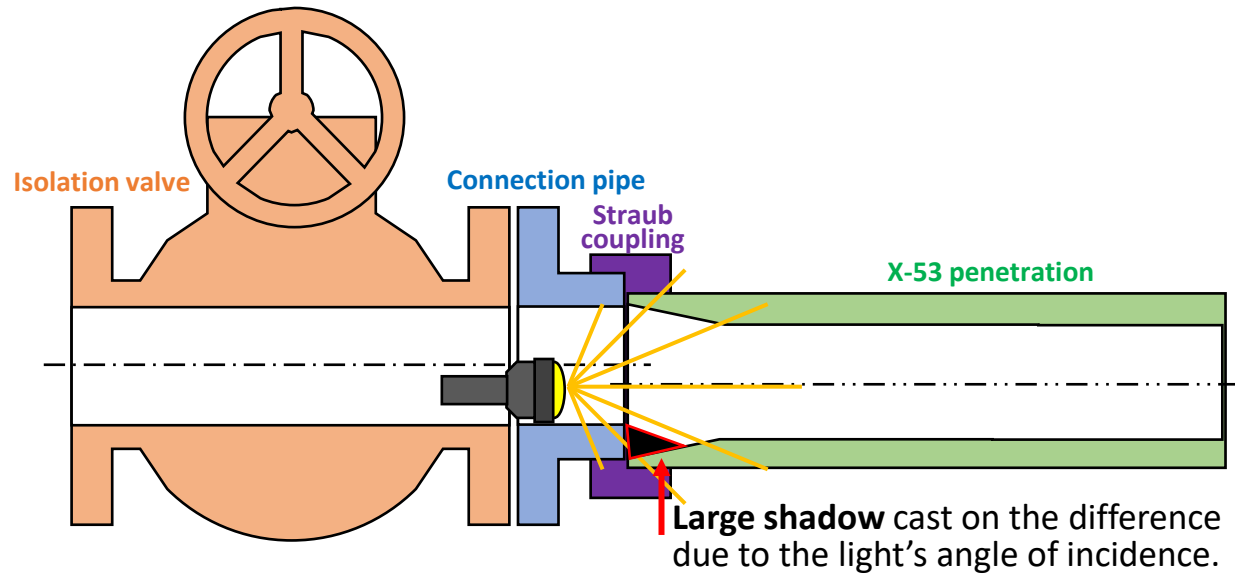
- When the lighting is positioned near the lower part of the piping (similar to the current PCV internal investigation).
