Fukushima Daiichi Nuclear Power Station Unit 3 PCV Internal Investigation (non-submerged area) using Micro-drones

March 26, 2026

Tokyo Electric Power Company Holdings, Inc.

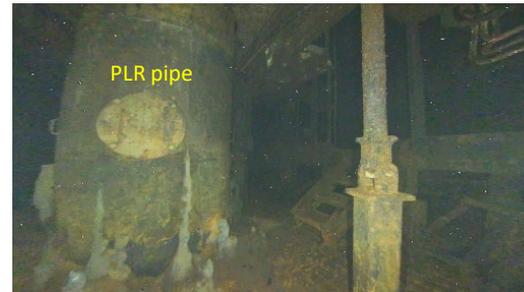
①: Outside the pedestal Northwest area

- **Component damage/Obstructions check:** No significant damage or obstructions were seen. (rust and fallen insulation were seen)
- **Flight history:** Excluding the southeast area where comms was poor, flights were implemented clockwise and counterclockwise around the D/W1FL area.

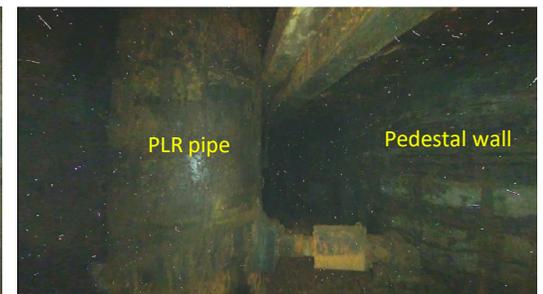
④: Outside the pedestal East area

- **Fog conditions:** As with Unit 1, fog was seen **outside the Unit 3 pedestal** (visibility was approx. 3m).
- **Ease of radio communication :** It was confirmed that **communications are poor** in the southeast area across from the X-53 penetration where the radio was.

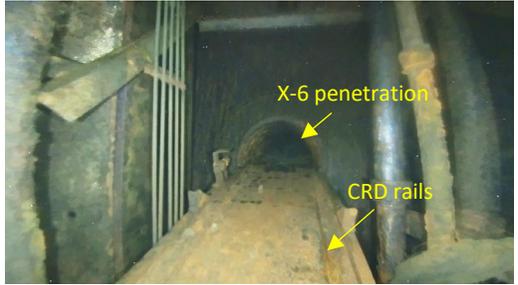
①: External view of X-6 penetration

- **X-6 penetration:** No obstructions were found in the vicinity of the penetration. **There are cables throughout the entire penetration** but no deposits like those found at Unit 2 were seen within the areas captured in this investigation.
- **CRD rails:** **No significant damage or obstructions were seen**, but a level difference was found.
- **CRD replacement opening:** **No obstructions were found in the vicinity of the opening.**

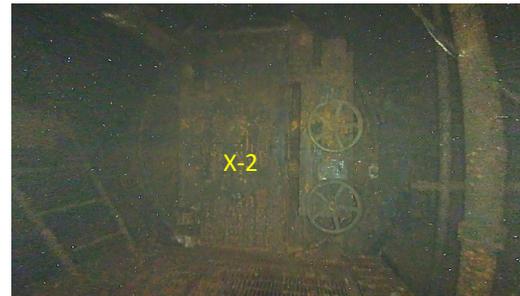
①:X-2 penetration

- **X-2 penetration、 X-1B penetration:** No obstructions nor damage or deformation of the penetration were found.
- **CRD insertion/withdrawal pipes (south):** No damage or deformation of the pipes on the southwest side were found. Communications were poor in the aforementioned area on the southeast side so no confirmation was possible because the area could not be flown.
- **Subfloor stairs (south):** No obstructions nor damage or deformation of the stairs were found.
- **X-35 penetration:** Communications in the southeast area outside the pedestal were poor, so no confirmation was possible because the area could not be flown.

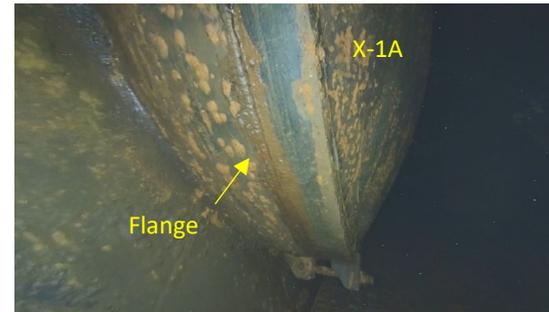
①: X-2 penetration (Flange)

- **X-1A penetration: No obstructions nor damage or deformation of the penetration were found.**
- **CRD insertion/withdrawal pipes (North): No damage or deformation was found to the pipes in the northwest and northeast.**
- **Subfloor stairs (North): No obstructions nor damage or deformation of the stairs were found.**

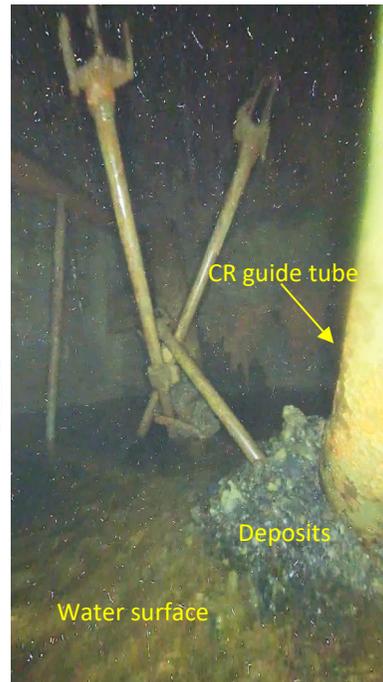
①: Deposits

- Deposits:** Deposits were found at the base of the CR guide tubes in the middle. It is assumed that there are CR guide tubes in the water as well.
- Fallen structures:** CR guide tubes, which are structures in the RPV, were found
- CRD replacement machine related equipment:** Deformation of the platform was found. The presence of other equipment is currently being reviewed through detailed analysis of the footage.
- Water in the PCV:** By comparing the height of the water surface with the surrounding structures, it was confirmed that the water level inside the PCV is consistent with the value converted from the S/C pressure gauge (and the level outside the pedestal is approximately the same).

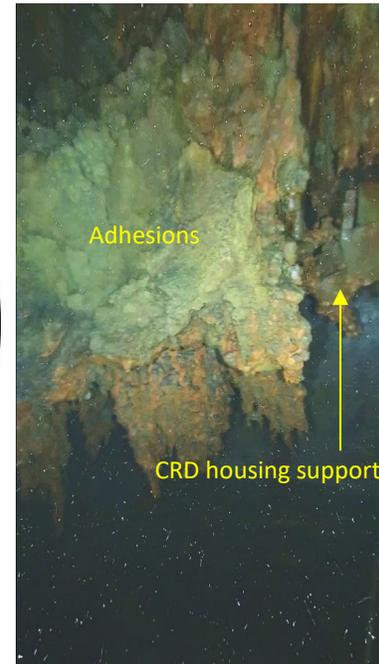
①:Adhesions

- **Adhesions:** The CRD housing group on the south side was found to have clump-like adhesions.
- **Pedestal wall surface:** No significant damage was seen within the scope of photography
- **TIP penetration:** The index tube was confirmed to be damaged
- **Fallen structures:** The CRD housing group, which is a RPV bottom structure, was found to be tilted

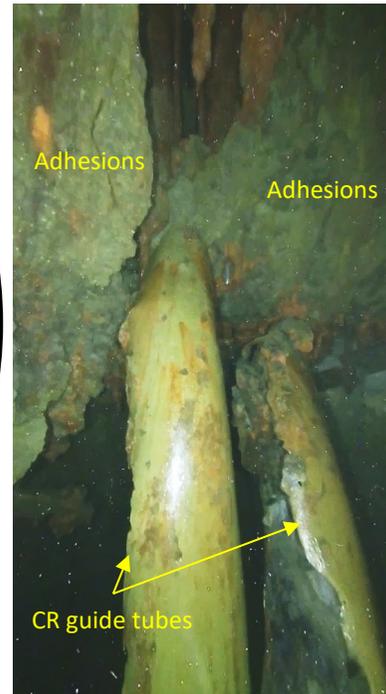
①:Below arrow

- Adhesions:** Clump-like adhesions found on the CRD housing group located the middle to the southeast
- CRD housing group:** Although tilting and deformation are observed, most of the structures remain near their original positions. **Voids** were found in the upwards direction from the middle to the southeast.
- CRD insertion/withdrawal pipes:** Only the southeast portions could be photographed, and **pipe damage** was found.
