Fukushima Daiichi Nuclear Power Station Unit 3 Drone Investigation Results of the inside of the reactor building

April 23, 2026

Tokyo Electric Power Company Holdings, Inc.

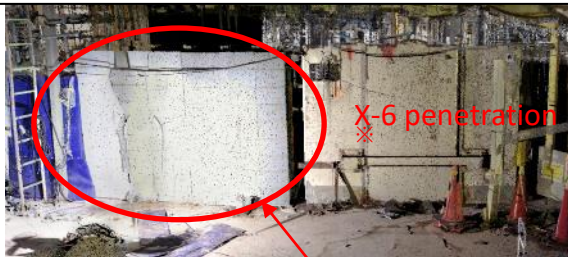
Jet pump instrument rack
(northwest area, 1st floor, reactor building)

- The jet pump instrument rack closest to the X-6 penetration in the northwest area contributes greatly to these high doses, and we are deliberating flushing the pipes or removing them in order to reduce doses, but since the pipes are connected to the PCV, removing them would require deliberation of how to build and seal a PCV boundary.

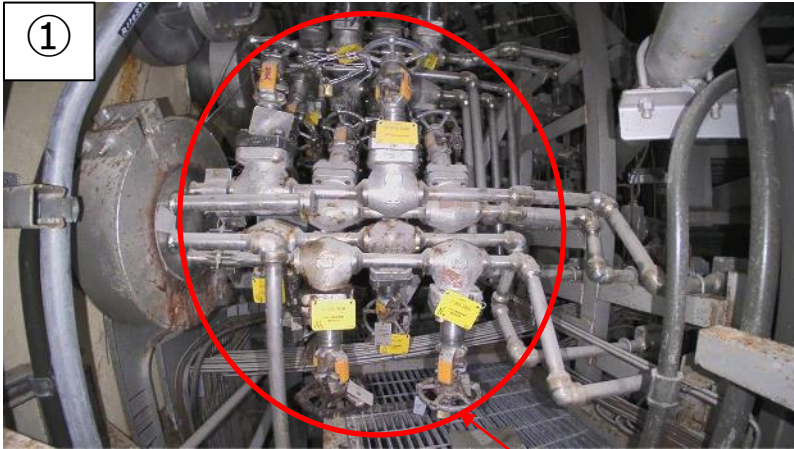
High pressure coolant injection system instrument line

- No remarkable damage, deformation, or excessive corrosion was found on the instrument line primary valve, etc.
 - It was also confirmed that there are many existing obstructions, such as piping and supports, in the vicinity or along the access route to the aforementioned valve.
- ➡ It is assumed that air dose rates are also high so workers will most likely not be able to get close enough to the target to operate it.

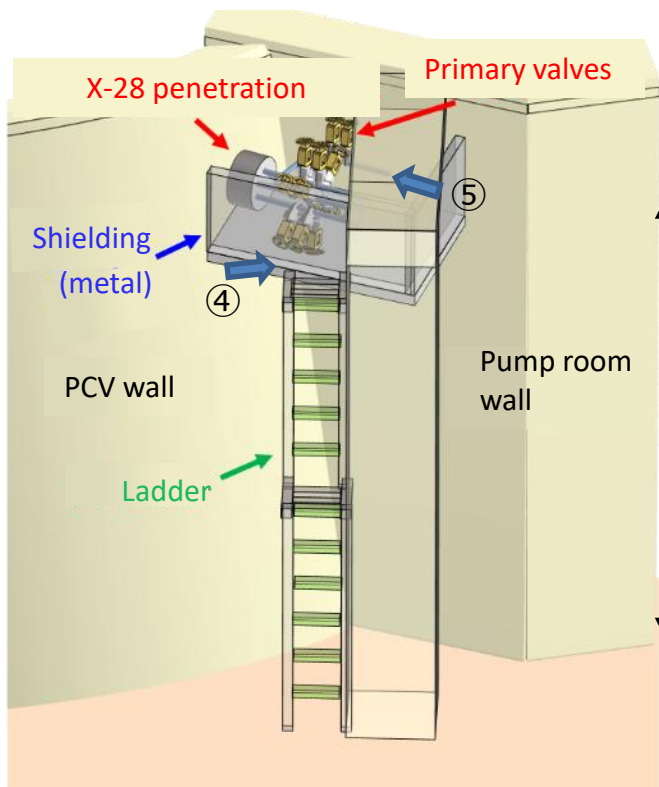
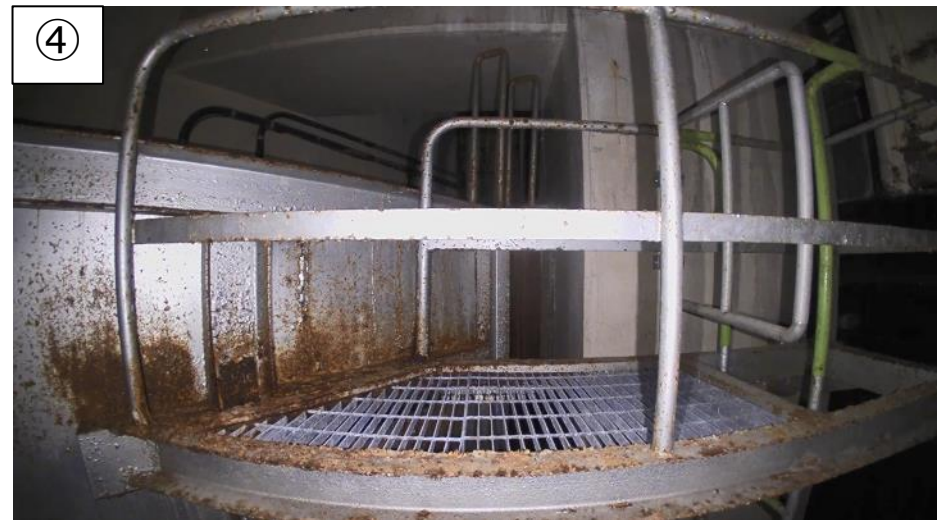
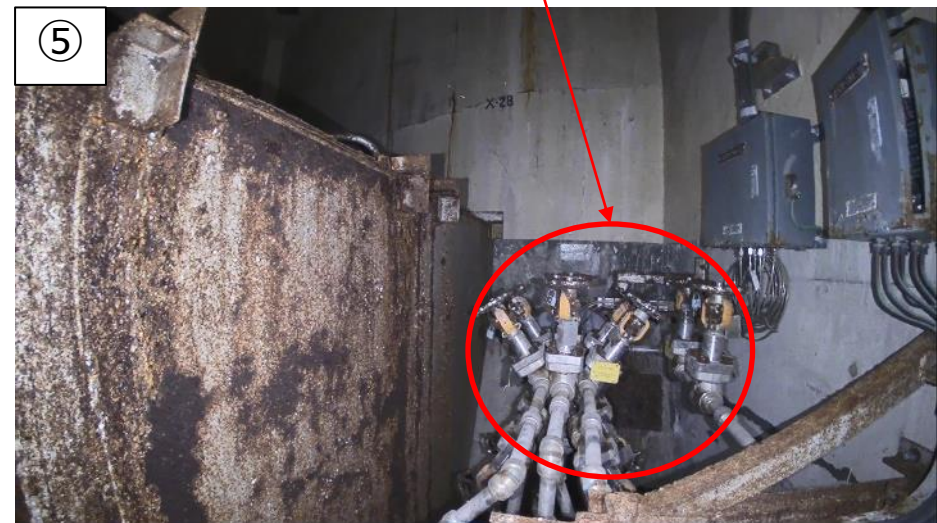
Jet pump instrument

- No remarkable damage, deformation, or excessive corrosion was found on the instrument line primary valve, etc.
- It was also confirmed that there are no remarkable obstructions in the vicinity or along the access route to the aforementioned valve. However, it was confirmed that the installation location of the valve is surrounded by shielding.

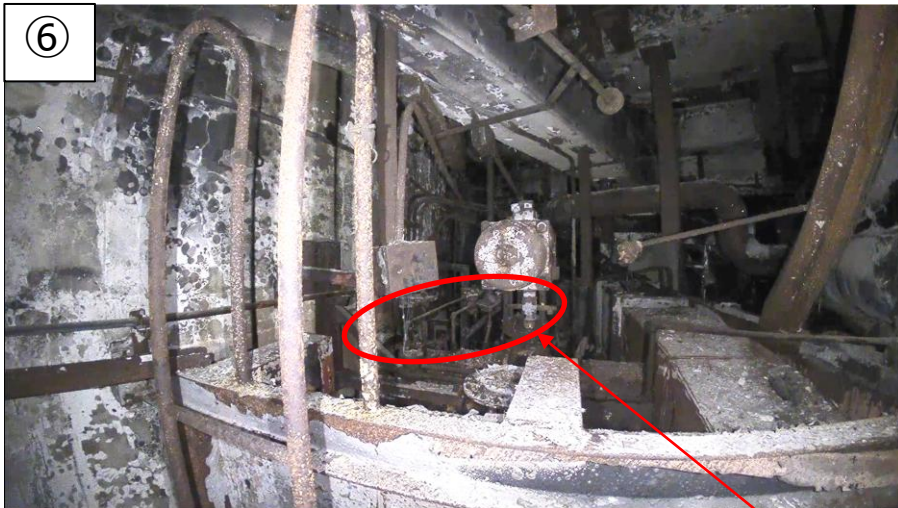
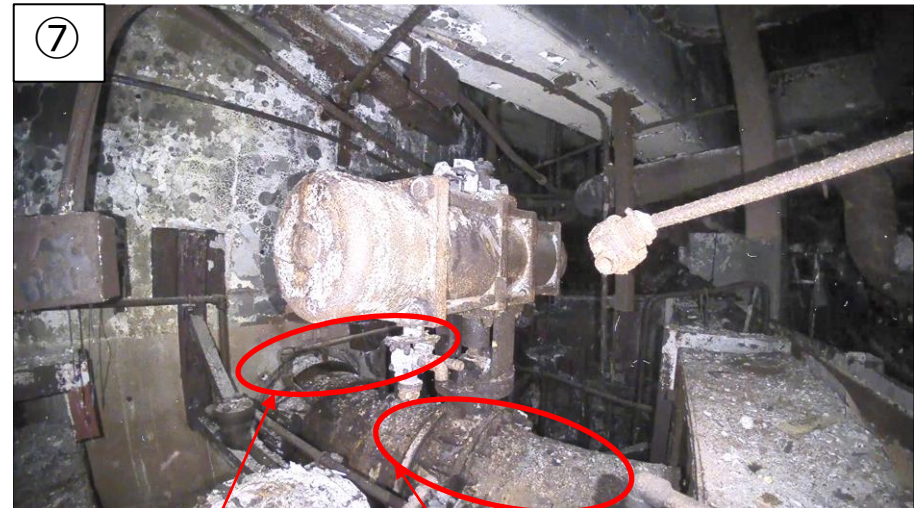
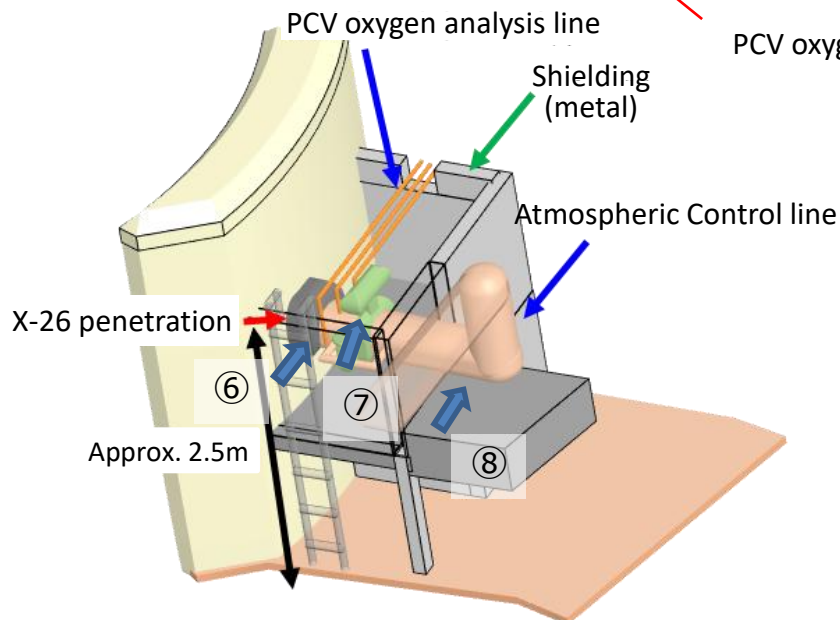
PCV oxygen analysis line

- No remarkable damage and deformation was found on the instrument line.
 - However, rubble was scattered in the vicinity of the aforementioned location and along the access route.
- ➔ Workers will most likely not be able to get close enough to the target to operate it.

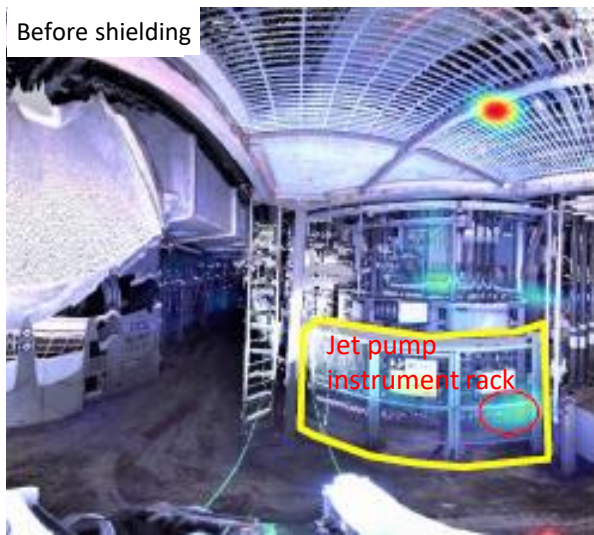
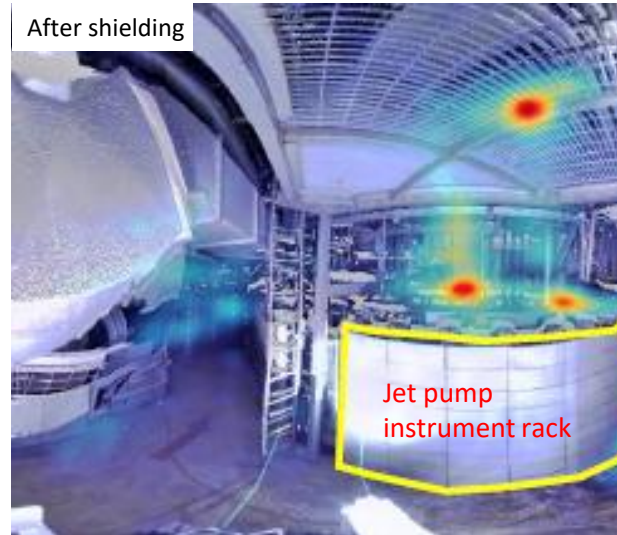
- The HCU (north side) is greatly affected by doses from the jet pump instrument rack, and it is not clear whether there are any other radiation sources.
- The HCU and jet pump instrument rack, which are the main radiation sources, have been shielded, and the air dose rate around the X-6 penetration is between 3~5mSv/h, thereby prohibiting workers from remaining in the area for a long period of time.

- Dose reduction measures for the jet pump instrument rack closest to the X-6 penetration are being deliberated.
- Due to the difficulty of work implementation, it is expected that much time will be needed to reduce doses in the HCU.
