# Fukushima Daiichi Nuclear Power Station Unit 2 Progress of Fuel Removal from Spent Fuel Pools

October 29, 2026

Tokyo Electric Power Company Holdings, Inc.

# 1. Unit 2 Fuel removal progress

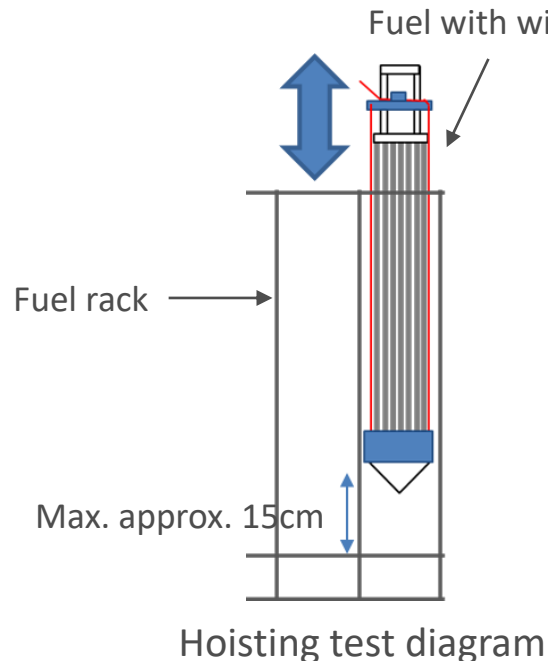
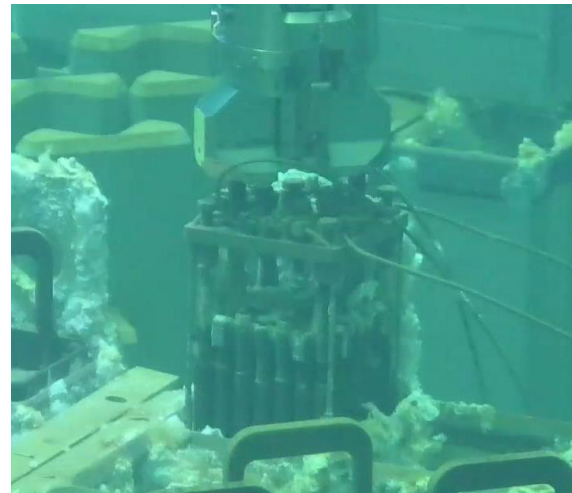
- A lifting test was conducted on August 18, 2026, confirming that there were no abnormalities such as wire slack and that the fuel could be lifted without any issues.

Being lifted approximately 15 cm  
(Photographed on August 18, 2026)

- Based on the test results, equipment will be prepared to safely transport the fuel to the transport cask, and the fuel will be removed last after all other fuel has been retrieved.

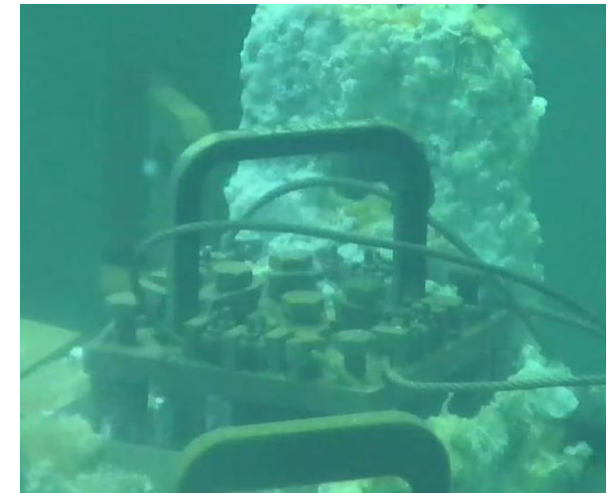
Upper section after the test  
(Photographed on August 18, 2026)

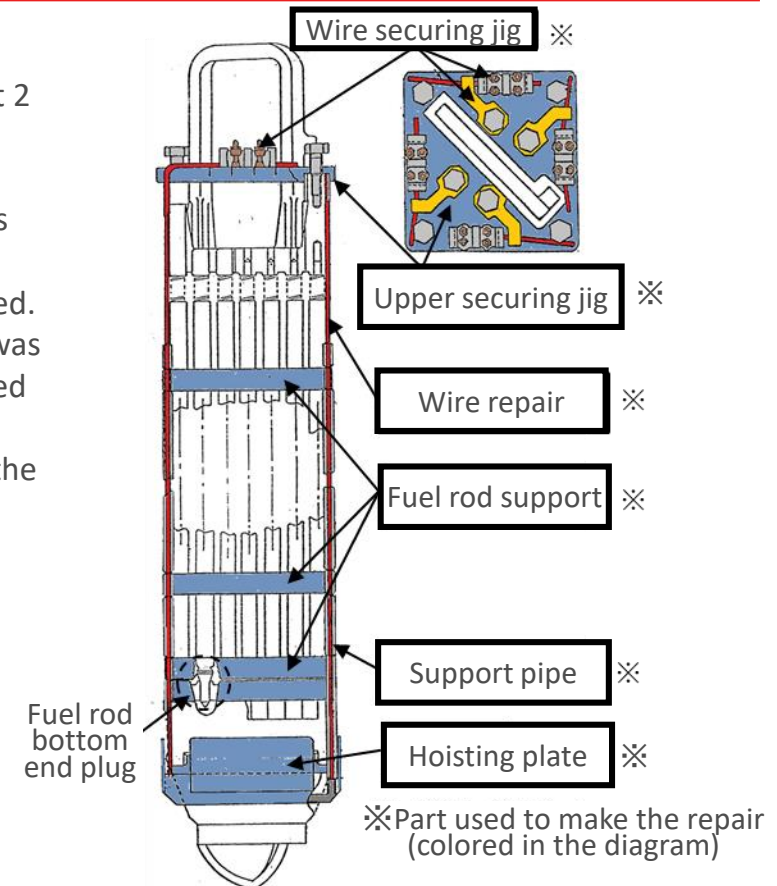
- In 1981, this fuel assembly was dropped when it was being handled inside the Unit 2 SFP. As a result, the bottom end plug of the joined fuel rods\*1 was damaged and cannot be used for hoisting. The following year, this fuel assembly was wrapped together with a wire to enable it to be handled with a fuel handling machine. It has remained in storage ever since. A visual inspection of the aforementioned fuel assembly has confirmed that cladding tube seal integrity has not been compromised.

\*1: This is a normal fuel rod, but the bottom end plug bolt has been cut off and the fuel rod has been joined with the bottom tie plate. When hoisting the fuel assembly, this is the part that supports the weight of the fuel assembly. There are eight joined fuel rods in one fuel assembly.

Diagram of the fuel repaired with a wire

- Methods for handling the aforementioned fuel assembly will be deliberated after the results of the corrosion test currently being implemented on the wire used for the repair have been obtained, and prior to handling the fuel, a hoisting test will be implemented to confirm that the fuel assembly can be hoisted.

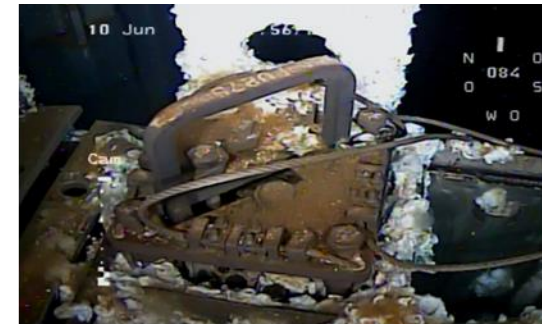
- During this investigation, the upper portion of the aforementioned fuel assembly was examined and a submersible ROV was used to search for any breaks in the wire used to make the repair or loose securing jigs. None of the above was found.

Photo of the top of the fuel repaired with a wire
