Initiatives Aimed at Improving the Overall Quality of Work at Power Stations in Light of the Incidents Involving the Unauthorized Access of a Power Station Building and the Partial Incompletion of Safety Measures at Unit 7 at the Kashiwazaki-Kariwa Nuclear Power Station

February 15, 2021
Tokyo Electric Power Company Holdings, Inc.

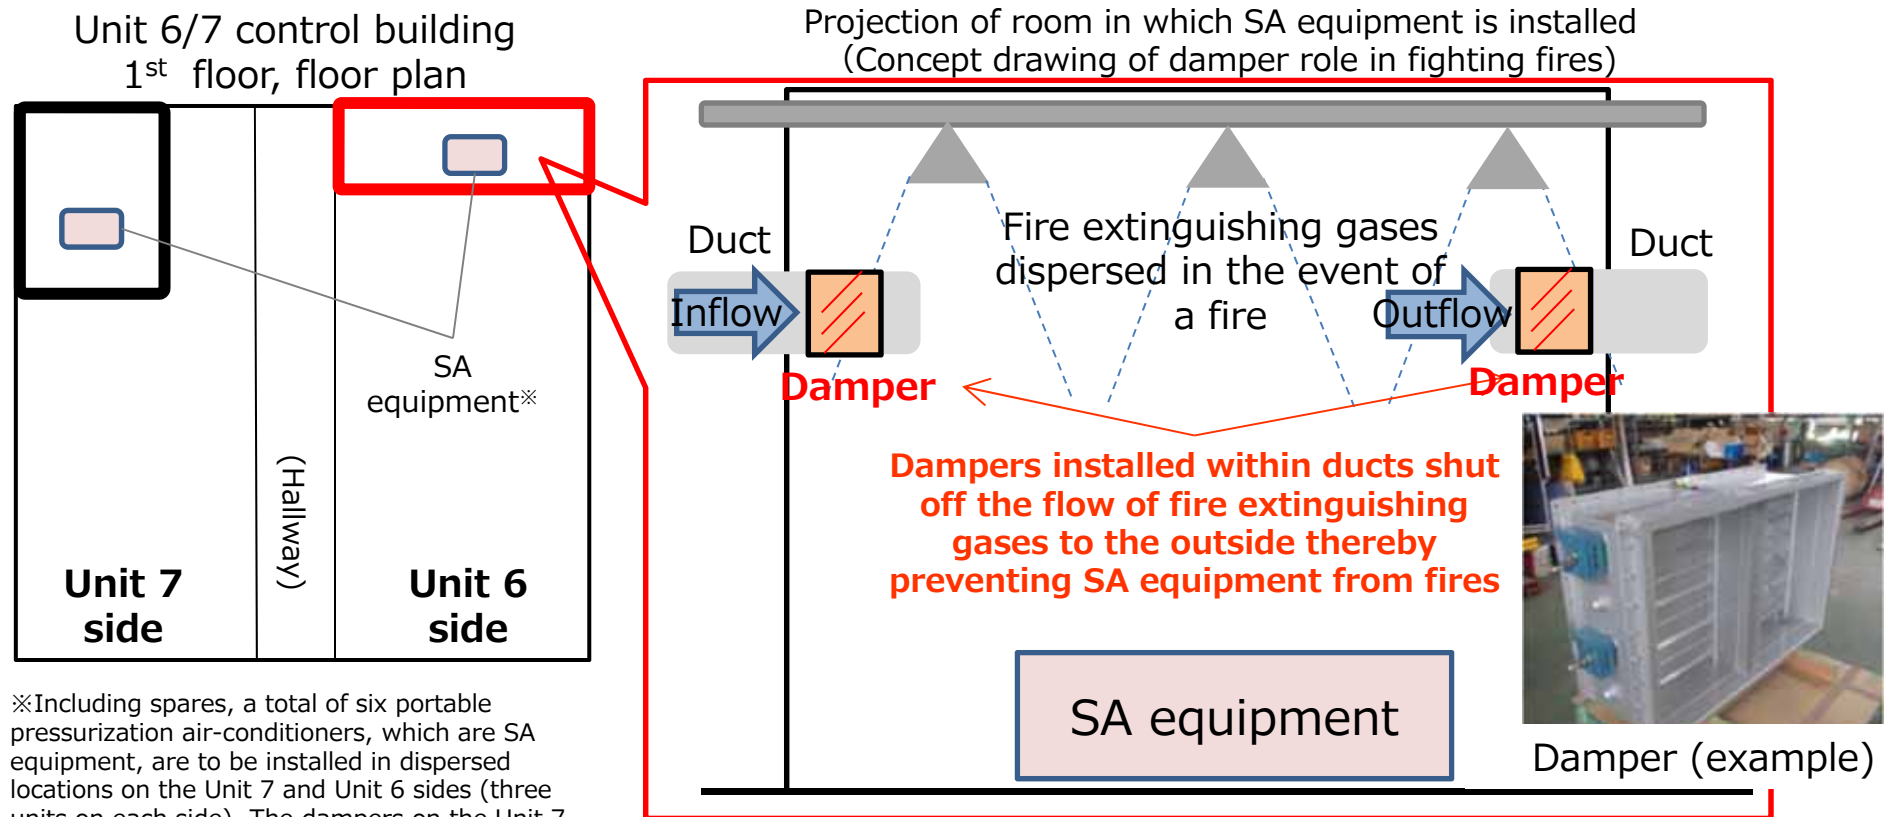
- On January 27, it was discovered that safety measure renovations (damper^{※2} installation) to prevent severe accident equipment (SA equipment)^{※1} dispersed in the Unit 6/7 control building from fires had not been completed.
- Dampers seal off rooms in which severe accident equipment (SA equipment) is located in the event of a fire thereby preventing fire extinguishing gases from leaking.
- The aforementioned damper installation is being implemented/managed as work to prevent other safety equipment for unit 6, and renovations at unit 7 needed to be changed in conjunction with installation of SA equipment, but failure to do this resulted in this renovation being overlooked.

※ 2 : Equipment that prevents fire extinguishing gases from leaking through air conditioning ducts connected to the outside. This equipment needs to be installed on air conditioning ducts at several locations in the aforementioned building.

※Including spares, a total of six portable pressurization air-conditioners, which are SA equipment, are to be installed in dispersed locations on the Unit 7 and Unit 6 sides (three units on each side). The dampers on the Unit 7 side have been installed.

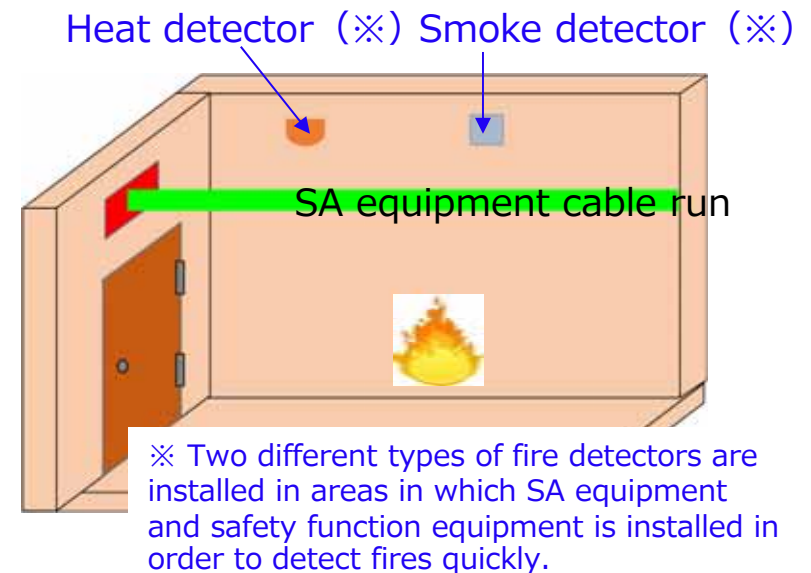
<Incomplete renovation (fire detectors)>

It was found that fire detectors have not been installed in the hallway in which cable runs for severe accident equipment (SA equipment) in the Unit 7 reactor building have been laid.

- A new wall has been built in a hallway to install fire extinguishing cylinders for the adjacent area.
- In conjunction with construction of this new wall, fire detectors need to be installed in the aforementioned area, but insufficient management of the entire project and design resulted in failure to install the aforementioned fire detectors. (= Same process that resulted in the failure to install dampers)

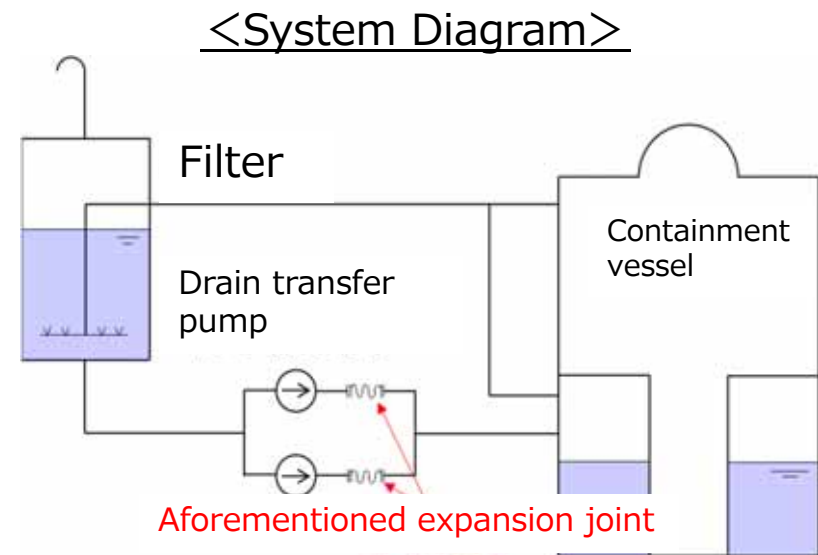
- Even though this work has been completed, an issue was pointed out in regards to welding of the expansion joints on Unit 7 filter vents by the Nuclear Regulatory Agency during the course of the inspection.
- In response to this issue being pointed out, the joints will be replaced in order to improve reliability of the aforementioned equipment
- We will continue to respond appropriately to contribute to improving the integrity and reliability of equipment as nonconformances are found during the course of future inspections.

- ✓ It was pointed out by the Nuclear Regulatory Agency in the course of inspections to confirm compliance with technical standards※ implemented for equipment on which work began prior to issuance of the new regulatory requirements that Unit 7 filter vent expansion joint welds need to be subjected to tests based on the welding standards put forth by the Japan Society of Mechanical Engineers.

- ✓ Although the aforementioned joints were ordered as pipes that require testing based upon welding standards during the ordering stage, the contracting company manufactured the joints without performing the tests.

- ✓ TEPCO has explained to the Nuclear Regulatory Agency that it can ensure the reliability of these joints based upon new regulatory requirements through assessment that uses technical assessment methods already stipulated by TEPCO.

- ✓ In response to this issue being pointed out by the Nuclear Regulatory Agency, the joints will be replaced in order to improve reliability of the aforementioned equipment
