Status of General Inspections Implemented after Discovering Partially Incomplete Safety Measure Renovations at Kashiwazaki-Kariwa Nuclear Power Station Unit 7

June 10, 2021

Tokyo Electric Power Company Holdings, Inc.

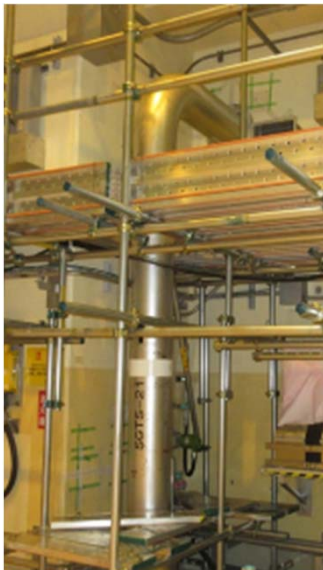
Prior to fire protection renovations

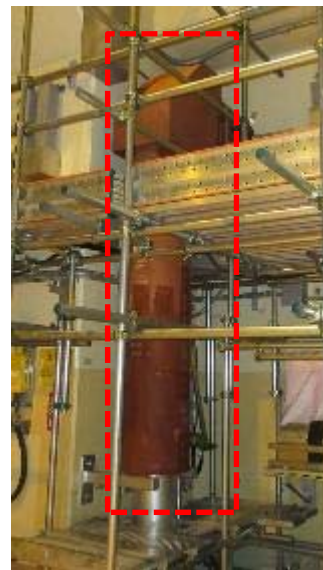
Pipe wrapped with fire retardant material

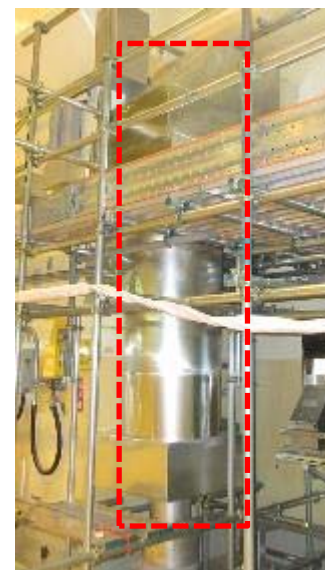
With cover plates attached

< Penetration fire protection renovations >
Fire retardant material is wrapped over which cover plates are attached in order to prevent flames and heat from reaching the other side of rooms and floors through piping penetrations

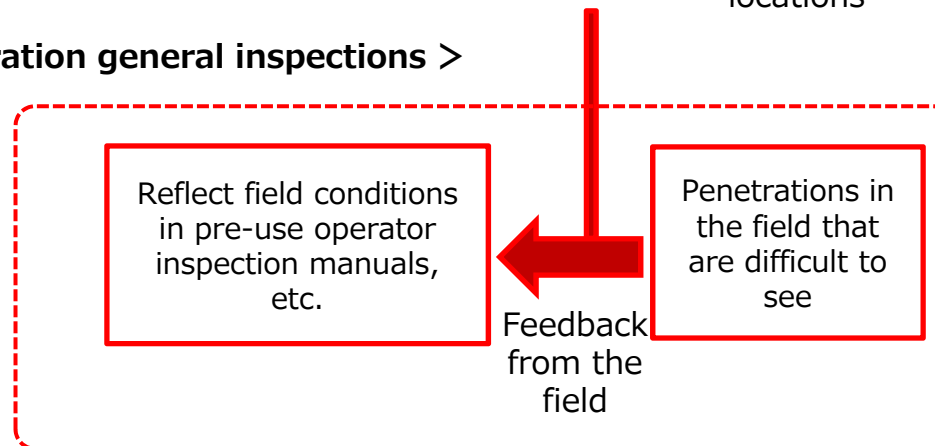
< Future penetration general inspections >

- A visual inspection of all penetrations subject to fire protection has been made, and **going forward an investigation will be performed of those penetrations that are in locations that cannot be directly viewed (penetrations located inside boxes)**
 - ※ In particular, electric wire conduits embedded in walls will be examined to find out where they connect to.
- During the course of this investigation the lids of each metal box will need to be unscrewed and removed, and scaffolding will have to be erected to reach penetrations in high locations, which will require time for preparations as well as the actual investigation. In addition, **field conditions need to be reflected in pre-use operator inspection manuals (to continue through autumn)**

Metal box used to house electric wire conduits

Penetration inside metal box

[Method of inspecting penetrations that are not easily visible]

- Find out where electrical wire conduits embedded in walls are connected to and if the areas they are connected to have been demarcated as fire protection zones
- Examine these penetrations after newly erecting scaffolding to reach high locations

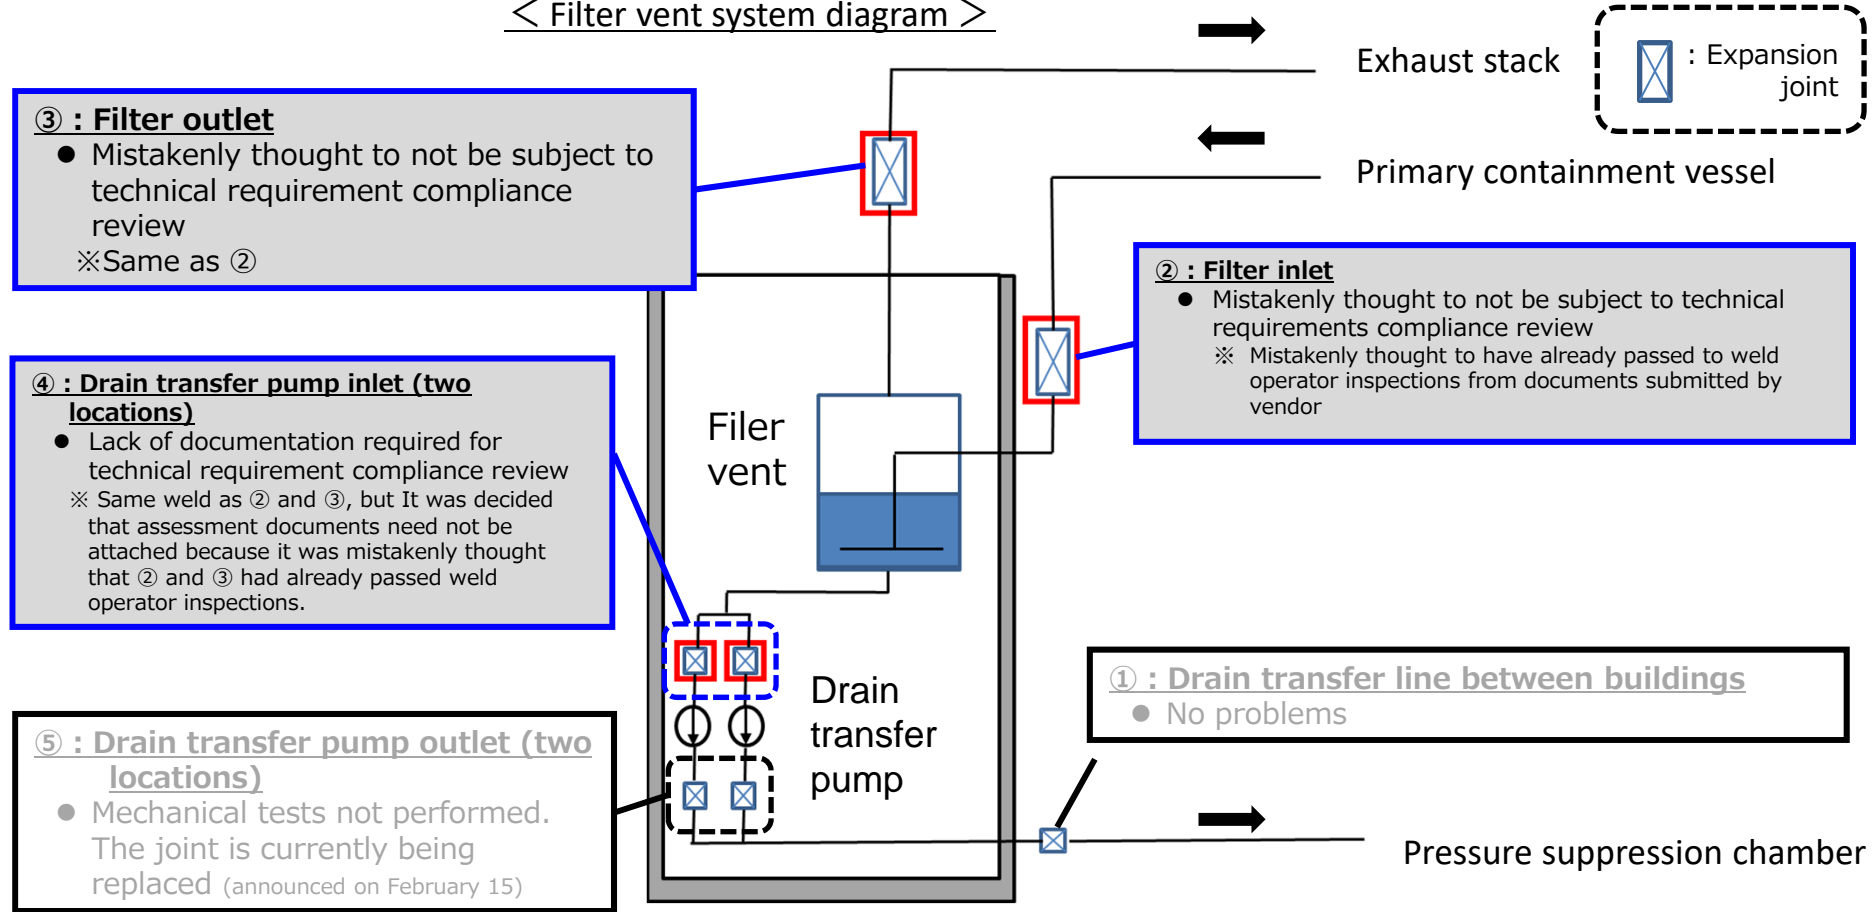
< Filter vent system diagram >

- An investigation to confirm that other filter vent expansion joint welds comply with technical requirements was conducted after the issue was pointed out by the Nuclear Regulatory Agency in the course of Unit 7 inspections (announced on February 15).
- The investigation found insufficiencies at four locations with assessment documents for expansion joints that had already been welded resulting from mistakenly thinking that the said expansion joints were not subject to technical regulation compliance review. An investigation is under way to search for other similar incidents.

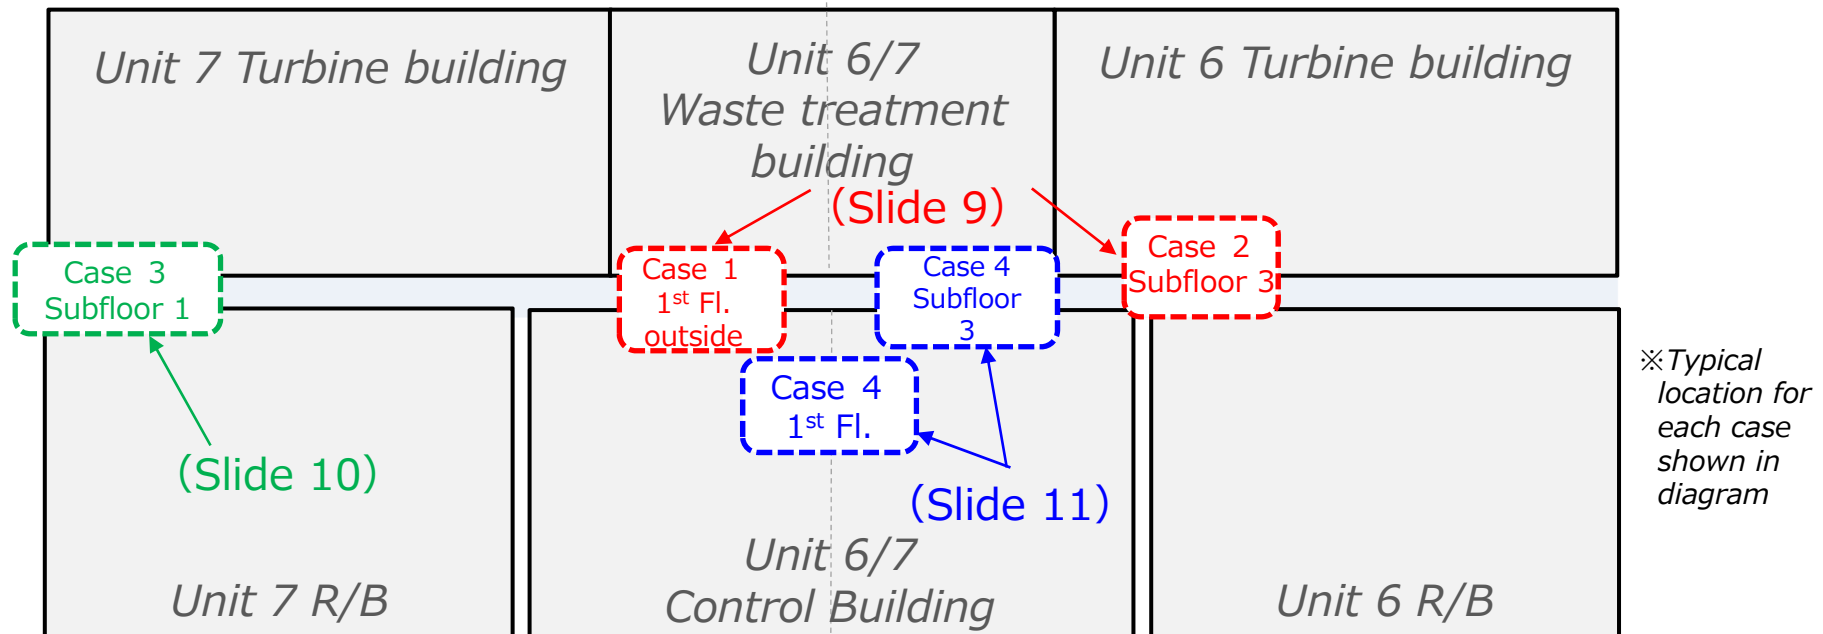
- Most penetrations subject to fire protection were identified correctly and the renovations were made.
- The 76 penetrations that were found to have been overlooked are either located in places where people do not usually go, such as between buildings, are three-dimensionally complicated, or are worked on by multiple manufacturers because they are shared by both Units 6 and 7.
- Penetration fire protection should have been ordered after identifying the penetrations to be subject to fire protection by comparing the schematics in the possession of both TEPCO and manufacturers, and conducting detailed field investigations, but coordination between TEPCO and manufacturers was lacking.

| Typical Case | Location | Process-related problems |
| Case 1/2 | Locations usually not accessed | Penetration fire protection should have been ordered after identifying the penetrations to be subject to fire protection by comparing the schematics in the possession of both TEPCO and manufacturers, and conducting detailed field investigations, but coordination between TEPCO and manufacturers was lacking |
| Case 3 | Three-dimensionally complicated locations | |
| Case 4 | Shared by both units 6 and 7 and therefore worked on by multiple manufacturers | |

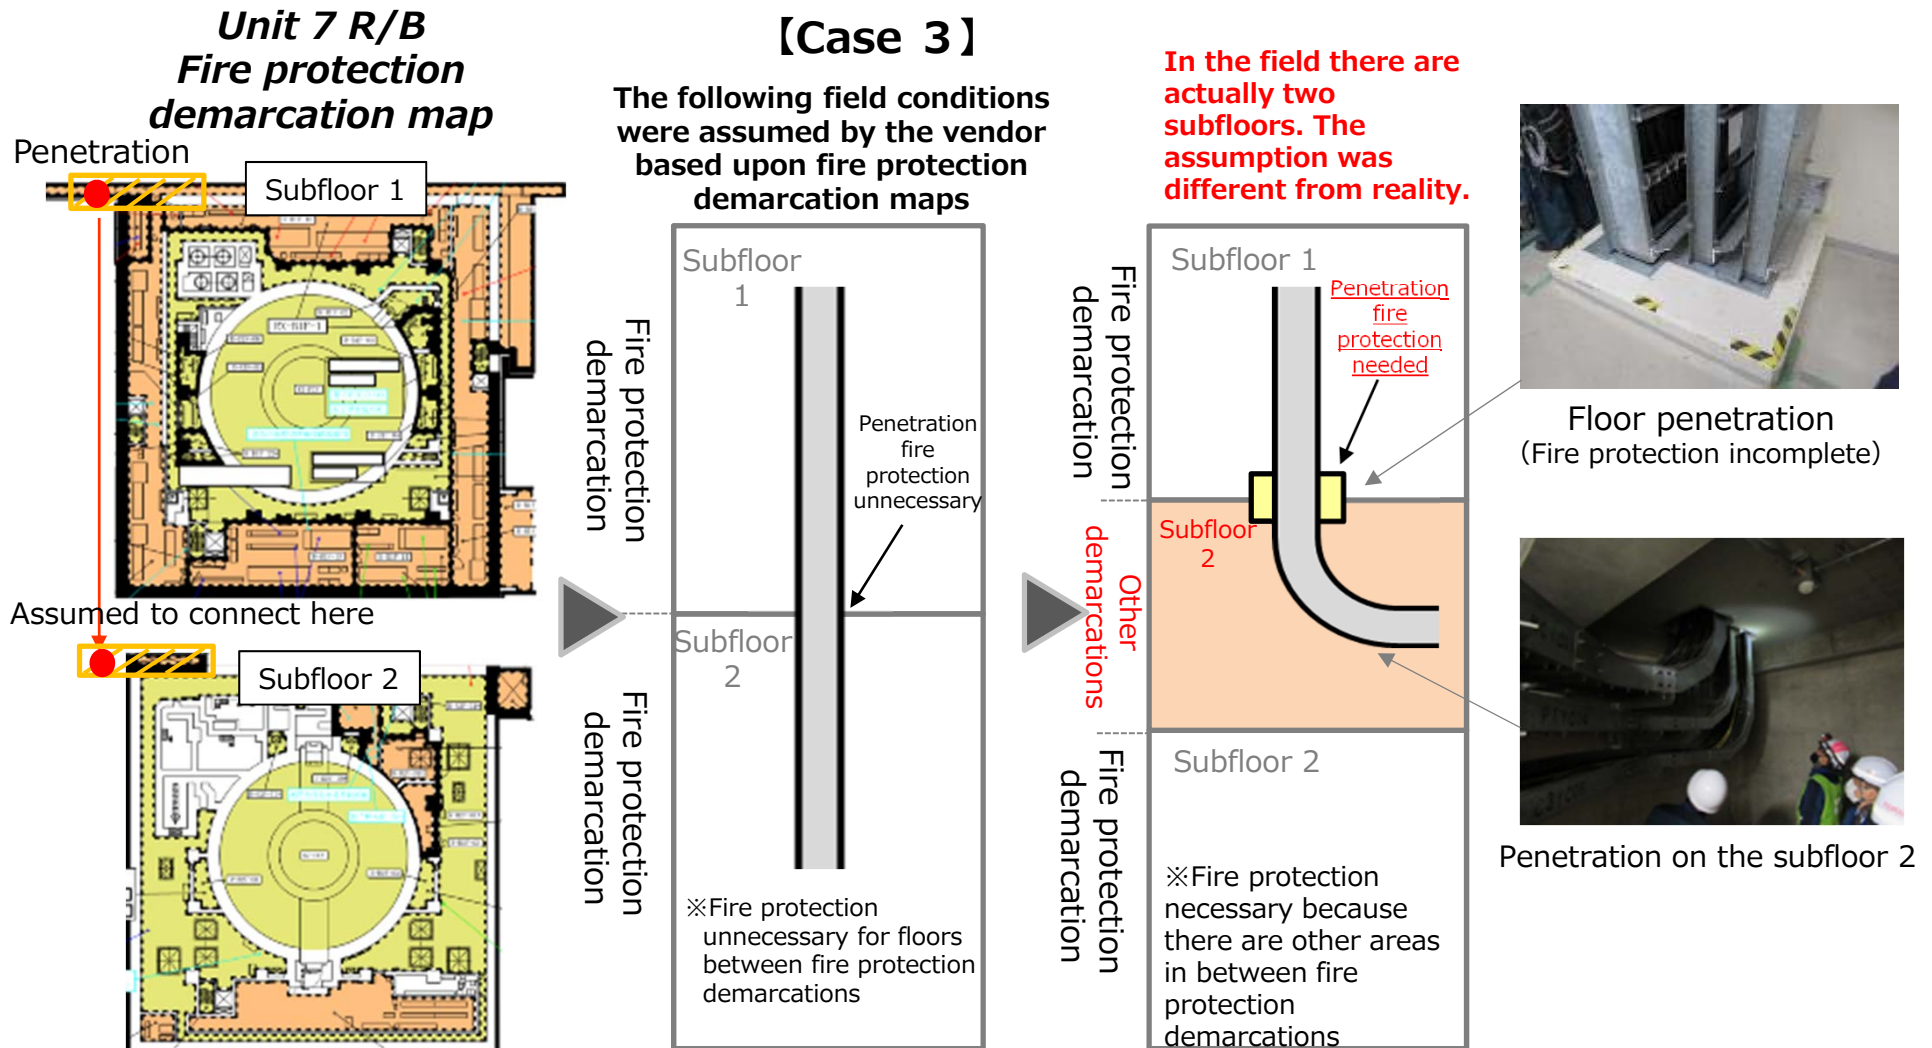
Reference Newly found penetrations (Case 3)

43 penetrations in total including similar cases

- Penetrations found in locations difficult to see on two-dimensional schematics because they are three-dimensionally complicated
- When identifying penetrations subject to fire protection, related schematics in the possession of the vendor (penetration manufacturer) should have been compared and a field investigation implemented prior to ordering.
