# The Great East Japan Earthquake and Current Status of Nuclear Power Stations

# 1. Overview of Earthquake, Tsunami and Nuclear Accident

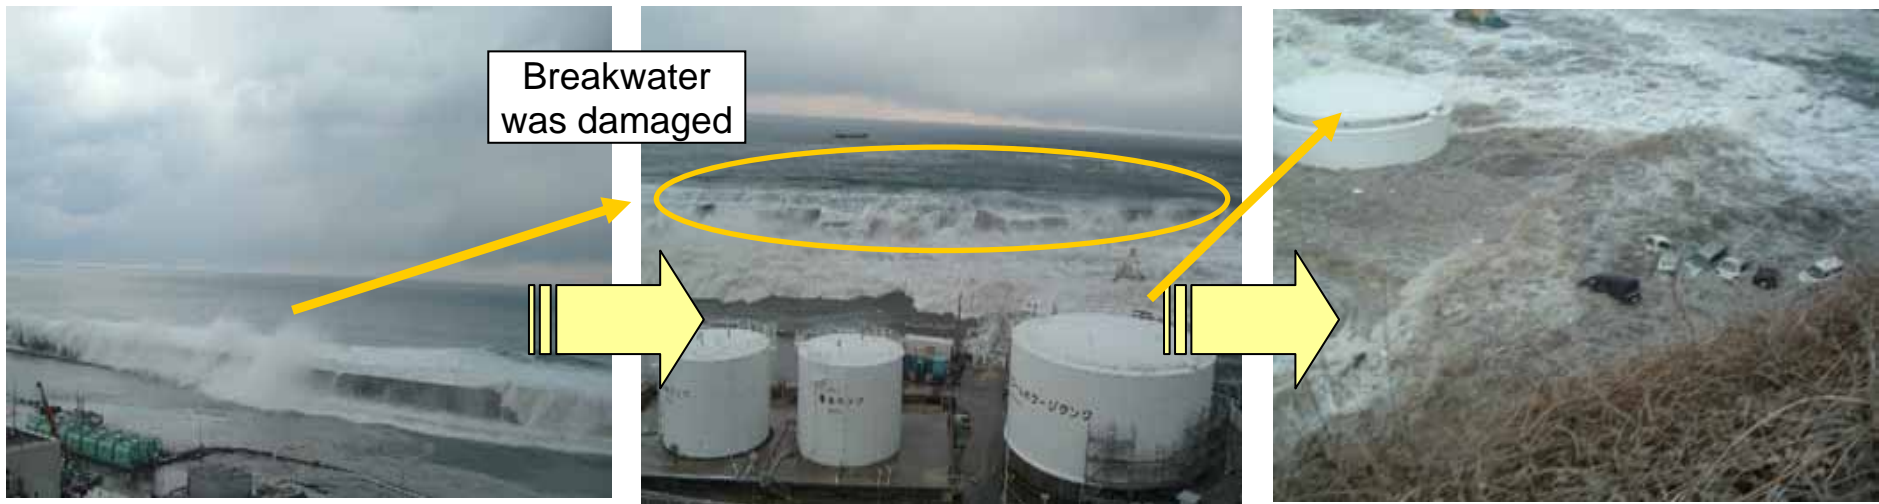
Taken from near the south side of Unit 5, looking east

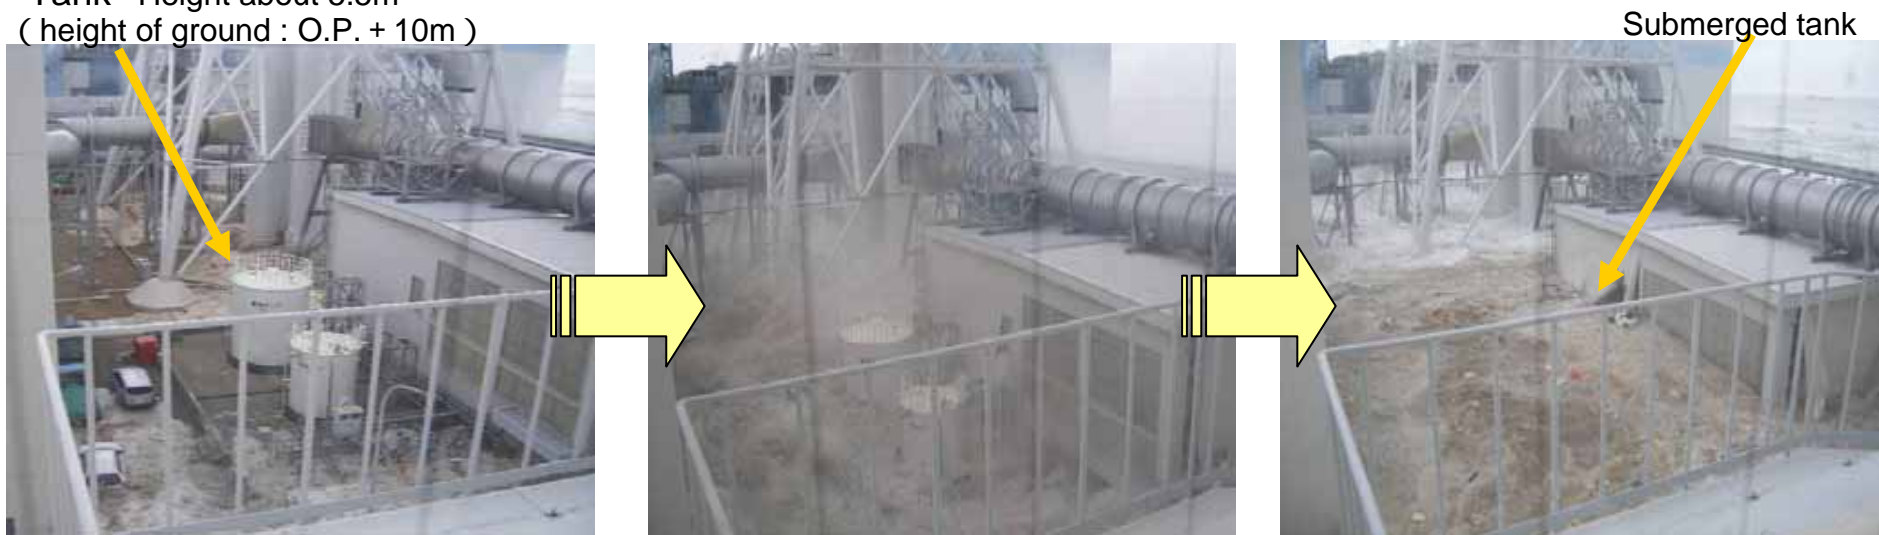
Taken from radwaste building 4<sup>th</sup> floor, looking north

Tank Height about 5.5m  
(height of ground : O.P. + 10m)

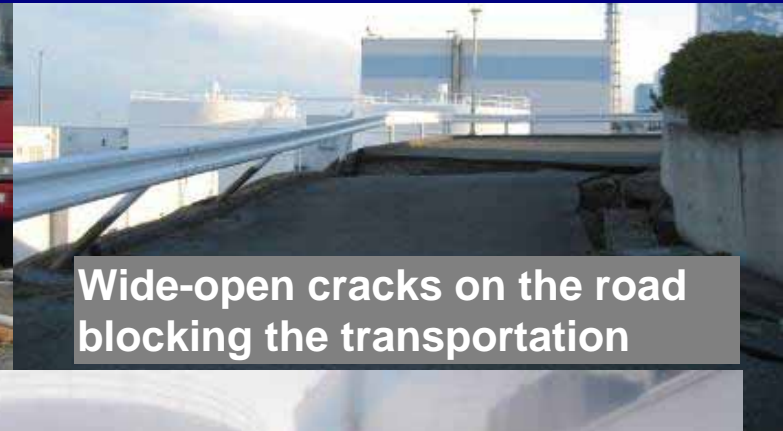
Wide-open cracks on the road blocking the transportation

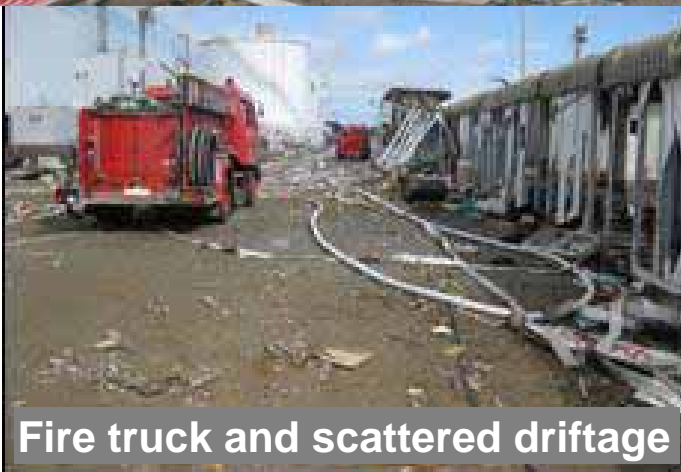
Fire truck and scattered driftage

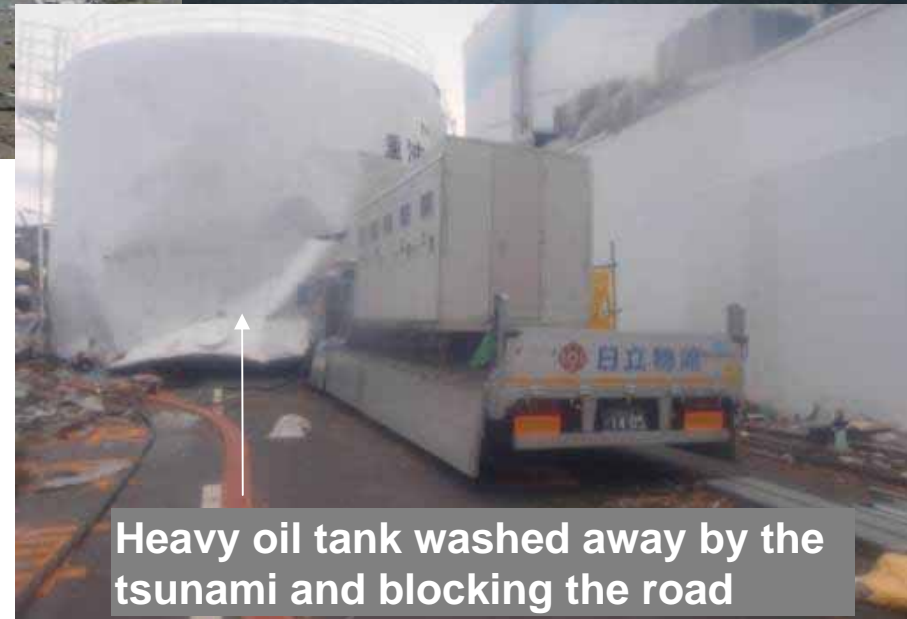
Heavy oil tank washed away by the tsunami and blocking the road
