Results of Soundness Inspection of Unit 2 TIP Guide Pipe for the Investigation of the Reactor and Thermometer Installation

March 1, 2013

Tokyo Electric Power Company

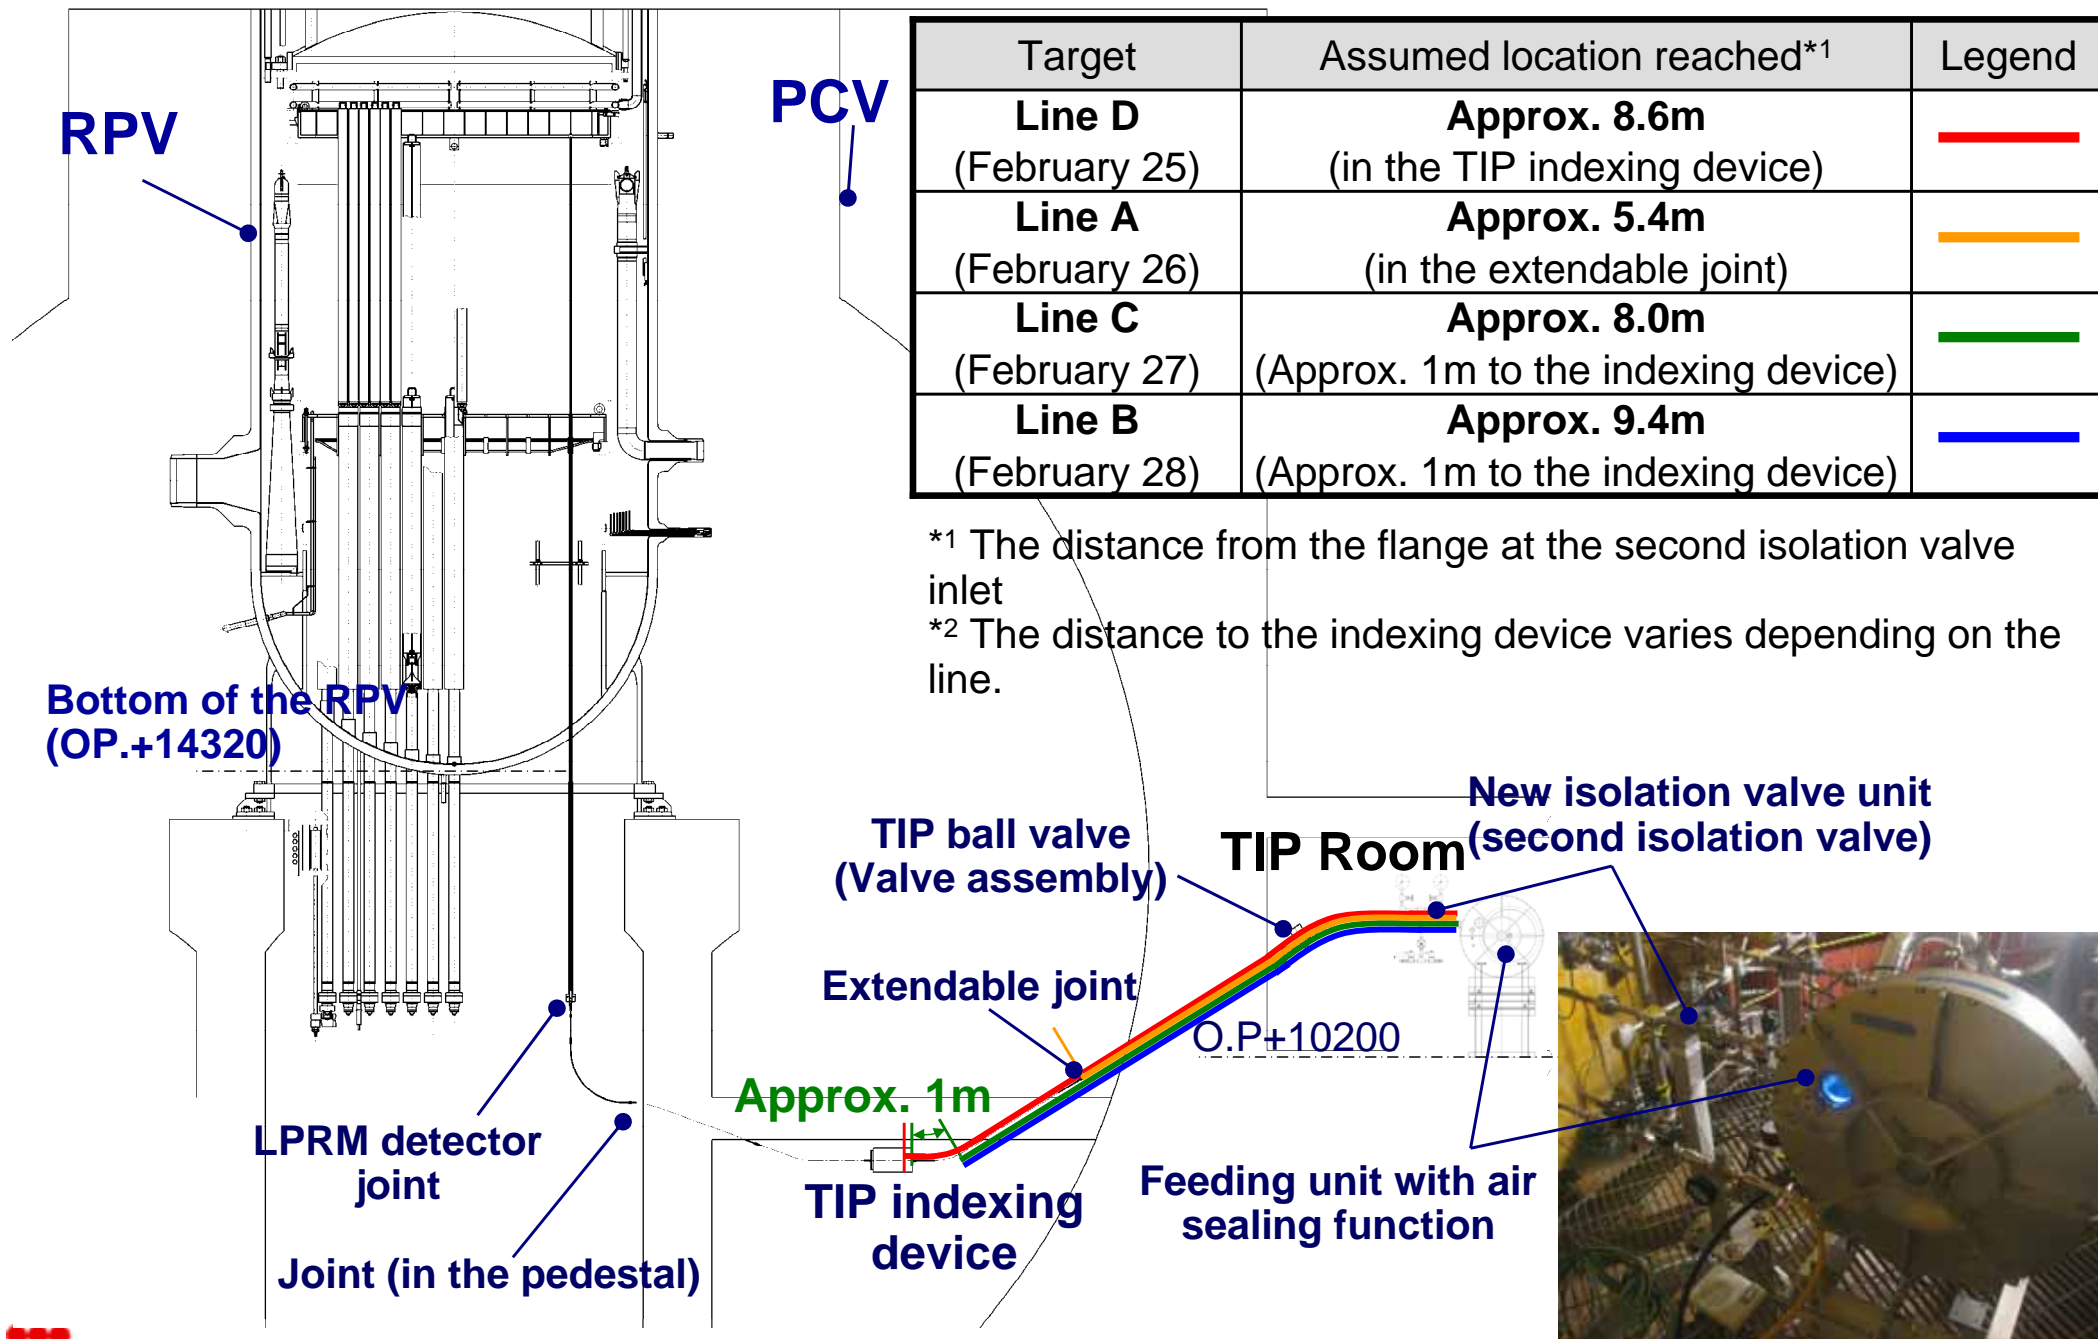
4. Results (February 25-28)

As a result of soundness inspection of the TIP guide pipe, the fiberscope could not be inserted all the way in all four lines.

1. Substances attached on the inside of the TIP guide pipe
2. The roller of the TIP indexing device limit switch not being pressed up

Considering the current conditions of the TIP guide pipe, it has been judged that **endoscope and thermocouple cannot be inserted.**

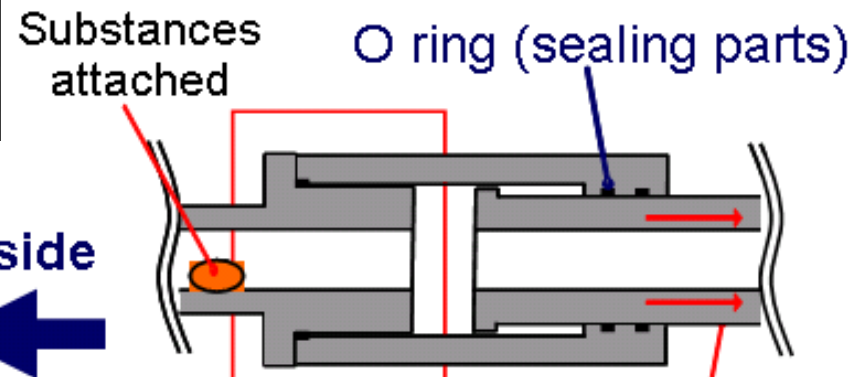
Extendable joint

The joint on the opposite side is fixed.

The joint is made extendable to allow for absorbing the PCV thermal displacement during regular operation.
