# Results of Investigation of the Lower Part of Unit 2 Vent Pipe at Fukushima Daiichi Nuclear Power Station

March 5, 2013

Tokyo Electric Power Company

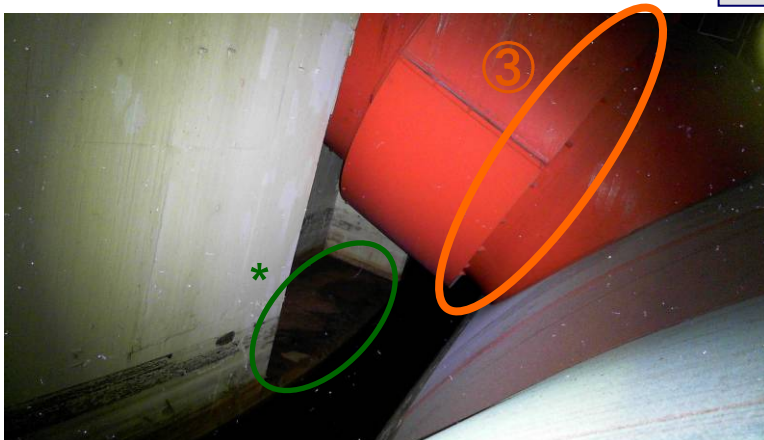
① Edge of the vent pipe sleeve

② Edge of the sand cushion drain pipe

③ Lower part of the vent pipe bellows cover: No water leakage found

No water leakage (water flowing) was found on the concrete stage \* on the lower part though the condition was not directly checked.

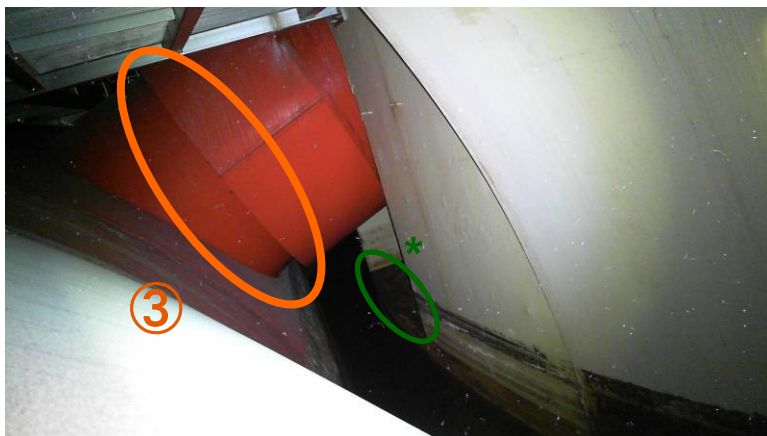
- ① Edge of the vent pipe sleeve
- ② Edge of the sand cushion drain pipe

- ③ Lower part of the vent pipe bellows cover: No water leakage found

No water leakage (water flowing) was found on the concrete stage \* on the lower part though the condition was not directly checked.
