Results of Investigation of the Lower Part of Unit 2 Vent Pipe at Fukushima Daiichi Nuclear Power Station

March 6, 2013

Tokyo Electric Power Company

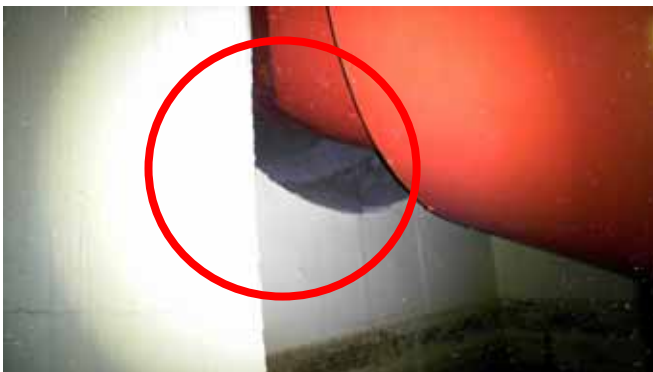
Edge of the vent pipe sleeve

1. No water leakage was found at the edge of the vent pipe sleeve.
2. No water leakage was found at the edge of the sand cushion drain pipe.
3. No water leakage was found at the lower part of the vent pipe bellows cover.
