Results of Investigation of the Inside of Unit 2 PCV

March 19, 2013
Tokyo Electric Power Company

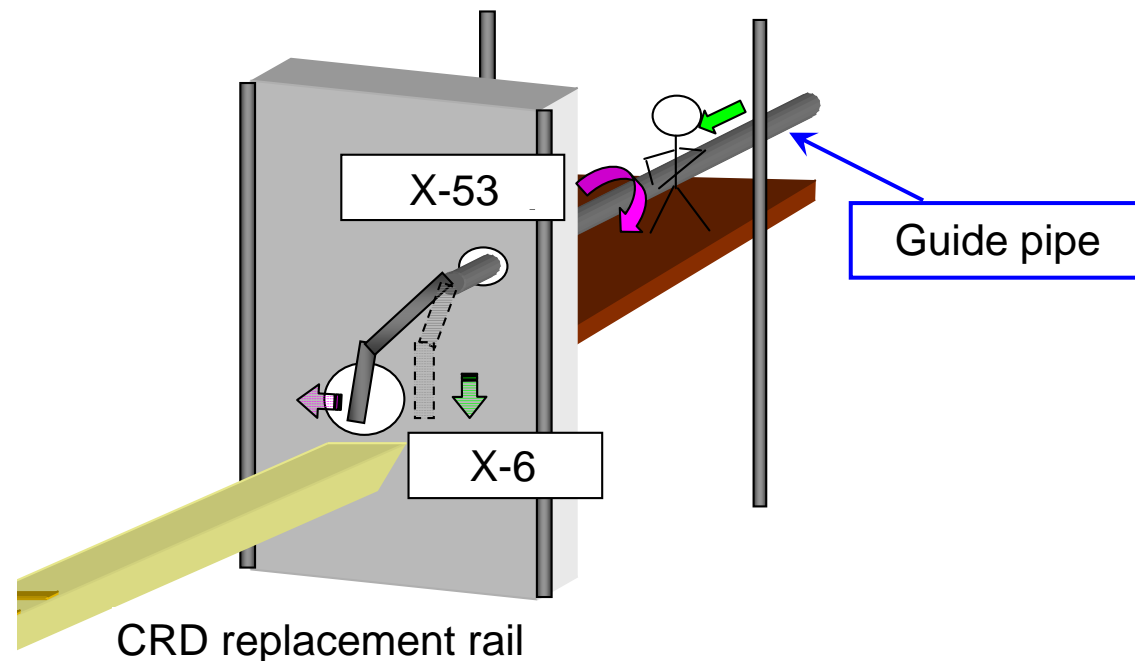
Though the guide pipe was initially planned to be removed and wiped off before completing the work, work was finished with the guide pipe still inserted since it got stuck and the exposure dose was getting close to the planned dose. The guide pipe will be removed as soon as finding out how. The PCV penetration opening is sealed by an O ring.
