Power Supply Facilities Failure (Units 3-4 Temporary M/C (A), etc.)

March 22, 2013

Tokyo Electric Power Company

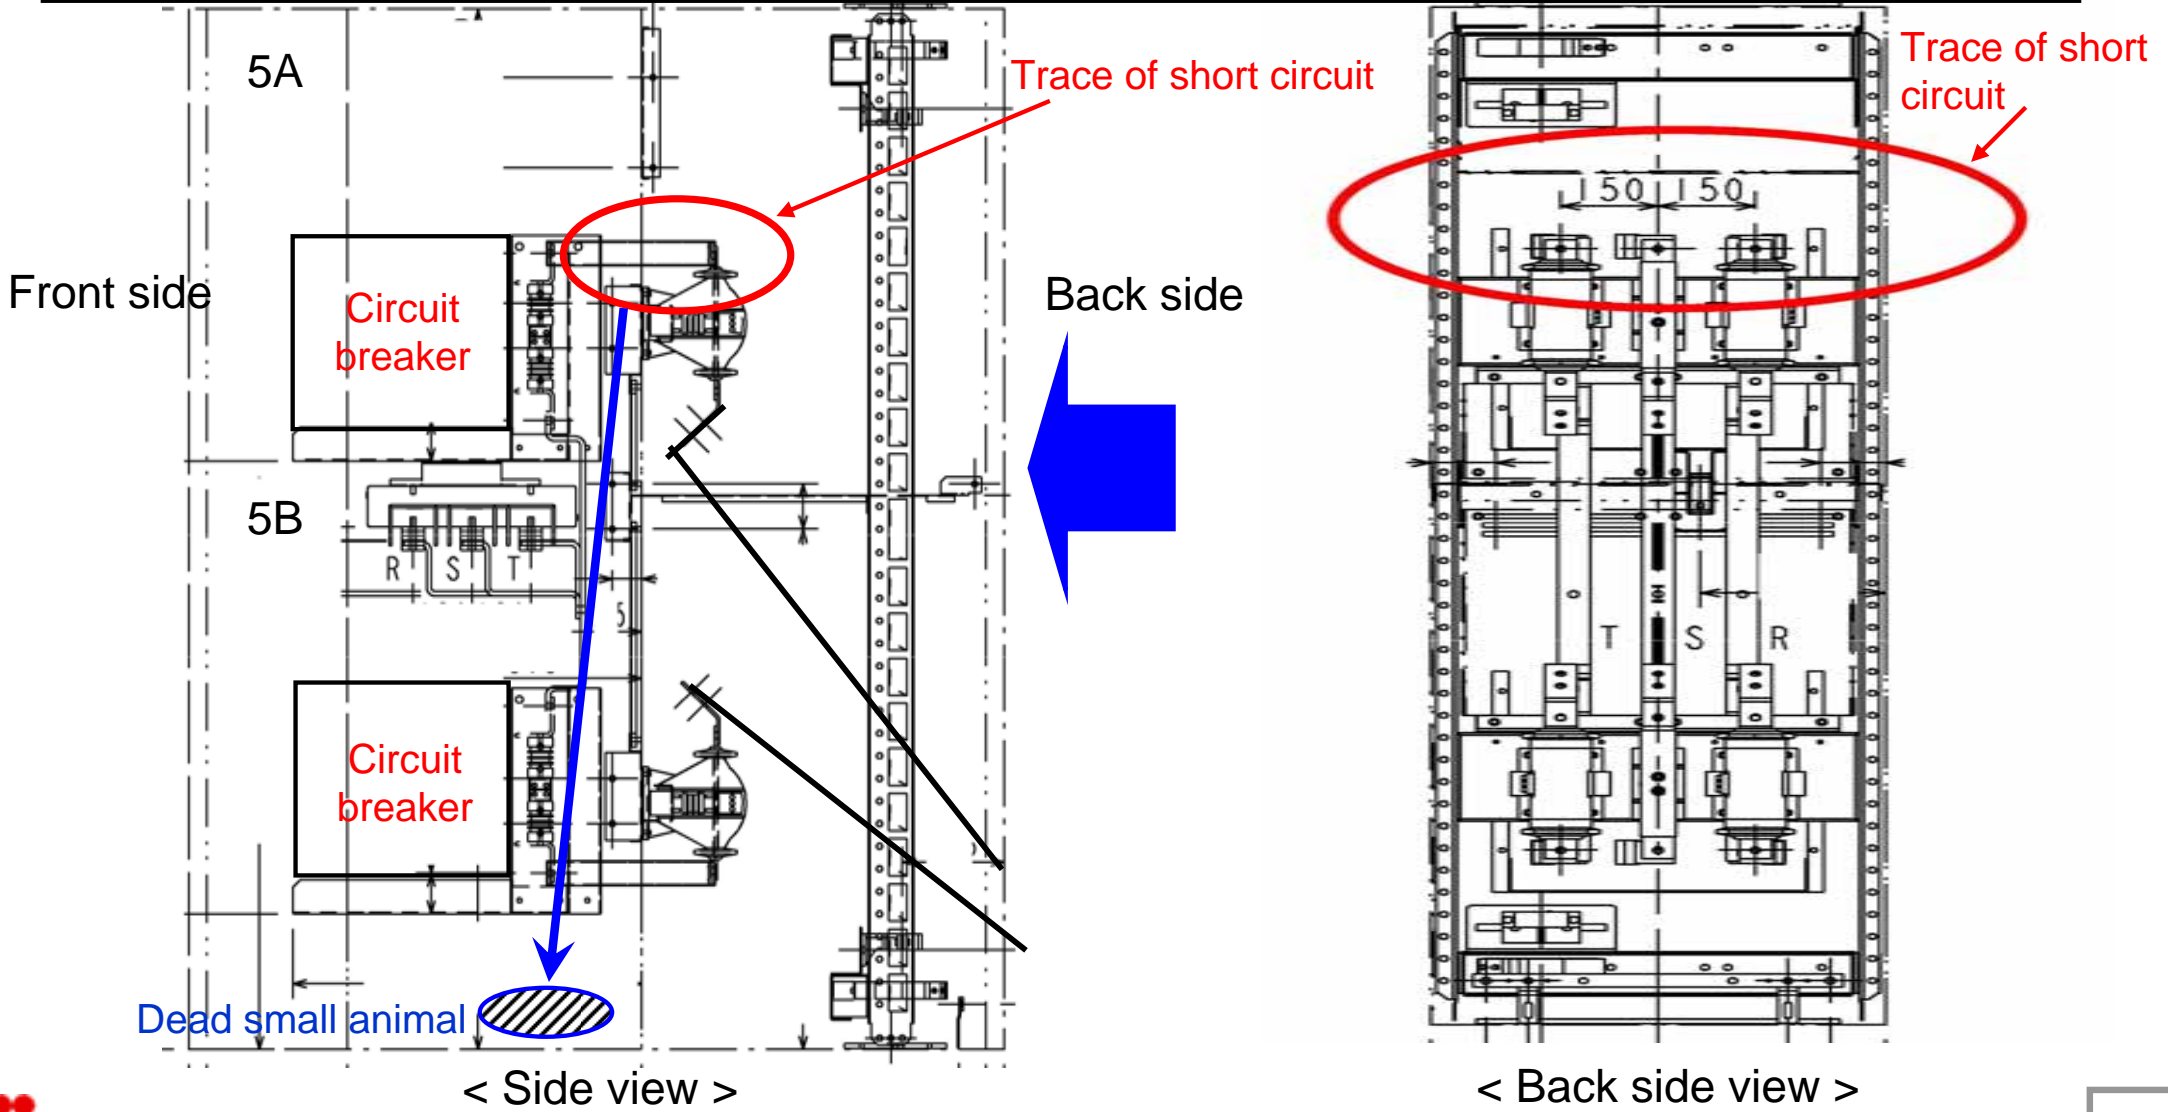
Investigation of Units 3-4 Temporary M/C (A) Unit (5A)

A trace of short circuit was found on the primary conductor (R, S, T phases) of the current transformer in the back of 5A unit of Units 3-4 temporary M/C (A). Also, a small animal was found dead on the floor of the same unit.

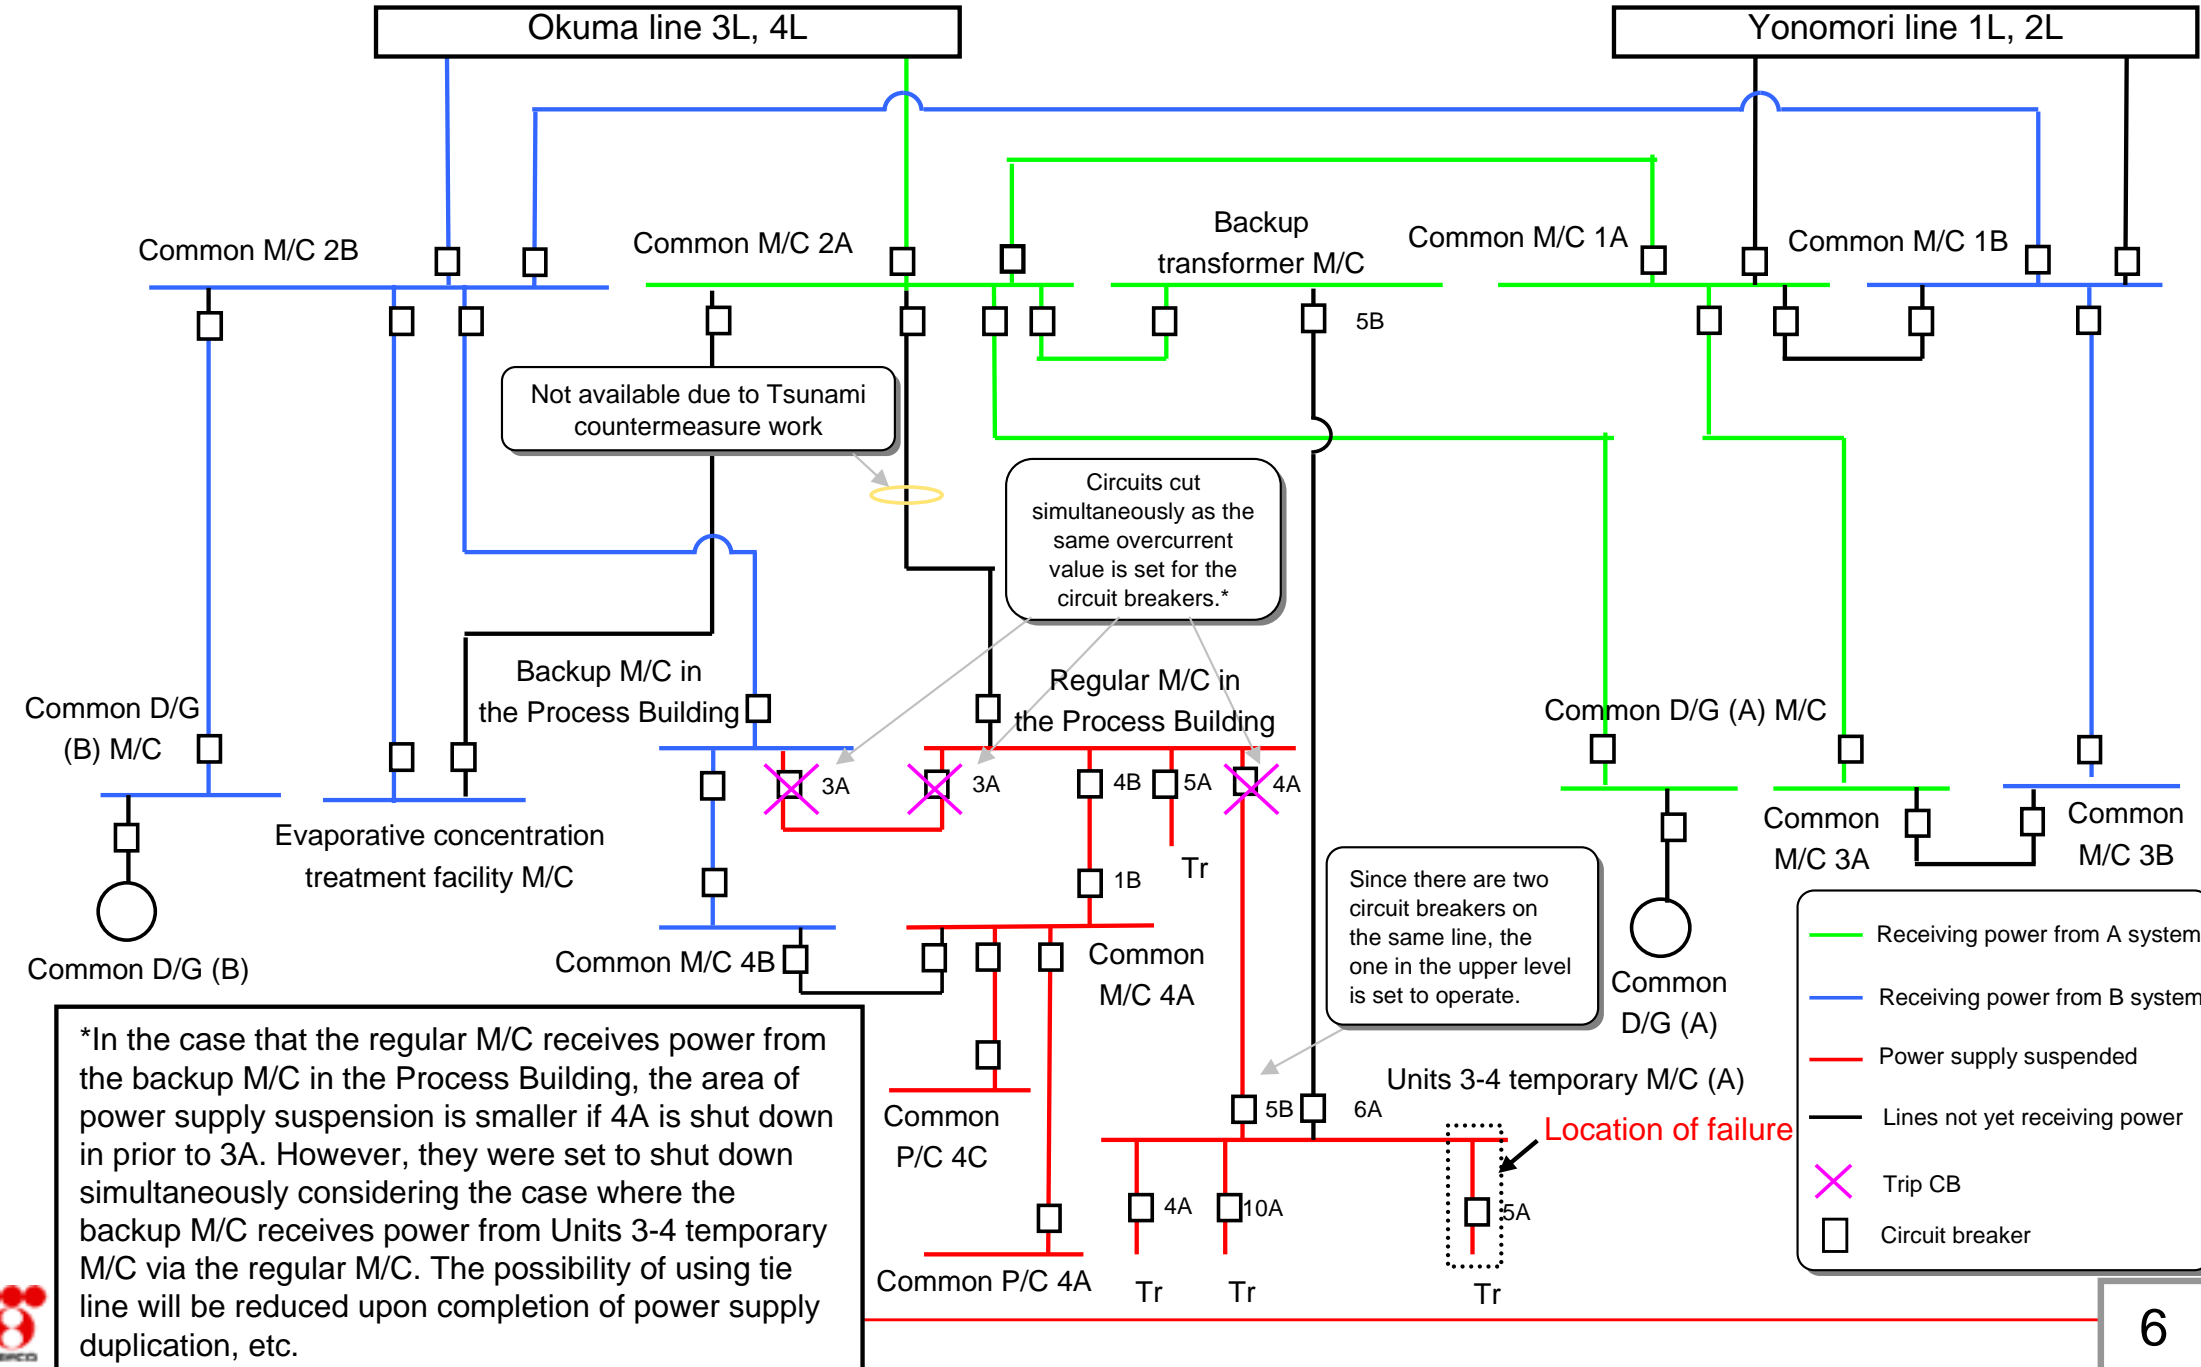
Power Supply System at the Time of the Incident

*In the case that the regular M/C receives power from the backup M/C in the Process Building, the area of power supply suspension is smaller if 4A is shut down in prior to 3A. However, they were set to shut down simultaneously considering the case where the backup M/C receives power from Units 3-4 temporary M/C via the regular M/C. The possibility of using tie line will be reduced upon completion of power supply duplication, etc.

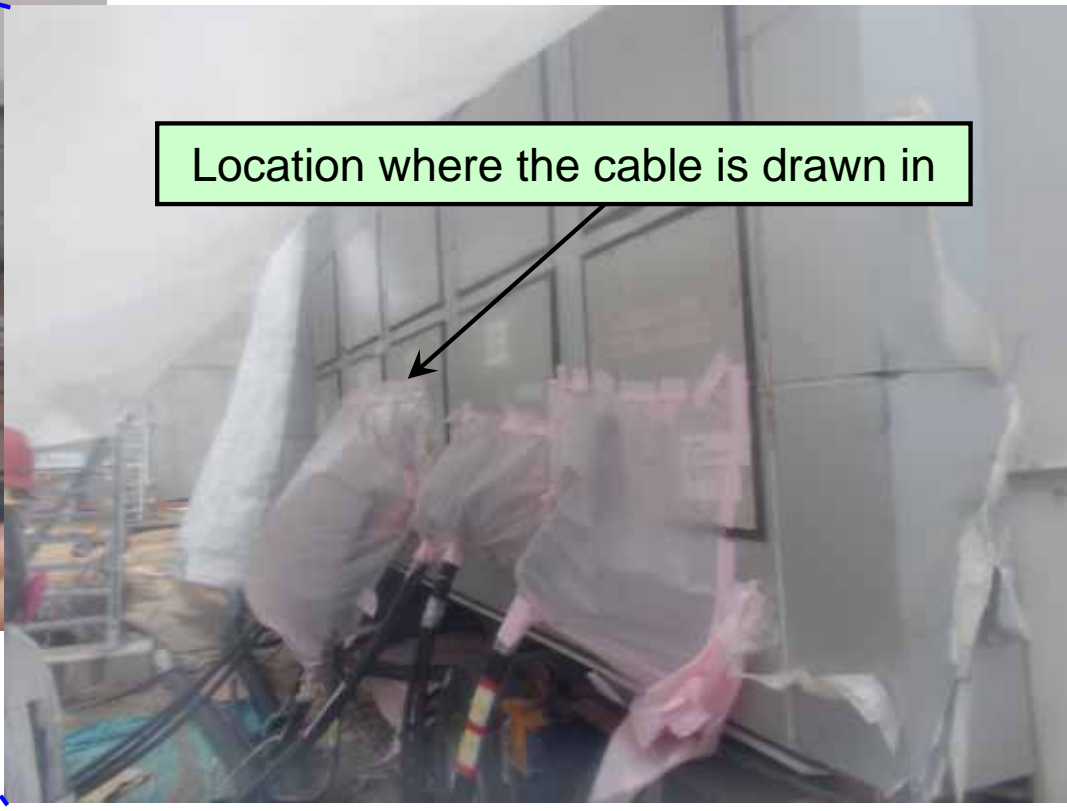
Location where the cable is drawn in

A small animal is assumed to have entered from the opening of Units 3-4 temporary M/C (A)

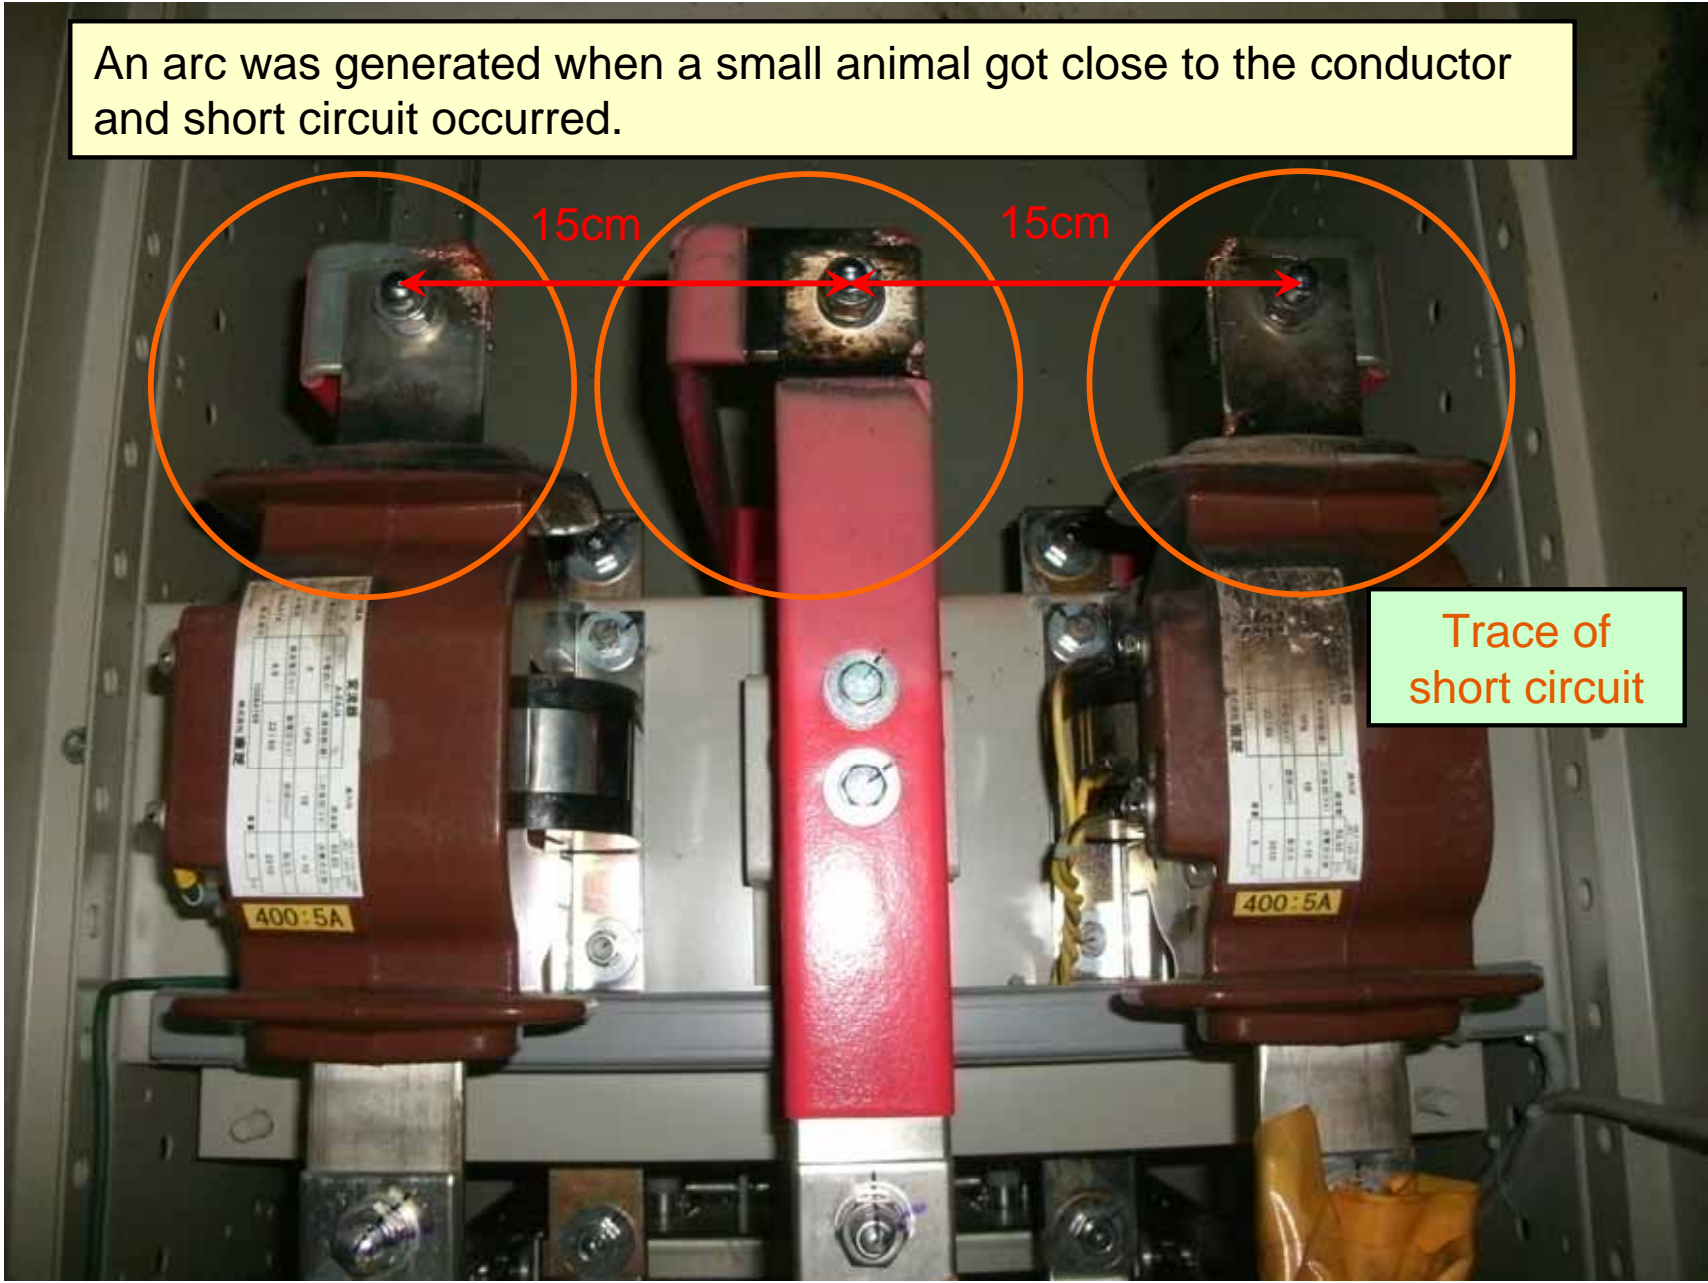
Photo Investigation of Units 3-4 Temporary M/C (A) Unit (5A)

An arc was generated when a small animal got close to the conductor and short circuit occurred.

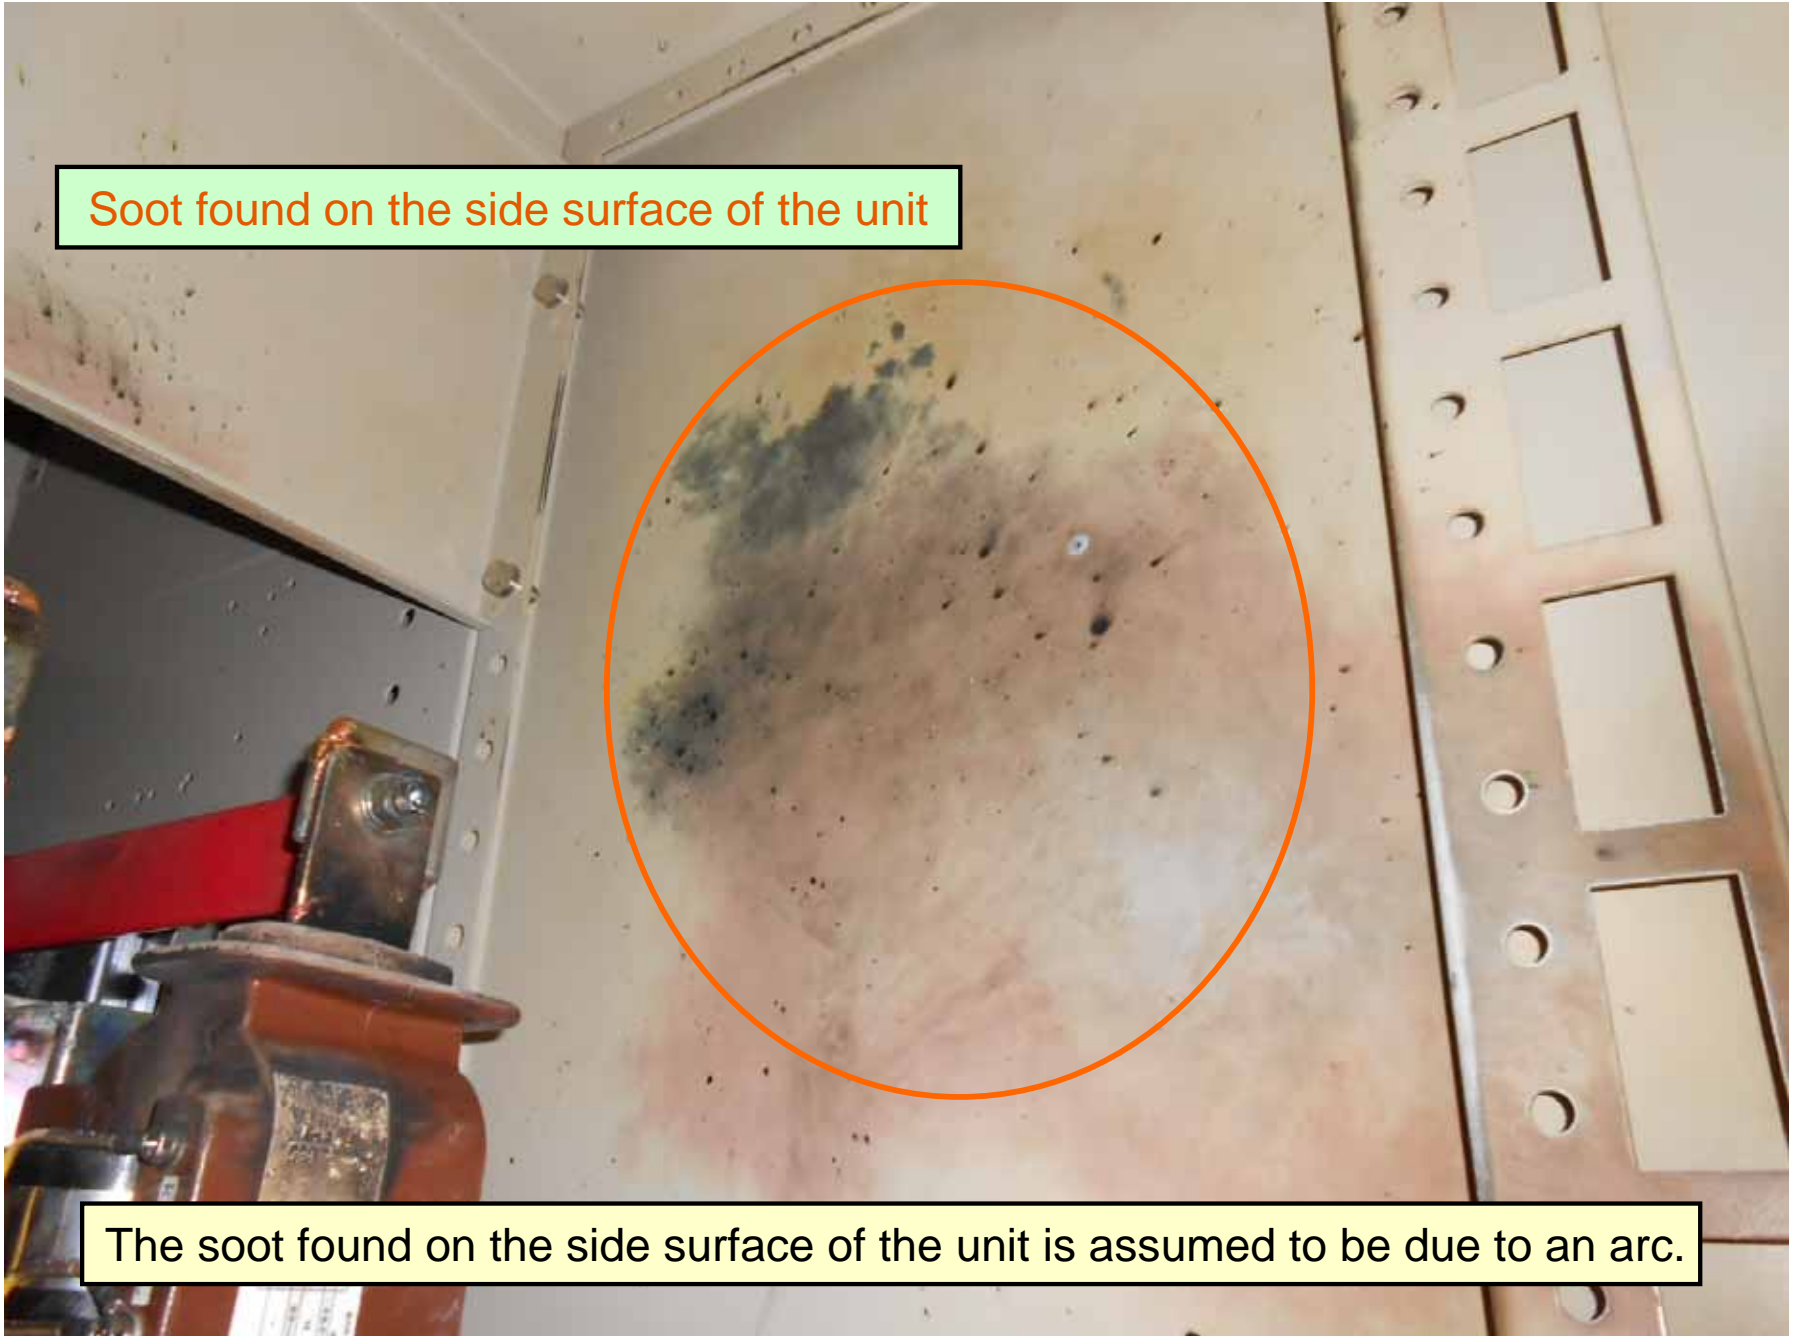
Soot found on the side surface of the unit

The soot found on the side surface of the unit is assumed to be due to an arc.

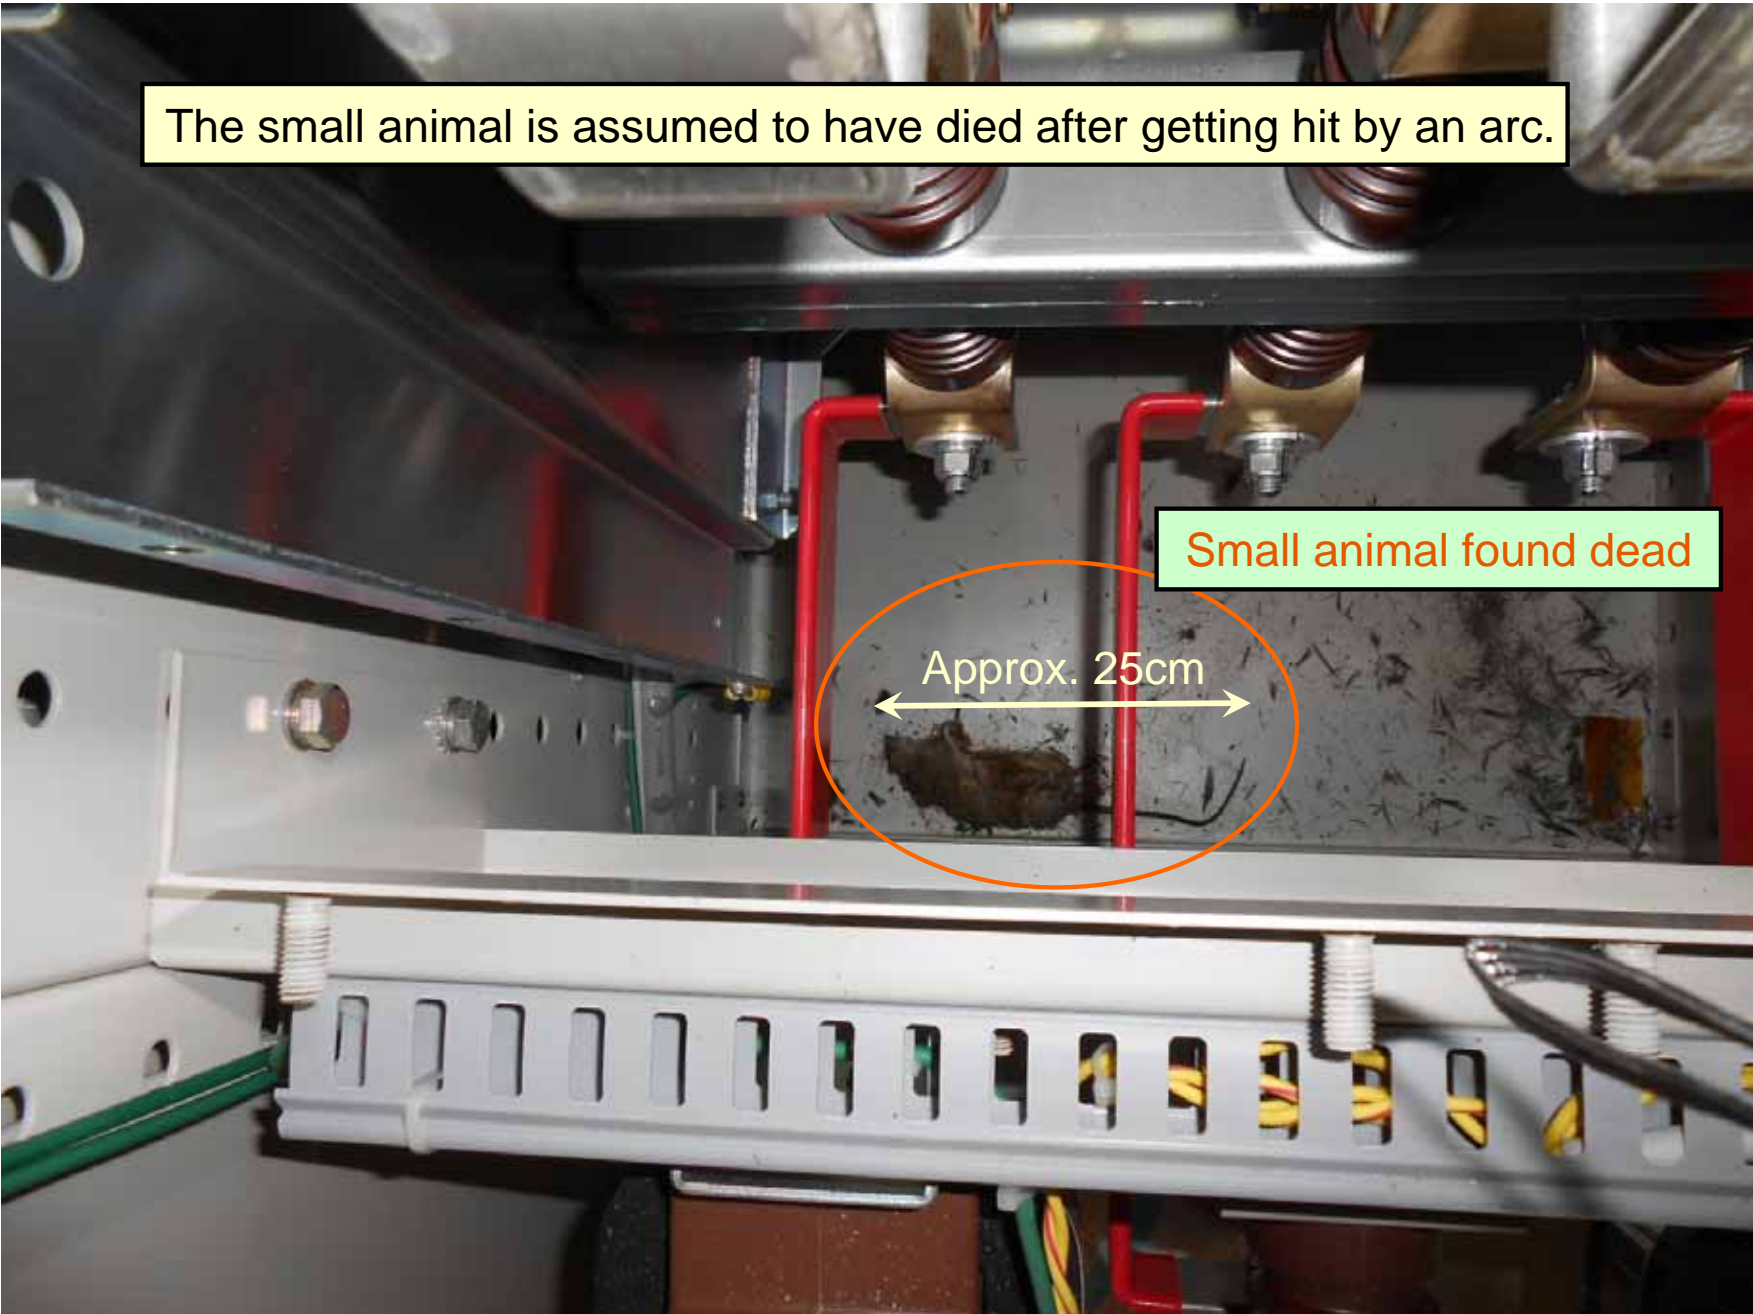
The small animal is assumed to have died after getting hit by an arc.

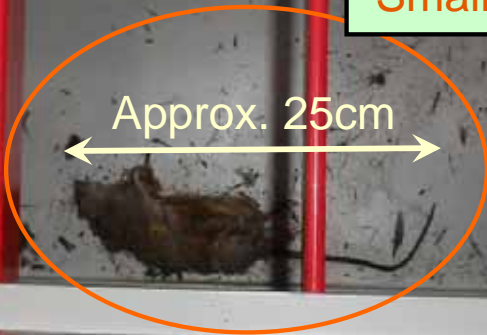
Small animal found dead
