# **Power Supply Facilities Failure at Units 1-4 of Fukushima Daiichi Nuclear Power Station**

**March 28, 2013  
Tokyo Electric Power Company**

# Investigation Result (1) Appearance Inspection: Trace of a short circuit found inside Units 3-4 Temporary M/C (A)

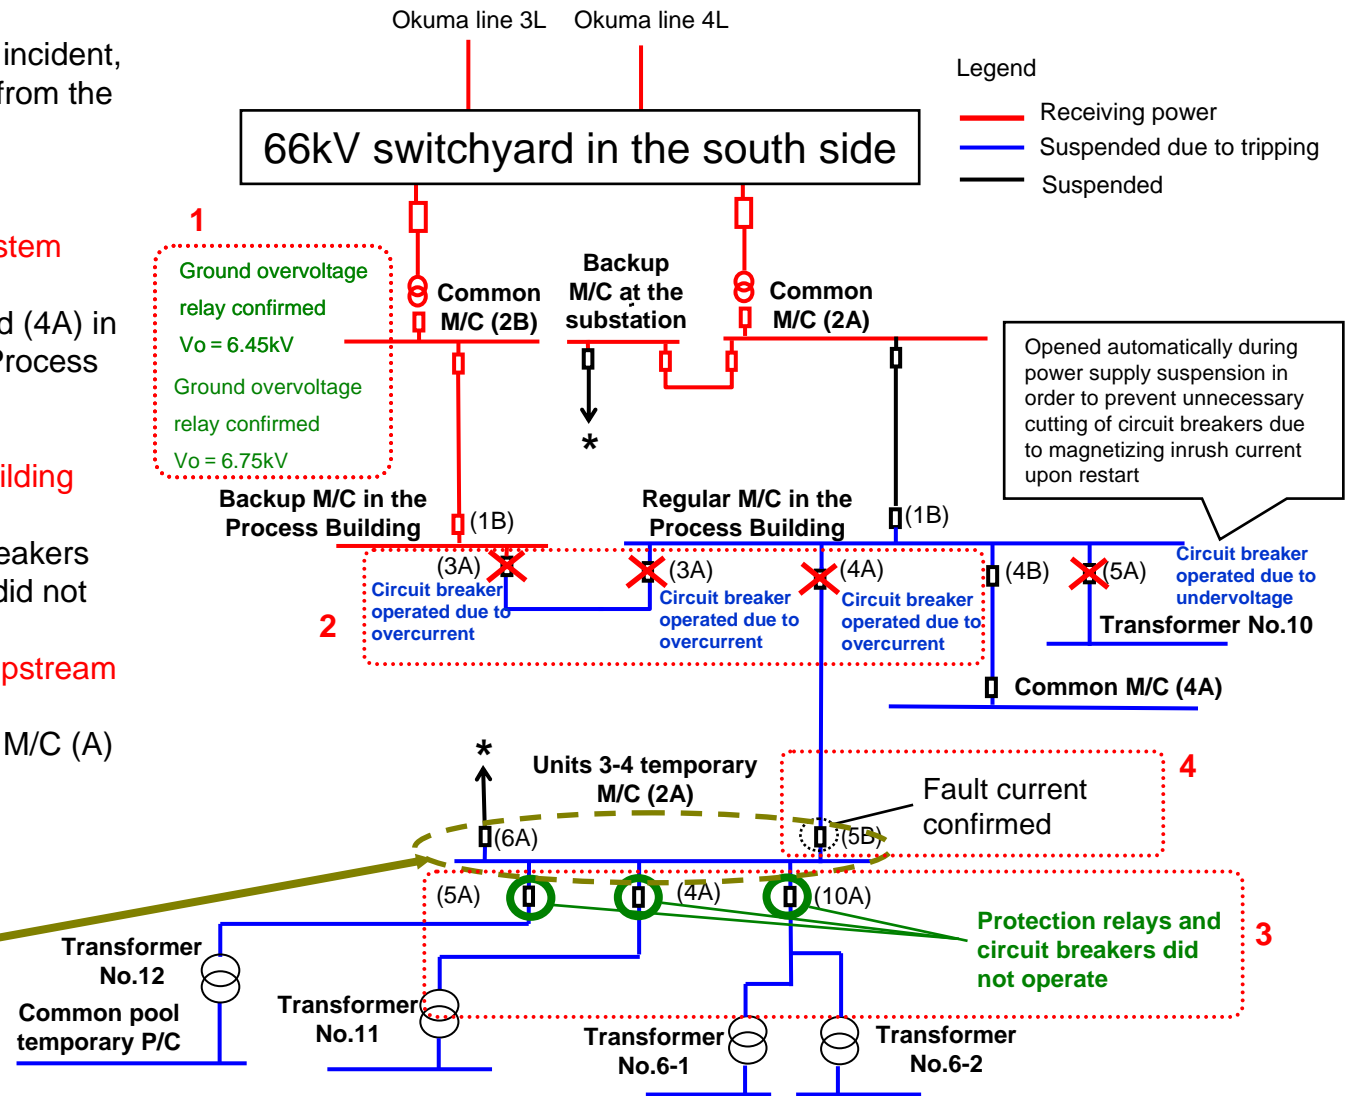
1. The ground relay in B system operated

: The failure is assumed to have occurred in B system and high voltage power supply system.

2. The circuit breakers of the regular M/C (3A) and (4A) in the Process Building and the backup M/C in the Process Building (3A) tripped due to overcurrent.

: The failure is assumed to have occurred in the downstream of the regular M/C in the Process Building (4A).

3. The ground directional relays and the circuit breakers of Units 3-4 temporary M/C (4A), (5A) and (10A) did not operate.

: The failure is assumed to have occurred in the upstream of the load systems of Units 3-4 temporary M/C.

4. Fault current was found in Units 3-4 temporary M/C (A) (5B).

: The failure is assumed to have occurred in the downstream of Units 3-4 temporary M/C (A) (5B).

The failure is assumed to have occurred in Units 3-4 temporary M/C (A).

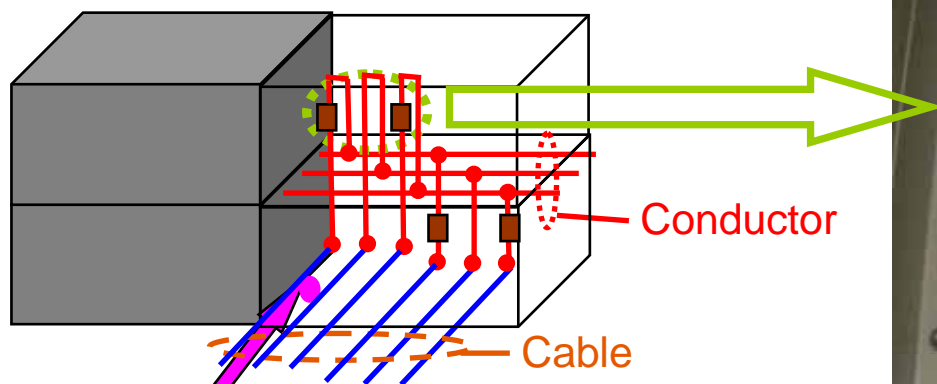
Unit (5A) enlarged

- Traces of short circuit were found on the conductor in the back of Units 3-4 temporary M/C (A) (5A). Also, a dead mouse (with an electric mark) was found on the floor of the same unit.
- No trace of short circuit or foreign substance was found in other units in Units 3-4 temporary M/C (A) and the main line.

Dead mouse

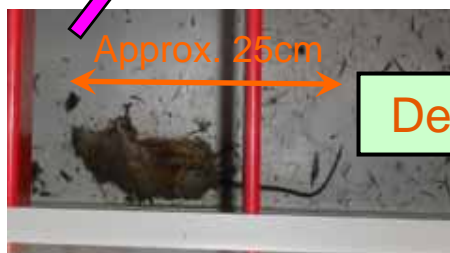
Traces of a short circuit

A mouse (25cm long) getting close to the conductor generated an arc leading to a phase fault which developed into a three-phase short circuit.

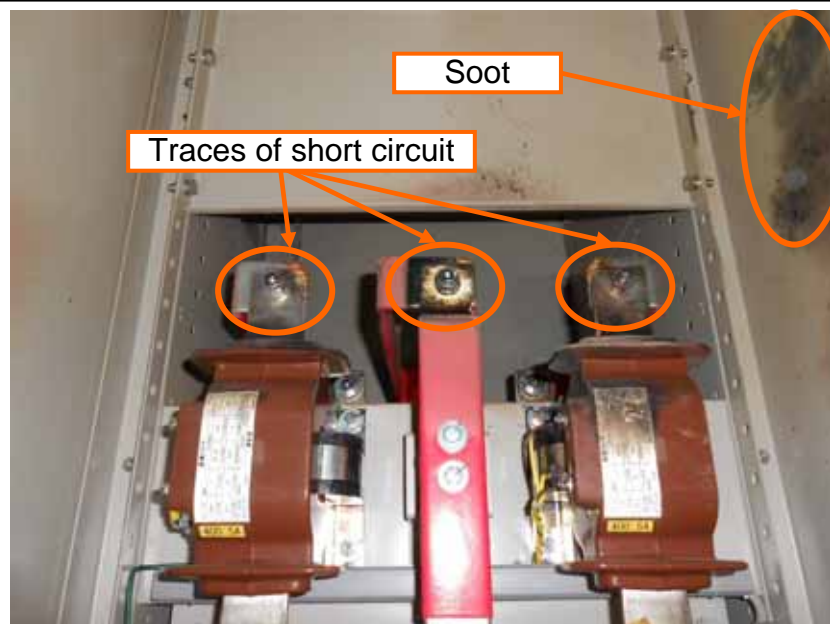
Inside the power panel (5A) after short circuit occurred

No problem was found with units other than 5A where short circuit occurred.

Photo 1: Inside the power panel after short circuit occurred

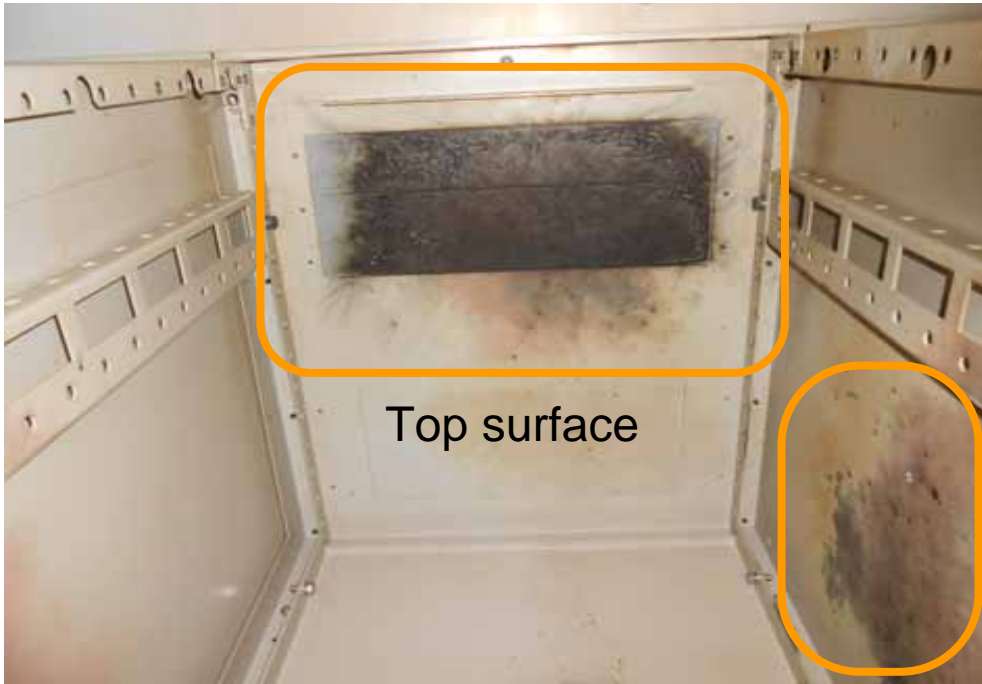
Traces of arc were found near the terminal of unit 5A.

Traces of short circuit found near the terminal of unit 5A

Trace of an arc found on the top surface of unit 5A

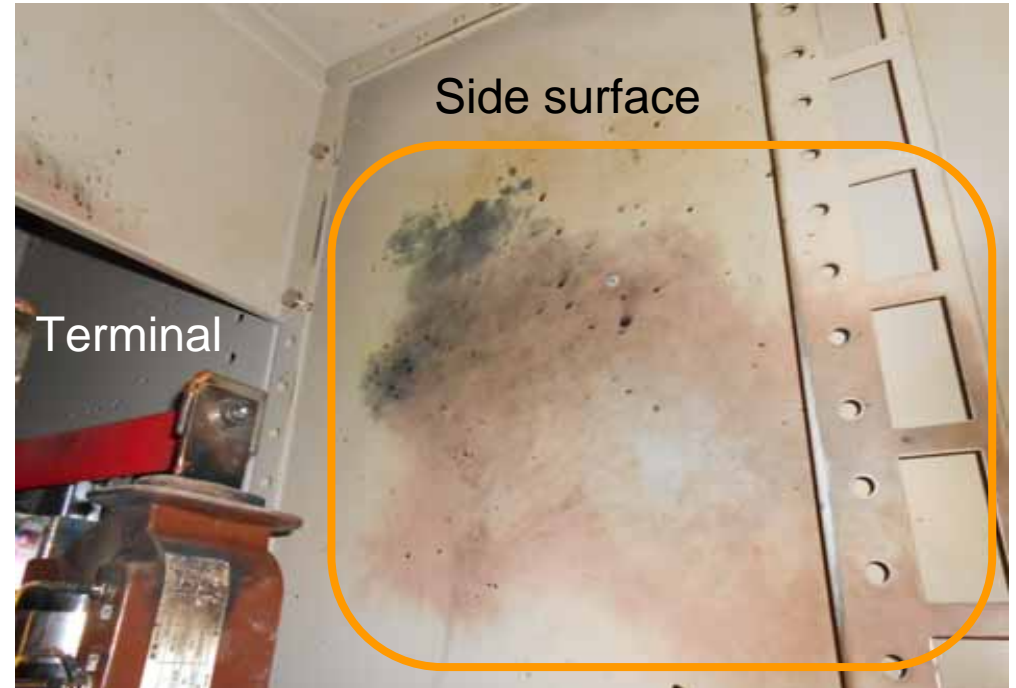
Trace of an arc found on the side surface of unit 5A

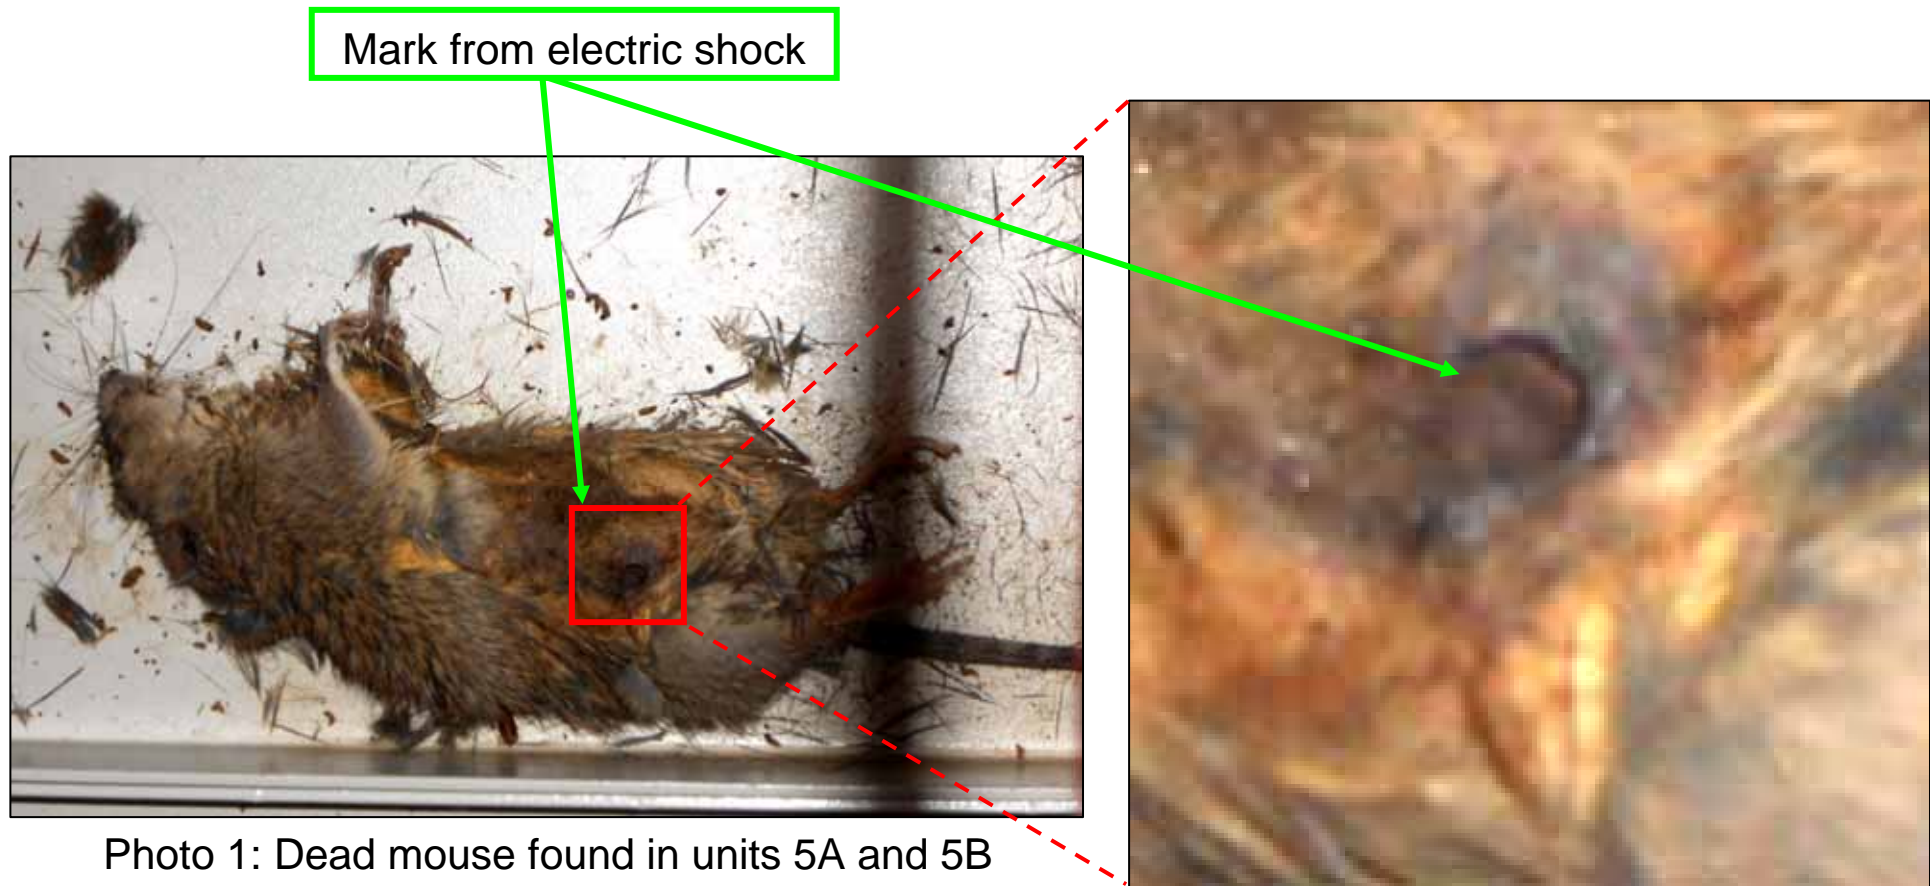
A dead mouse (Photo 1) was found on the floor of Units 3-4 temporary M/C (A) unit 5A. An electric mark (Photo 2) was found on its body.

Photo 1: Dead mouse found in units 5A and 5B

Photo 2: Enlarged image of the electric mark

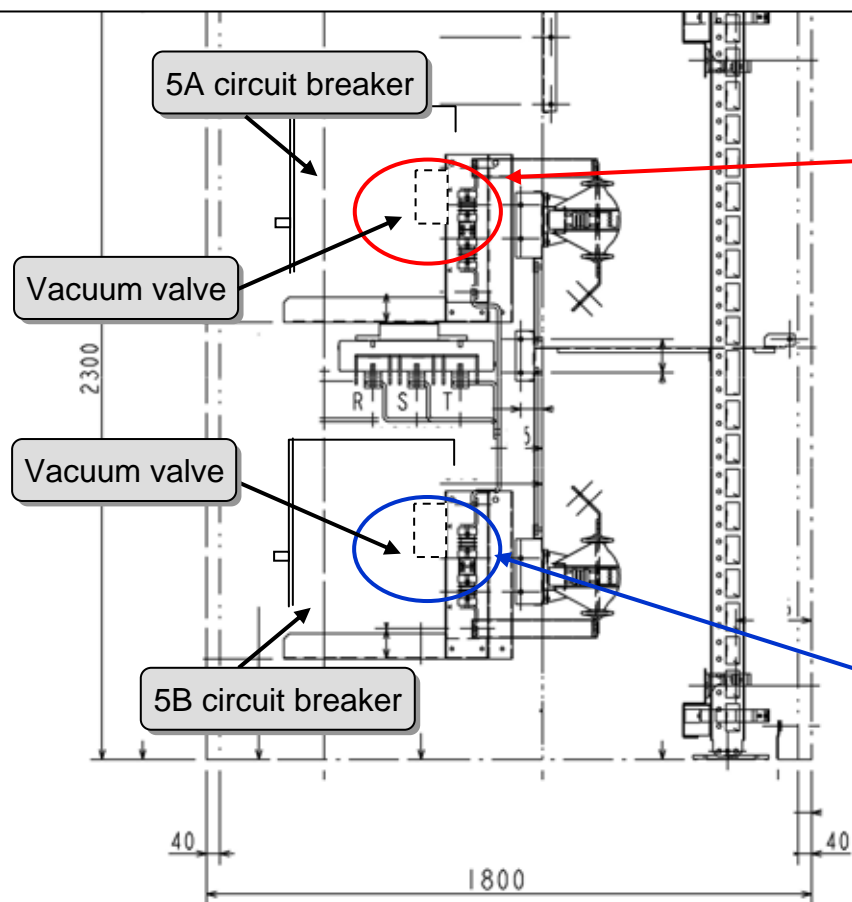
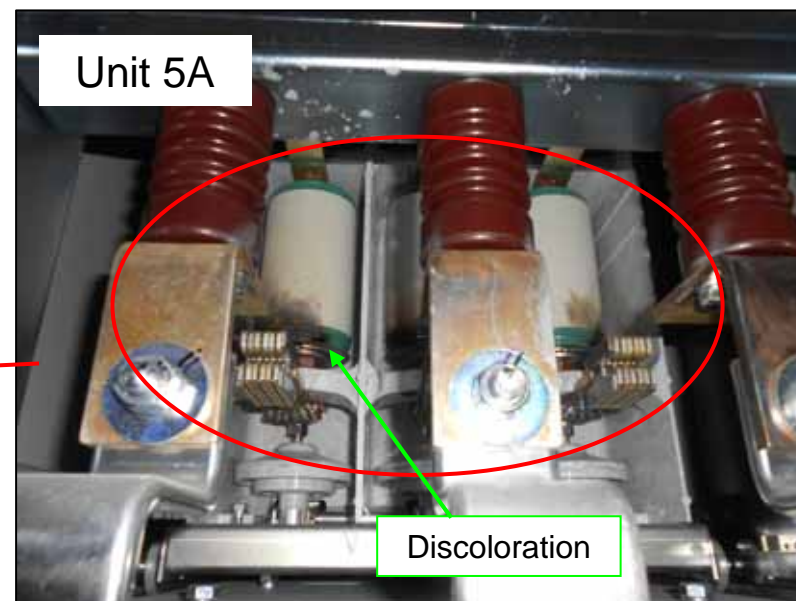
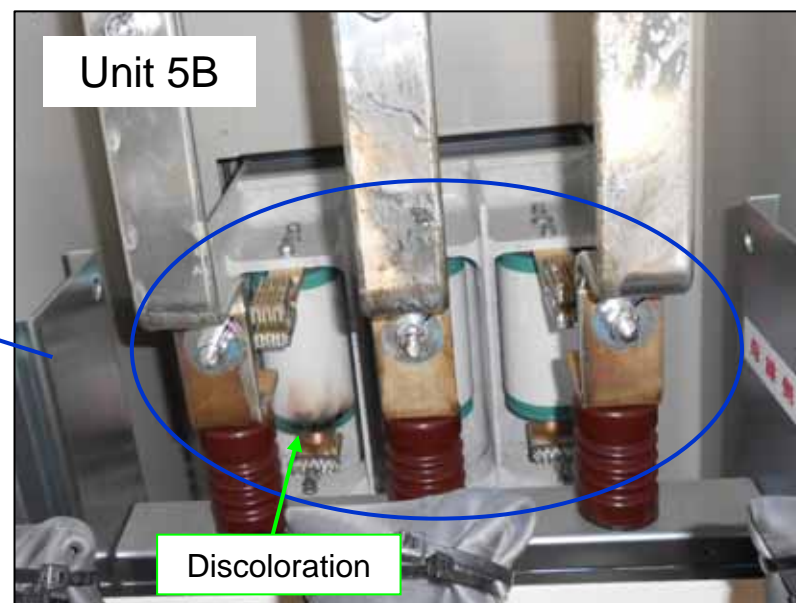
As a result of appearance inspection of circuit breakers and insulation resistance test, discoloration was found in the lower part of the vacuum valves in units 5A and 5B circuit breakers which is considered to be due to the fault current.

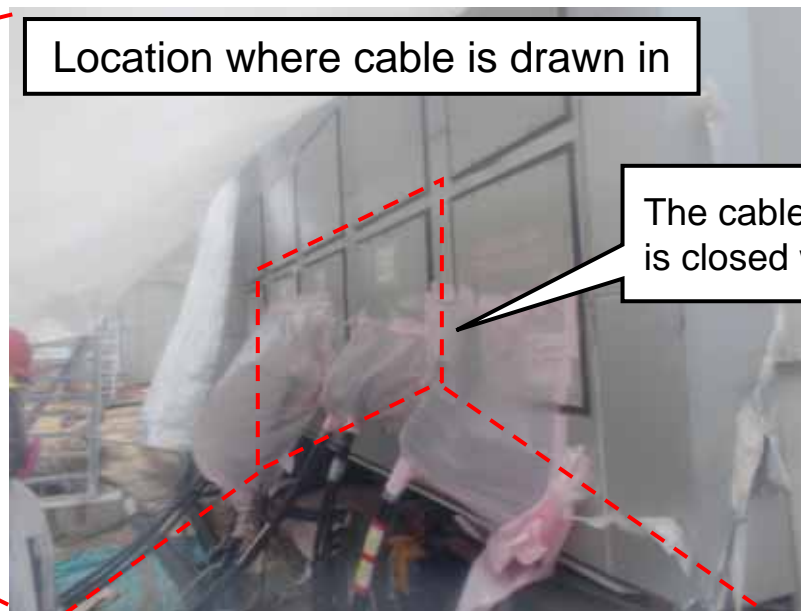
Location where cable is drawn in

The cable penetration area is closed with a sheet.

- A mouse may have gotten into the unit from the opening generated by sheet partially coming off.
- Since the sheet was removed for investigation, trace of mouse, etc. could not be confirmed.
- No abnormality was found with the appearance of the sheet, etc. at the time of inspection performed in the morning of March 18.

In addition to the countermeasures for small animals currently being implemented, the openings such as cable penetration areas will be closed for high voltage power panels which can be significantly affected by power supply failure.

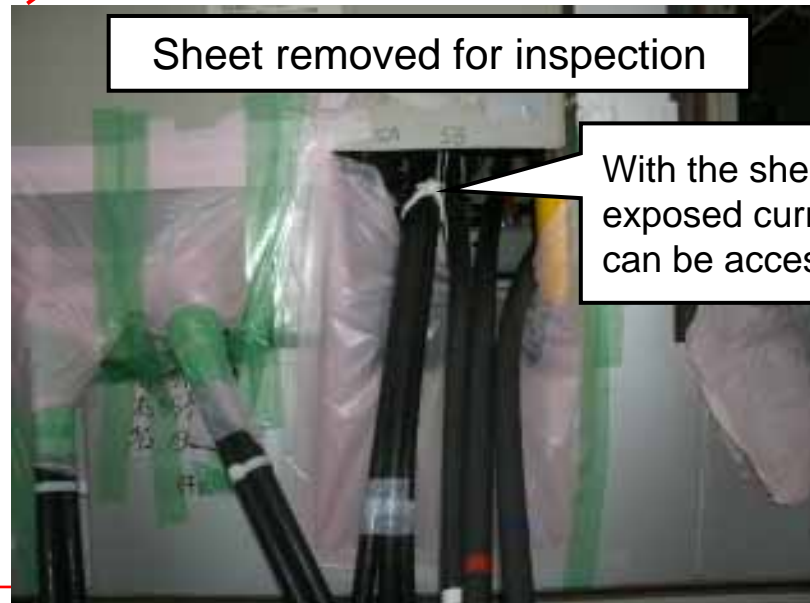
Sheet removed for inspection

With the sheet removed, the exposed current-carrying area can be accessed.

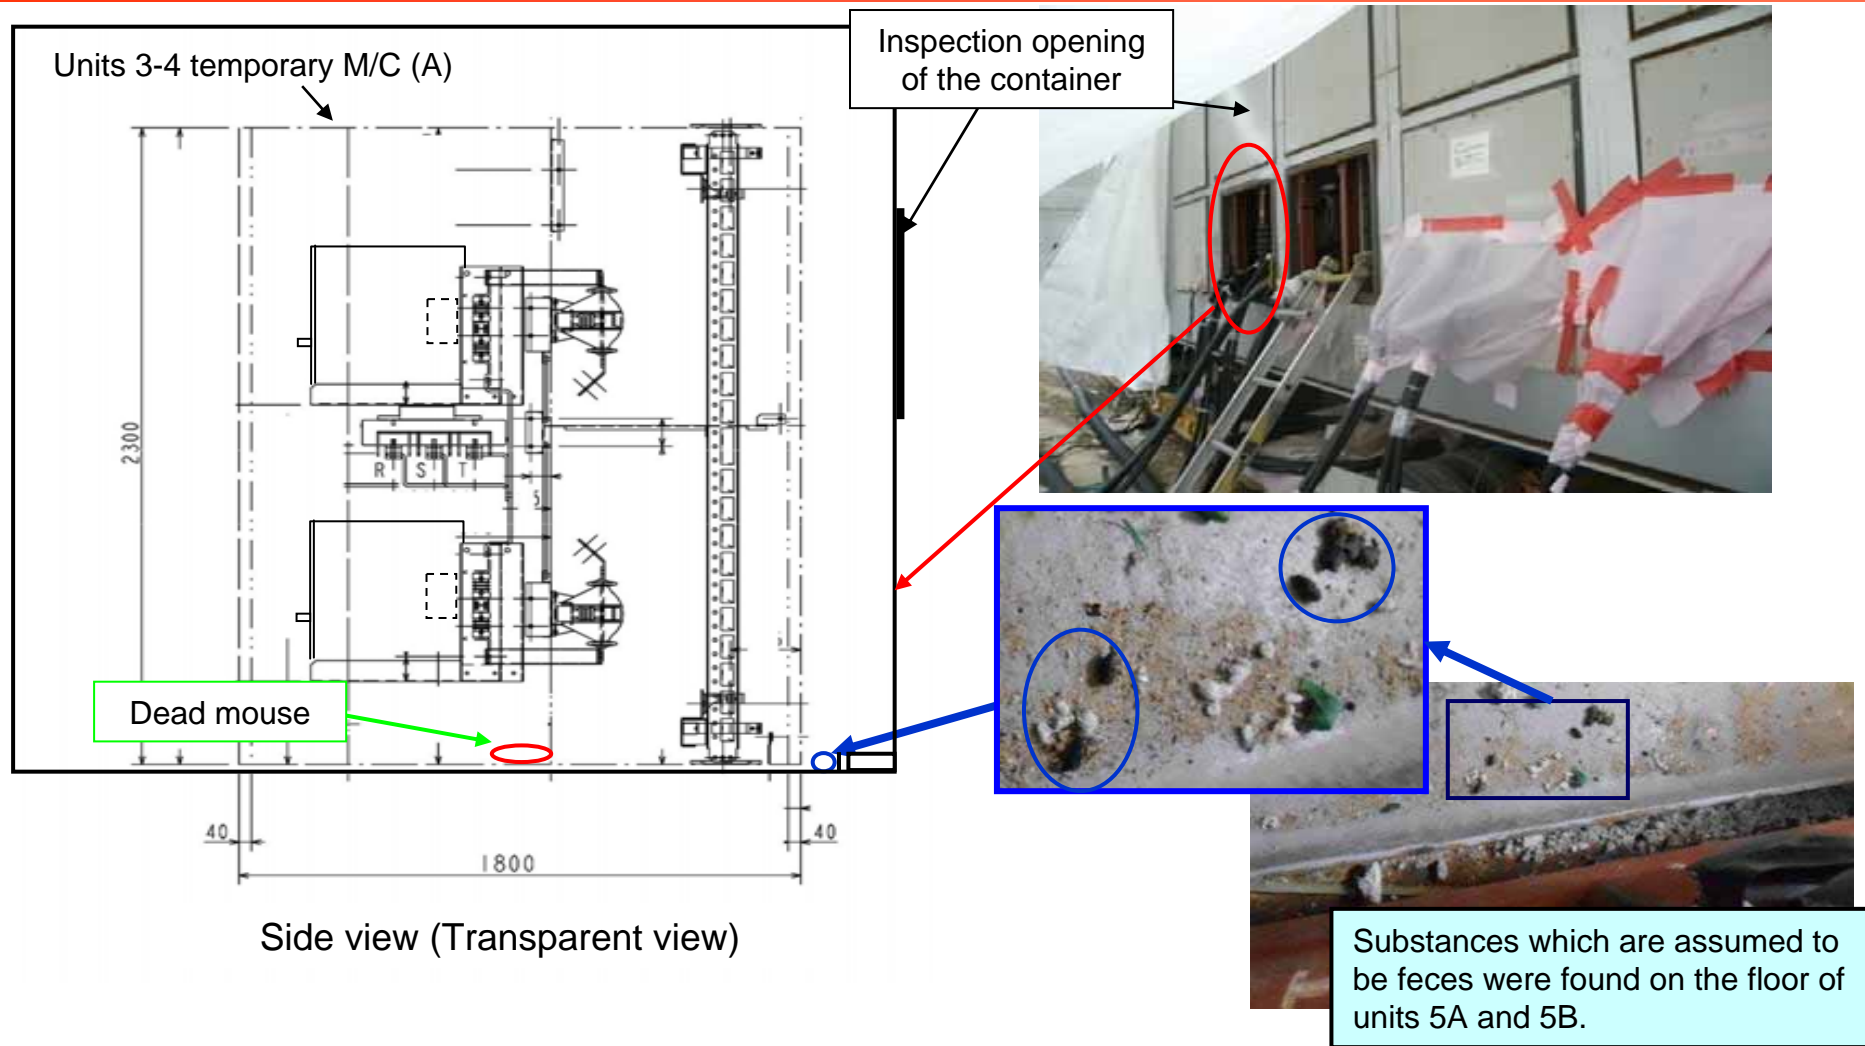
Substances which are assumed to be mouse feces were found on the floor of Units 3-4 temporary M/C (A) unit 5A and 5B.
