**Current Handling of  
the No. 3 Underground Reservoir  
( As of 6:00pm, April 7, 2013 )**

April 7, 2013

Tokyo Electric Power Company

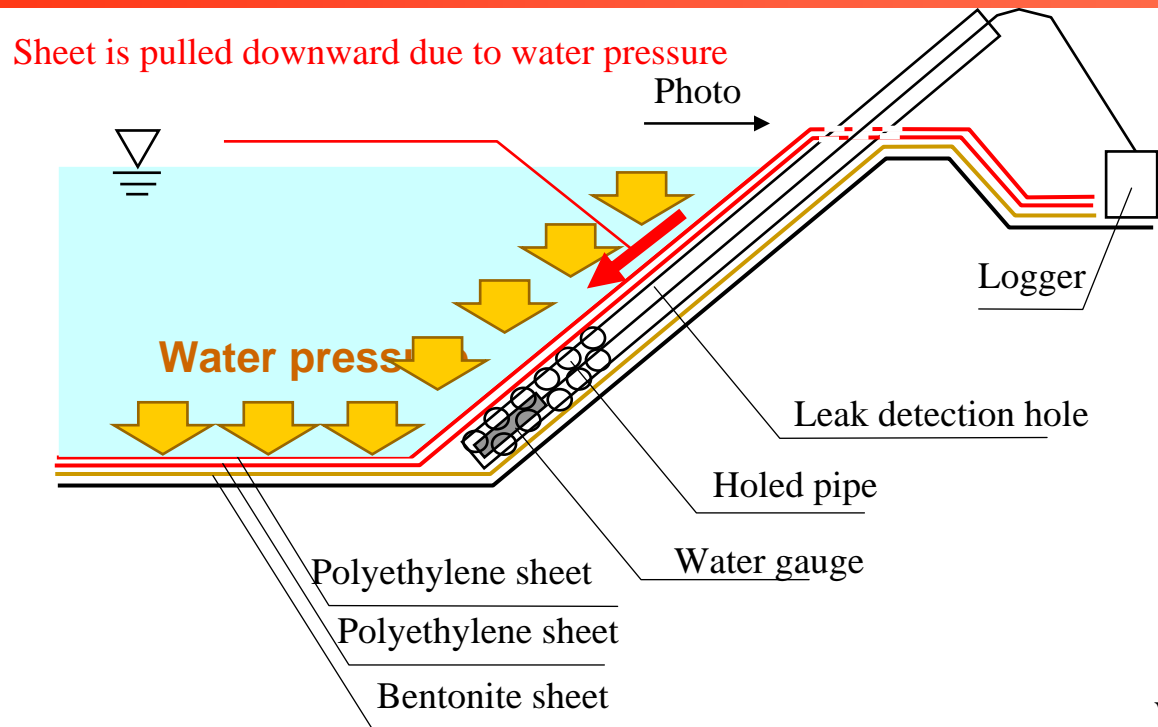
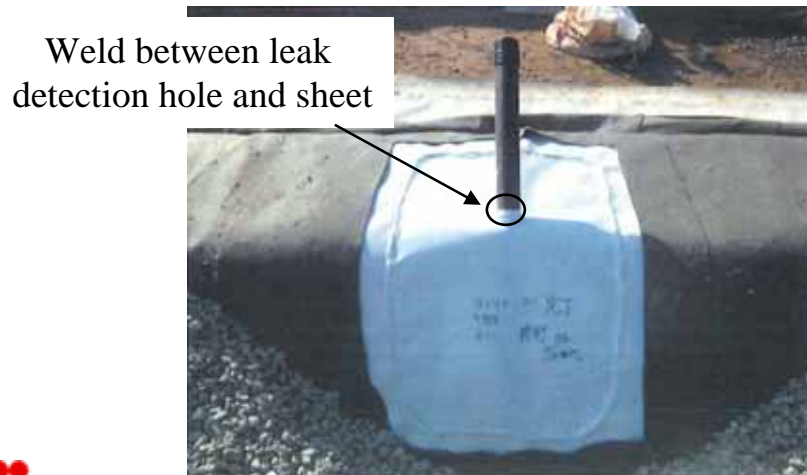
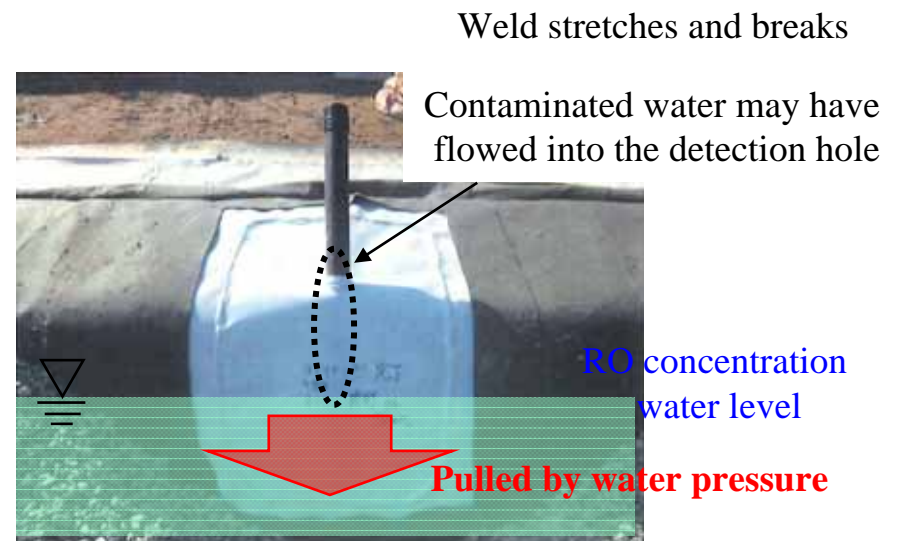
### 3. Scenario where the area near the leak detection hole penetration is damaged

- The underground reservoir has manual welds and is subject to large tensile forces, so areas penetrated by different types of materials (leak detection hole penetration) are difficult to construct and may have lost durability.

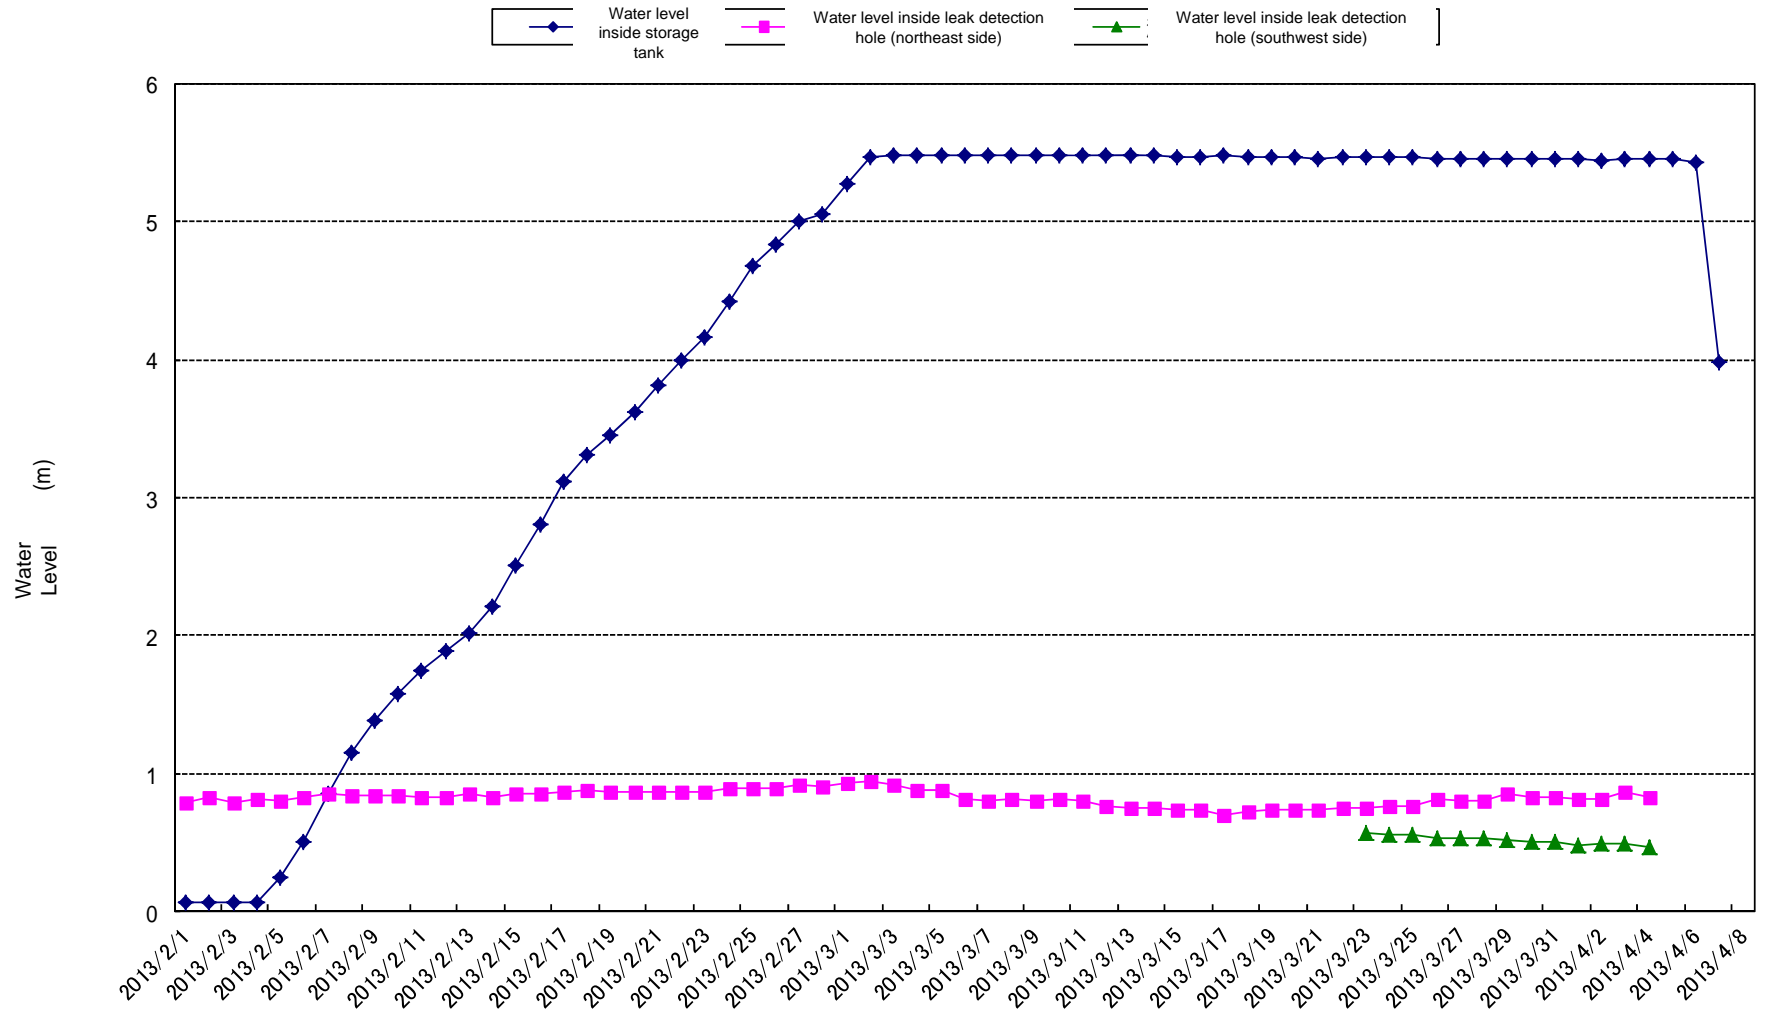
# underground reservoir No. 2 water level

Water level changes in the storage tank and section holes have been slow. Water concentrations in the detection hole and drain hole on the northeast side show rises in saline and all beta radiation thereby suggesting a leak from the top.

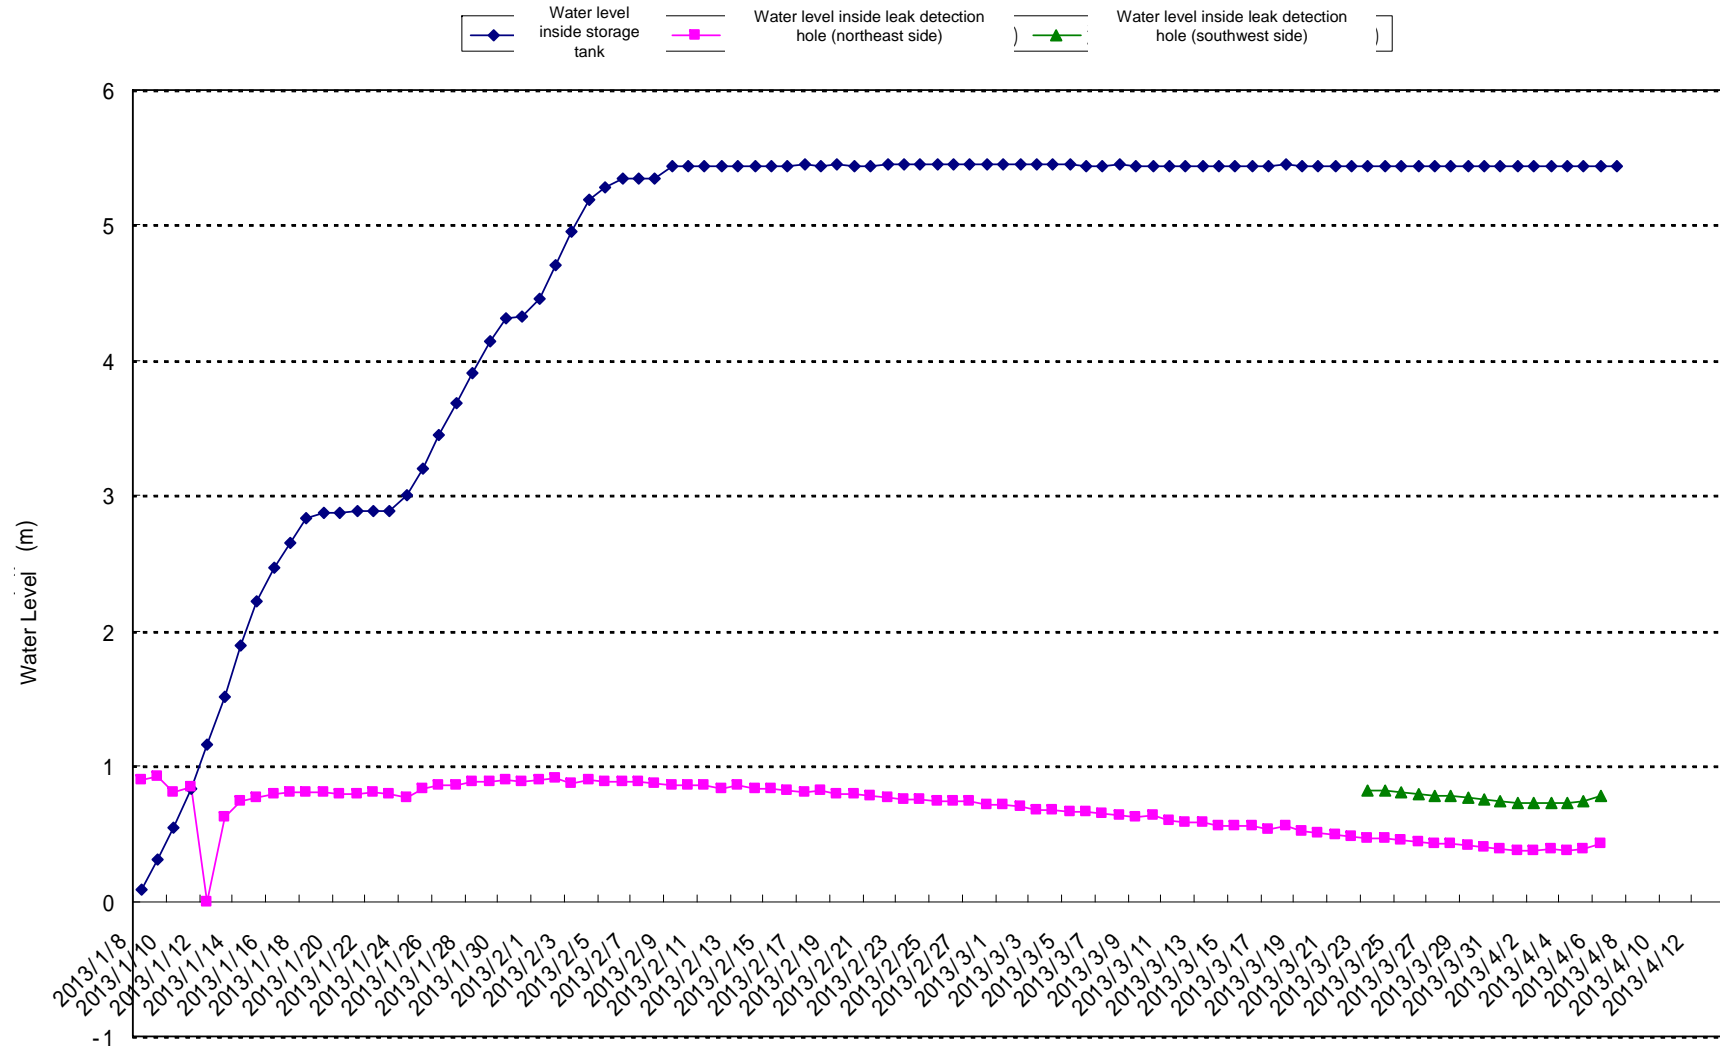
# underground reservoir No. 3 water level

There have been no changes in the water levels of the storage tank and the detection holes, rather only an increase in the concentration of water in the detection hole thereby suggesting a leak from the top.

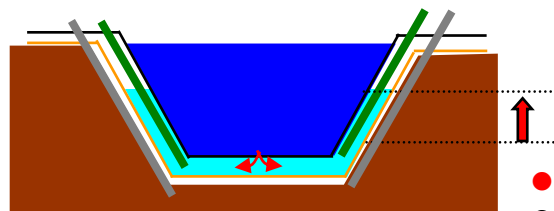
Leak from the bottom

- Quick rise in water level
- Increase in leak detection whole water concentration
- Increase in drain hole water concentration

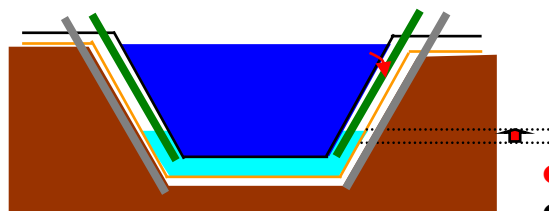
Leak from the top

- Slow rise in water level
- Increase in leak detection whole water concentration
- Increase in drain hole water concentration

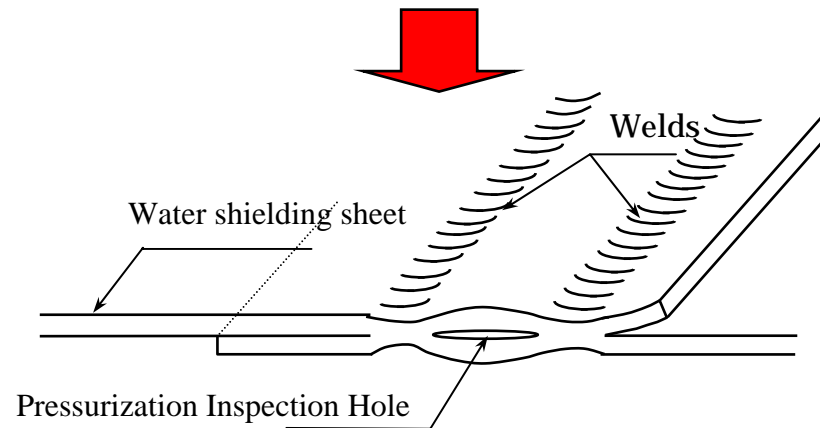
Water shielding sheet welds

3 : A full-scale negative pressure inspection is underway and there is medium possibility of a nonconformity with welds since they are done manually.
