# Suspension of Unit 3 Spent Fuel Pool Circulation Cooling System at Fukushima Daiichi Nuclear Power Station: Cause Analysis and Countermeasures

April 15, 2013

Tokyo Electric Power Company

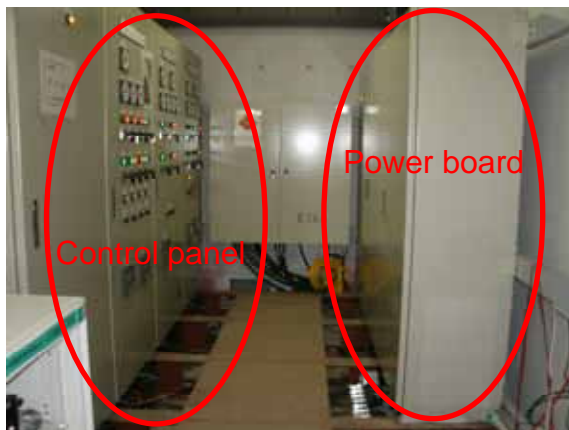
Control panel

Power board

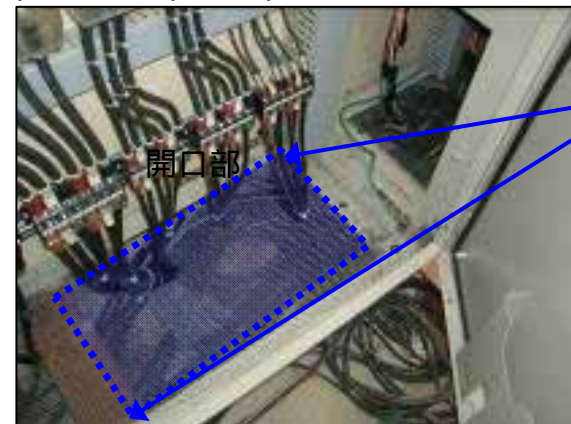
Opening

Lower part of the power panel in the container house

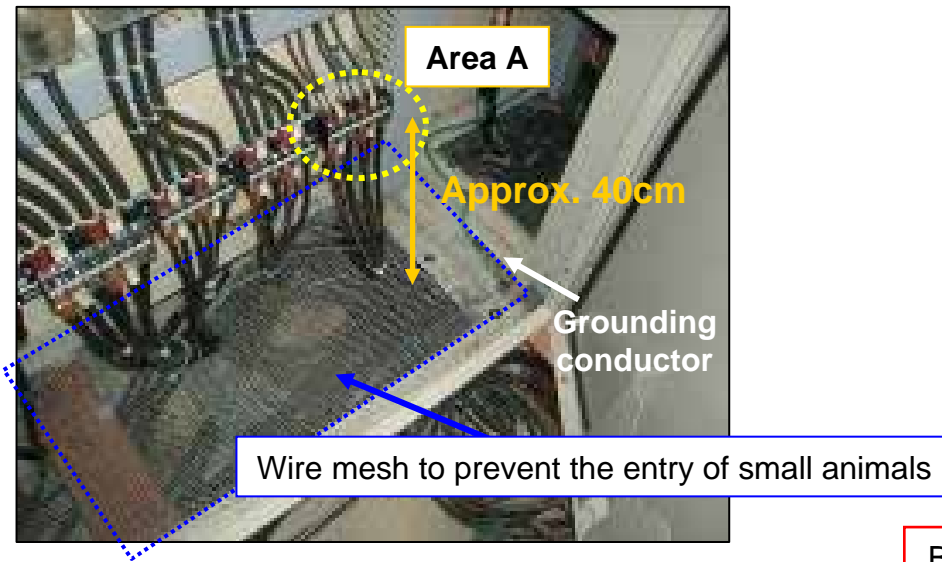
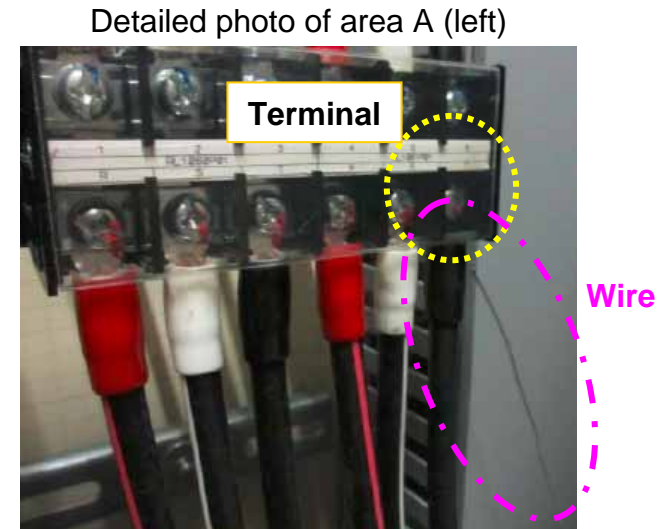
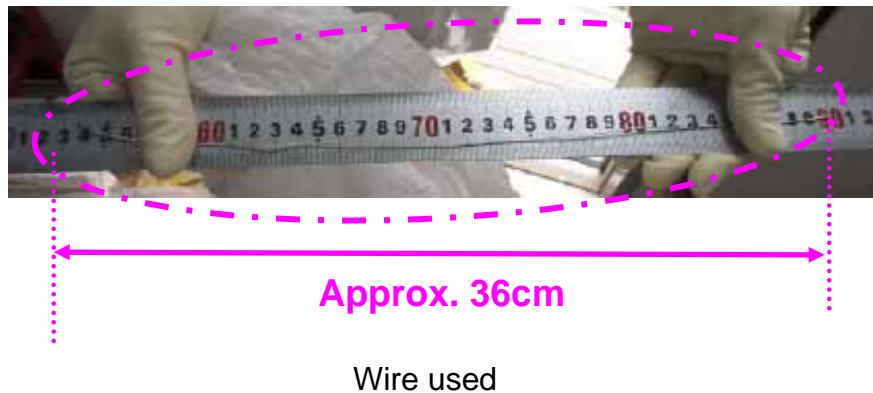
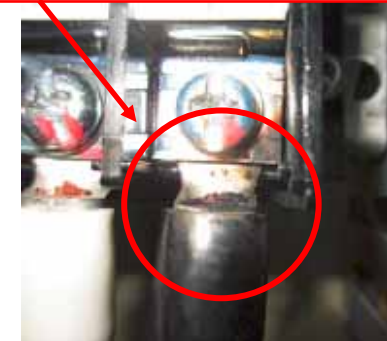
As a result of site investigation performed after the alarm went off, **burn was found on the edge of a piece of wire and a current-carrying terminal (which were being used for the work) due to a ground fault.**

Burn found on the edge of a piece of wire and a terminal

1. The wire which was being used for fixing the wire mesh touched a terminal and the terminal got connected to the grounding conductor through the wire and the wire mesh, resulting in a ground fault.
2. Due to the ground fault occurred, the circuit breaker of the distribution board in the upstream of the power board operated. As an alarm indicating a “power board failure” went off, the SFP circulation cooling system was suspended.

The ground fault was directly caused by not implementing any of the following measures.

- The power was not turned off during the work.
- The current-carrying area was not being protected.

In addition, as an indirect cause, the worker may have had the wire in his hand accidentally touch the terminal with his ability to concentrate lowered after long hours of work.
