# The Activity Status of the “Emergency Response Headquarters for Reliability Improvement at Fukushima Daiichi Nuclear Power Station”

May 16, 2013

Tokyo Electric Power Company

# **Transfer of Retained Water from the Underground Reservoirs No.3 and No.6 to G6 Tank**

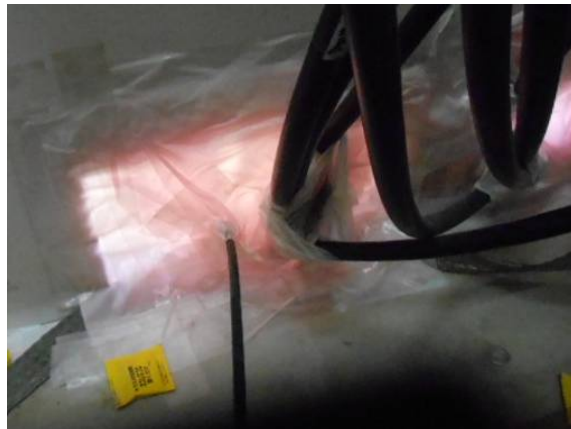
Response result at Section A

Inside an electrical item container at Unit 2 SFP alternative cooling facilities

Emergency responses that can be performed immediately have already been implemented.

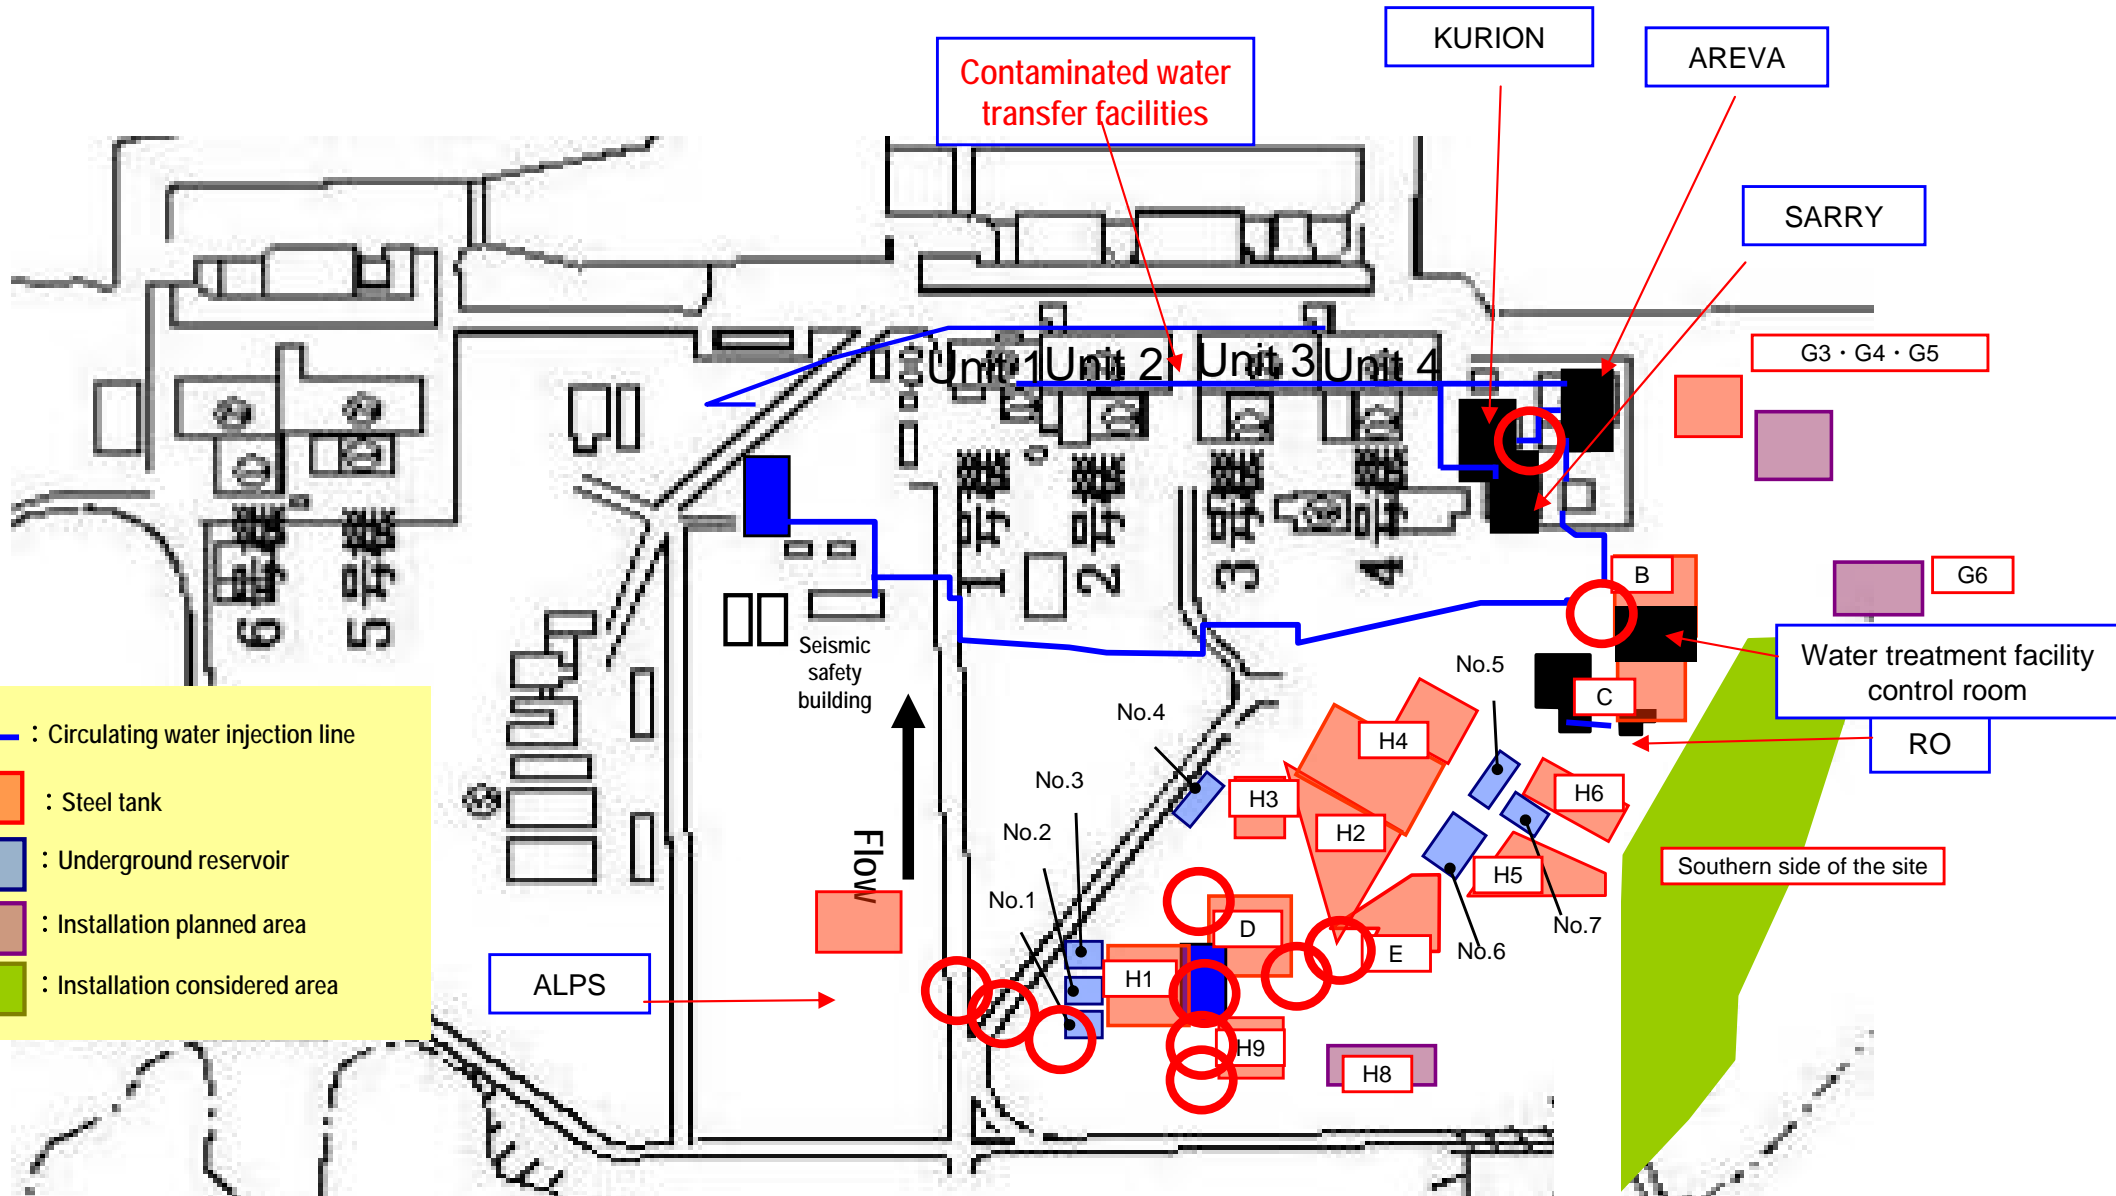
Example of a location requiring action (H1 – H9 areas)

Tasks	<p>Contaminated water transfer facilities had areas with no protection (e.g. guardrails) at locations where they are crossing a road or running near a road.</p> <p>A car accidentally driving into such a location could damage the facility and suspend the transfer of contaminated water, potentially losing the water treatment function. (There is also a risk of contaminated water leaking into surrounding soil.)</p>
Countermeasures	<p>Install makeshift guardrails, etc. at applicable locations to raise caution to passing vehicles and protect the facilities from damage at the same time. There are 12 locations that require countermeasures, according to on-site checks so far.</p> <p>Start the countermeasures from locations exposed to frequent traffic of large vehicles for completion by around the end of July.</p>

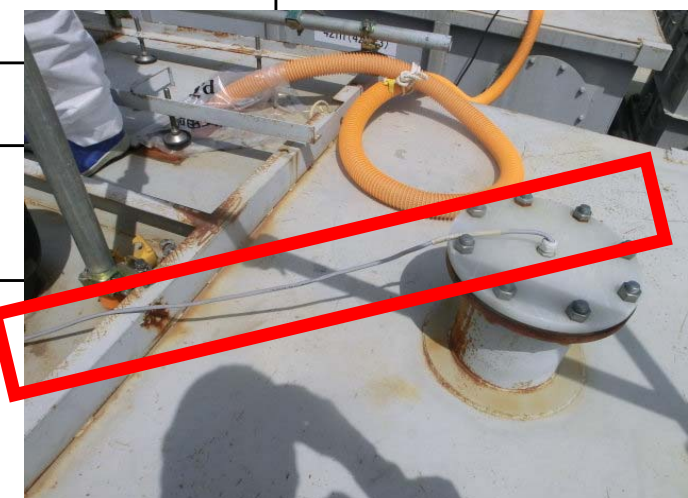
Tasks	There are locations where the cables for reservoirs' / tanks' water level gauges are not in protective covers (Eflex pipes). Any damage to the cable could lead to overflow.
Countermeasures	Install protective covers to prevent the cables from becoming exposed. A total of four locations were identified in on-site check, to be addressed by the end of August 2013. In the mid- to long-term, consider adopting redundancy to water level gauges for tanks that make up a large circulation system.

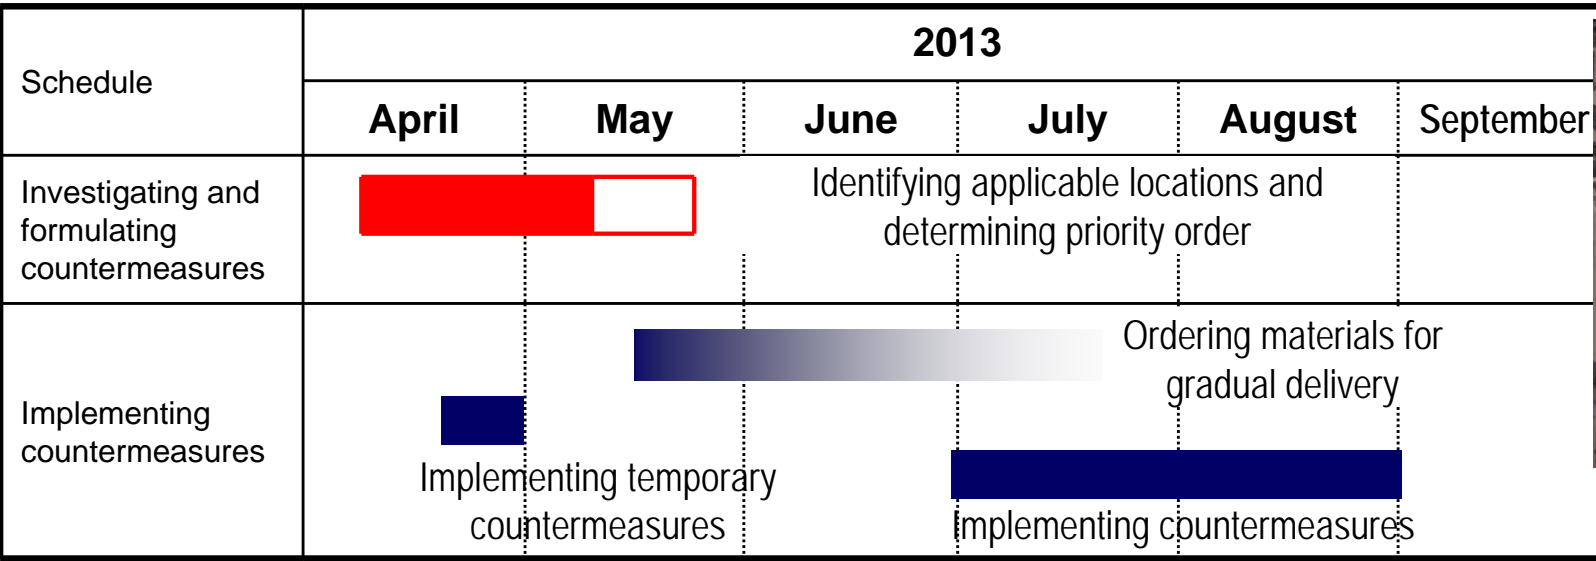
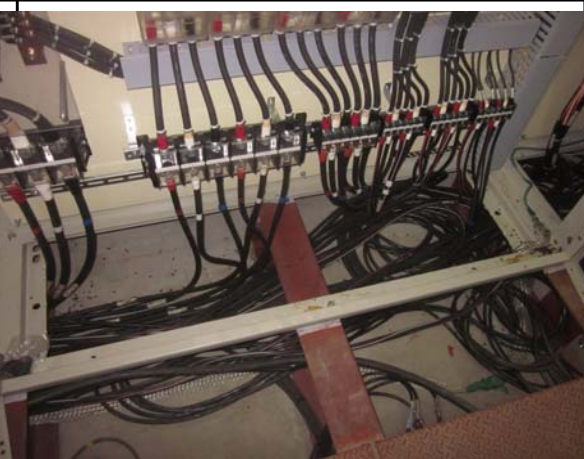
Tasks	The gaps at the penetrations for power panel cables allow small animals to enter inside, potentially causing a short-circuit / grounding, suspending power supplies to SFP alternative cooling facilities and halting the cooling function for SFP.
Countermeasures	Cover the penetration locations to prevent small animals from reaching power panels. A total of 56 locations have been identified in on-site check as locations that could allow the entry of small animals. Tentative sealing has been performed as emergency response in April. More permanent action is to be applied by August.

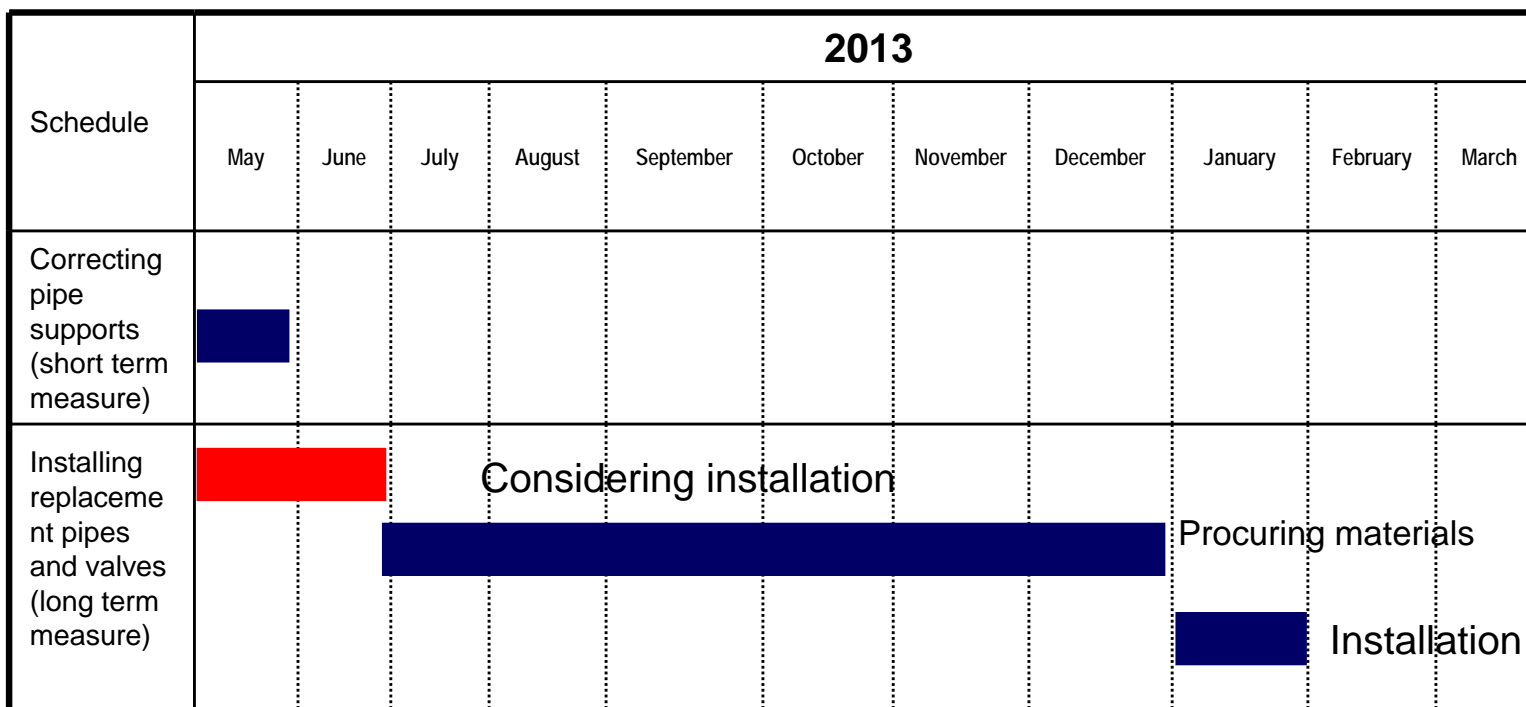
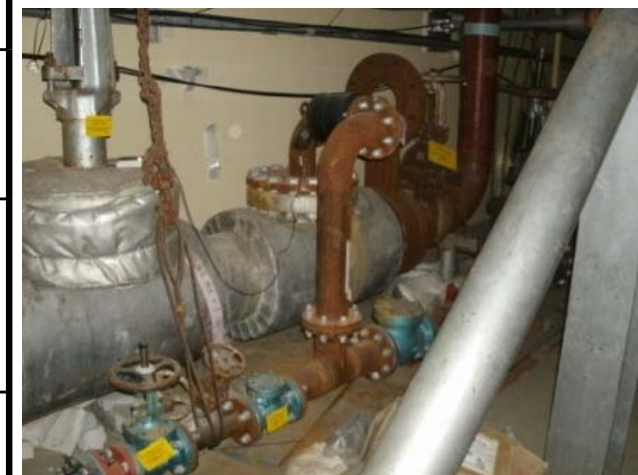
Tasks	The corrosion of feedwater system's pipes and valves at Units 2 and 3 could cause leakage from flange joints. Chain blocks are used to support pipes.
Countermeasures	Correct pipe supports at the two locations as a short-term measure, and replace the pipes and valves as a long-term measure.

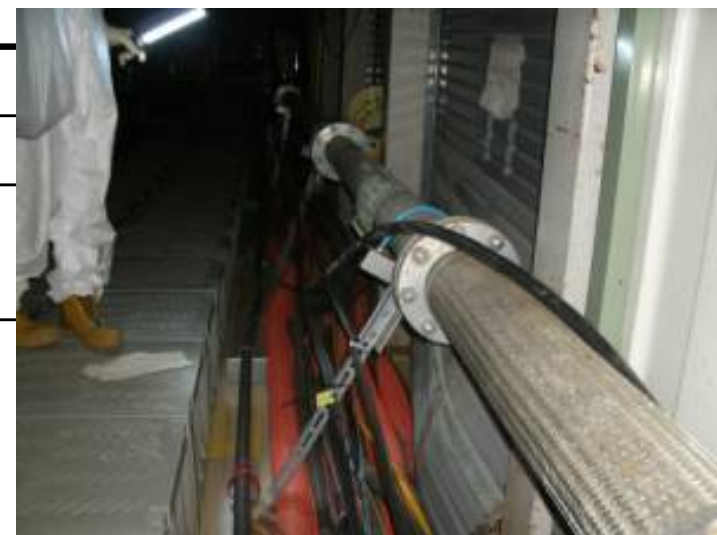
Tasks	Some pipe supports at Unit 2 have become tilted, possibly from external force. Leaving the supports in the tilted state could concentrate the load on flexible parts, potentially resulting in leakage.
Countermeasures	Remove the tilted supports and review the structure for reinforcement, e.g. changing the foundation structure from the screw-on system to the anchored system. Check the applicable locations and repair tilted supports at around ten locations (to be completed by the end of June).

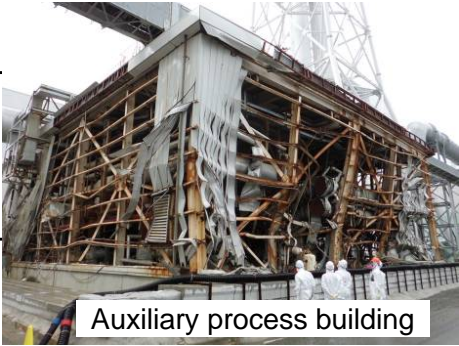
Tasks	<p>Damaged building parts may fall, damaging retained water transfer pipes and power cables underneath to cause the leakage of retained water or power outage.</p> <p>Building damage could affect the supports for power cables running across the top section of the building, resulting in cable severing and power outage.</p>
Countermeasures	<p>Install protection materials on retained water transfer pipes and power cables, and remove materials that could fall. (short- to mid-term measure)</p> <p>Add supports for power cables. (long-term measure)</p>

<p>Auxiliary process building</p>
Implementing countermeasures	Installing protection materials and removing materials that could fall					Implementing additional measures such as adding supports for power cables

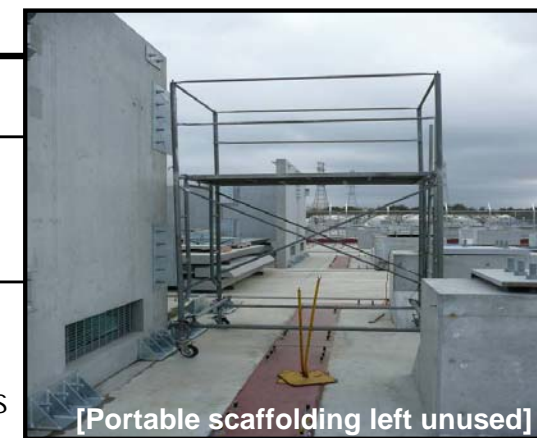
Tasks (Issues)	<p>Failure to fully observe 5S (organization, tidying, sanitation, cleaning, discipline) on site has been identified.</p> <ul style="list-style-type: none"> <li>• Leaving disused items such as portable scaffoldings / ladders and scaffolding pipes without any sign prohibiting their use</li> <li>• Leaving flammable items (wood shavings, etc.) in the proximity of locations for open-flame work (welding, etc.)</li> </ul> <p>These items could interfere with work, compromising work efficiency (reducing work quality), or might be used carelessly, due to the lack of appropriate labeling, resulting in injuries and other personnel accidents (compromising industrial safety). Sparks from open flame work could also ignite flammable items to cause fire.</p>
Countermeasures	<p>Relevant sections must swiftly examine on-site status and instruct contractors to correct such practices according to the rules demanded by the specifications. Based on TEPCO's instructions, the contractors must inspect their status of on-site work areas to verify whether they comply with the rules demanded by TEPCO in its specifications, and correct any non-compliances. TEPCO must continuously carry out on-site observation to confirm the status of response to its instructions, and issue renewed instructions for any failure to implement corrective action.</p>

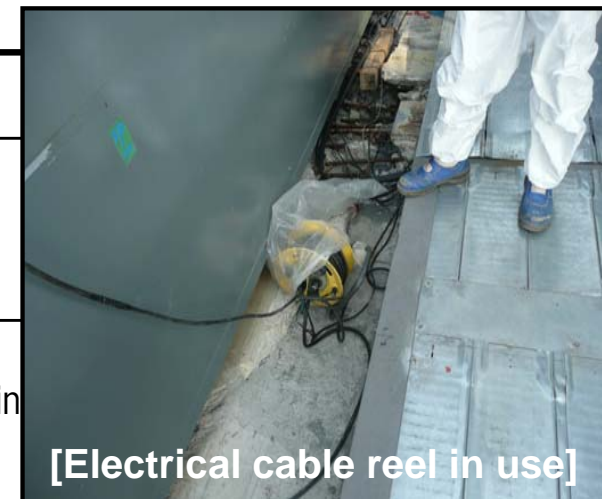
Tasks (Issues)	<p>Failure to thoroughly enforce basic action / safety rules has been observed.</p> <ul style="list-style-type: none"> <li>• Failure to use a safety belt / hook while working at an elevated location</li> <li>• Using electric cables while they are still on a reel (possible fire from heating)</li> <li>• Failure to use leather gloves when using blades</li> <li>• Accessing work areas (off limit), etc.</li> </ul>
Countermeasures	<p>TEPCO must instruct contractors to observe basic action / safety rules at the meeting of the Safety Promotion Liaison Council, etc. The contractors must circulate the contents of the specifications TEPCO demands (common specifications, safety response specifications, etc.) on occasions for issuing safety instructions in order to ensure compliance with the basic action / safety rules. TEPCO must continuously carry out on-site observation to confirm the status of improvement.</p>

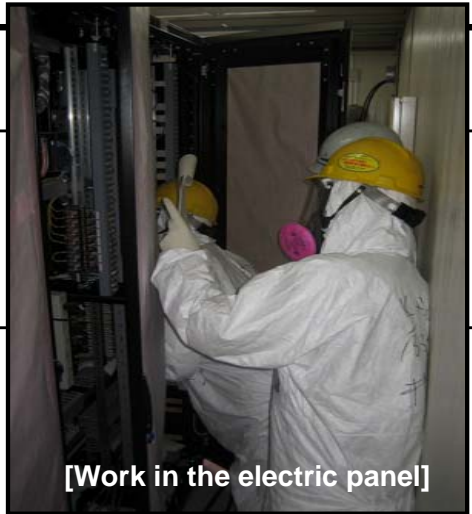
Tasks (Issues)	<p>Failure to fully cover open flames or charged surfaces on site has been observed.</p> <ul style="list-style-type: none"> <li>Sparks were seen flying from insufficiently covered locations during outdoor work involving open flames (in strong winds)</li> <li>During work in the control panels, an adjacent unit was charged, but was not sufficiently covered.</li> </ul> <p>During work involving open flames, the flames could ignite surrounding flammable items (Tyvek items, etc.) to cause fires / burns. In the control panels, an accidental contact with a charged section could lead to electric shocks and facility fault.</p>
Countermeasures	<p>Relevant sections must swiftly examine on-site status and instruct contractors to cover open flames and charged sections according to the rules demanded in TEPCO's specifications. Based on TEPCO's instructions, the contractors must inspect their status of on-site work areas to verify whether they comply with the rules demanded by TEPCO in its specifications, and correct any non-compliances. TEPCO must continuously carry out on-site observation to confirm the status of response to its instructions, and issue renewed instructions for any failure to implement corrective action.</p>

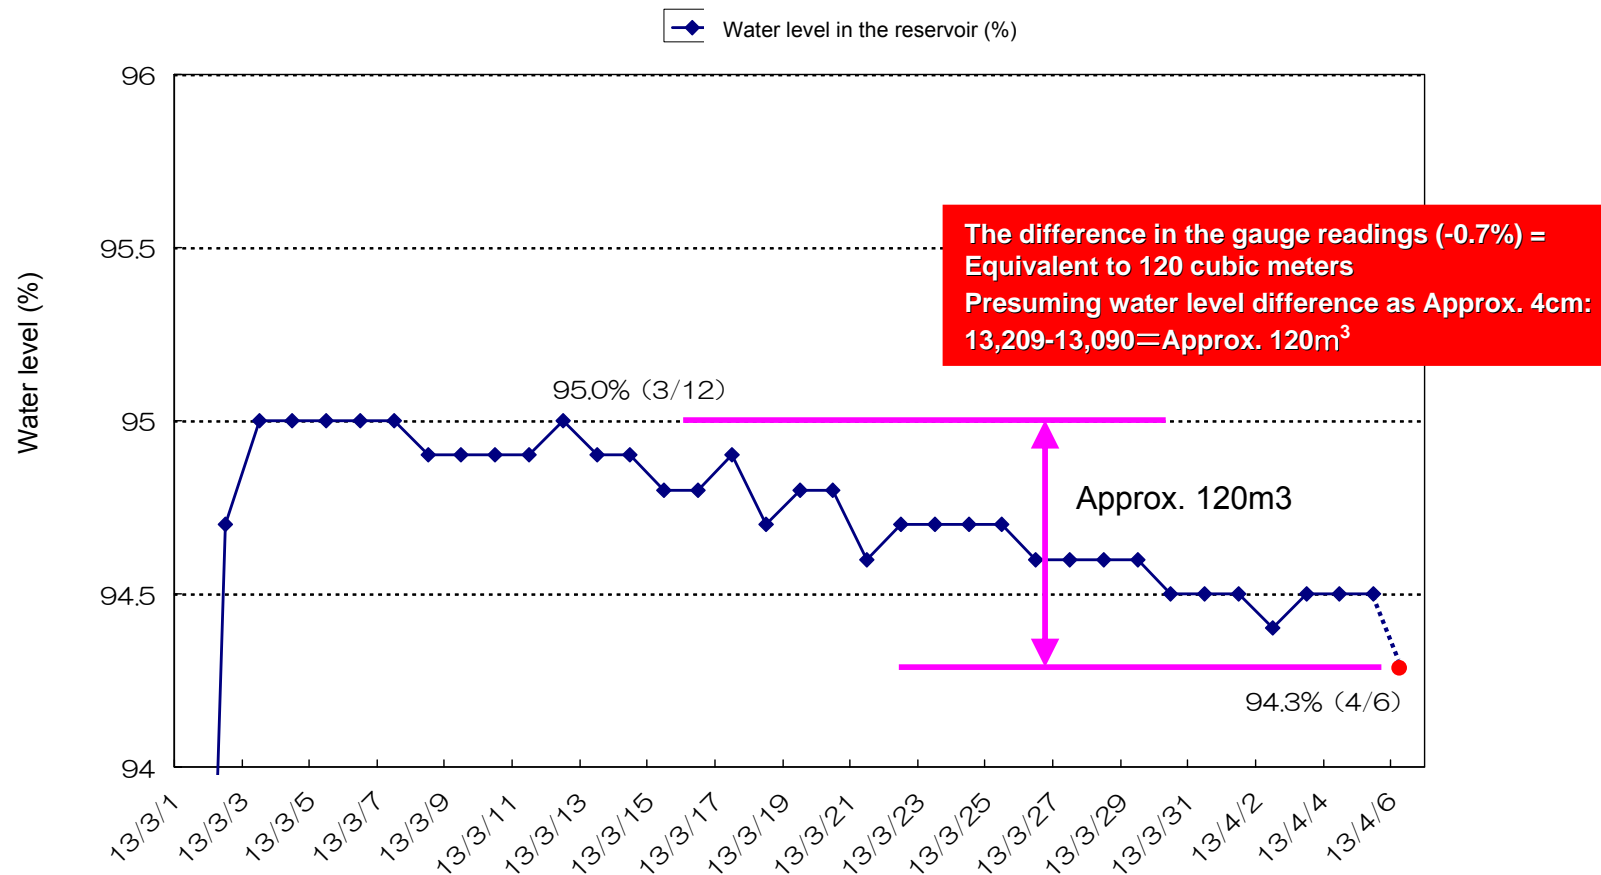
Measurement results for Underground Reservoir 2

- When the possibility of a leak from Underground Reservoir No.2 was identified (as of April 6, 2013), 0.7% of level drop, shown in the water level gauges installed in the reservoir, was used to estimate the leakage volume to be up to 120 cubic meters.

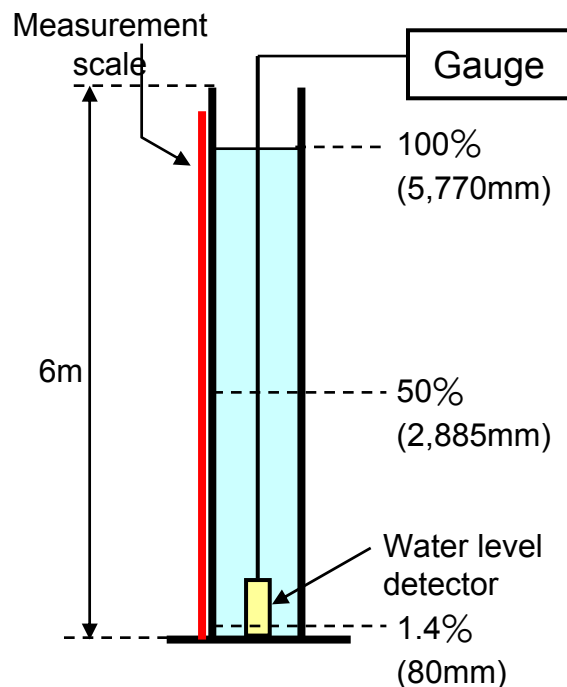
- A makeshift water column (filtrate) was used to compare the reading of water level gauge against the actual water level. These two levels must ordinarily be a 100% match, but the comparison confirmed that the level gauge's reading has a drift\* of -0.6%.

Actual water level measurement	Level gauge reading	Difference
At the completion of Underground Reservoir 2	98.06% (5,658mm)	98.0% (5654.6mm)	-0.06%
At the level gauge inspection (April 25)	100% (5,770mm)	99.4% (5,735mm)	-0.6%
