# Oil Leakage from Unmanned Heavy Equipment Used for Debris Removal in Unit 3 Reactor Building at Fukushima Daiichi Nuclear Power Station

May 20, 2013

Tokyo Electric Power Company

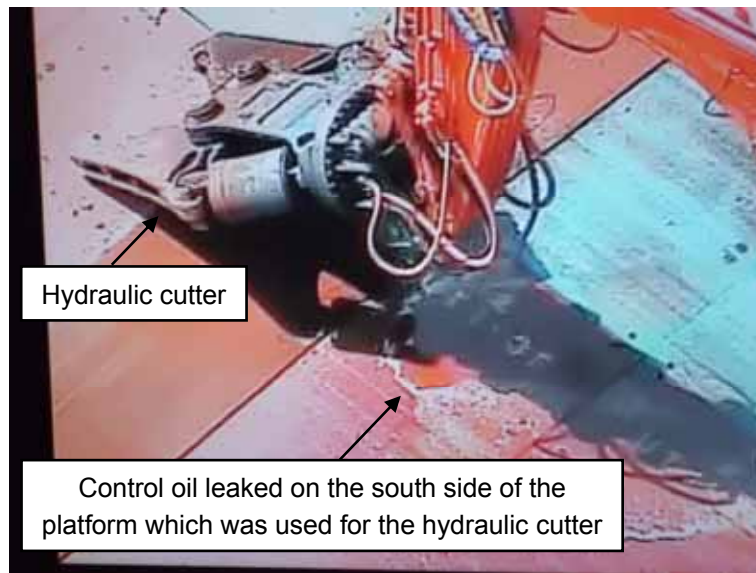
Photo taken on May 18, 2013

- At around 2:08 PM on May 18, 2013, a TEPCO employee at a remote operation room found the leakage of oil which was used for the control of hydraulic cutter attached to the tip of unmanned heavy equipment for debris removal in the upper part of Unit 3 Reactor Building. Later at around 2:33 PM, we reported this incident to the fire station.
- The leakage has stopped since the use of unmanned heavy equipment has been suspended.
- As a result of monitor check at the remote operation room, leaked oil was found to be spread approx. 4m x approx. 5m on the south side of the platform which was used for debris removal in Unit 3 Reactor Building, and the leakage amount is estimated to be around 20 liters.
- Leaked oil does not affect the spent fuel pool since the location where the oil was spread is sufficiently far from the spent fuel pool.

As a result, we have found the leakage was caused by coming off of a control hydraulic hose at the front end of a hydraulic cutter.

We have attached the control hydraulic hose to the hydraulic cutter.

- A cooperative company worker removed the leaked oil by oil absorption mat and wiping rags.
