# Water Leakage from the Flange of G6 Area Tank (Cylindrical Steel Tank)

June 5, 2013

Tokyo Electric Power Company

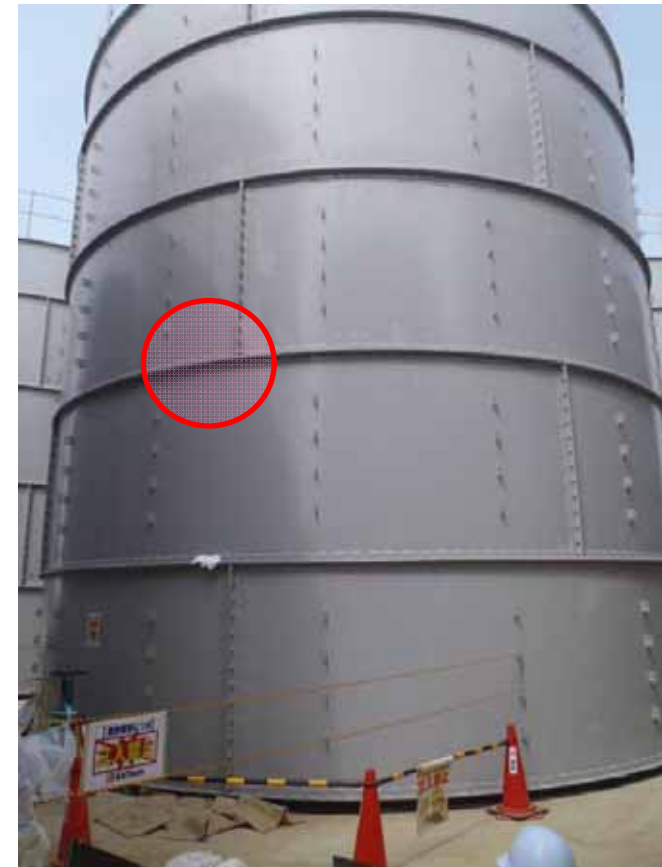
- Date and Time:  
Around 12:15 PM on June 5, 2013
  - The first person to find:  
A cooperative company worker
  - Leakage location:  
The joint between the second and third layer (counting from the bottom) of the G6-1 area No.9 cylindrical steel tank side wall  
Dose measurement results:  
 $\gamma$  = Approx. 0.06mSv/h  
 $\beta$  = Approx. 12mSv/h
  - Leakage amount: One drop per 3-4 seconds
  - Cause of the incident: Under investigation
  - Leakage situation:  
Water was found to be seeped from the flange of upper part of the second layer at G6-1 No.9 tank, and dropped from the side of the tank.
- ⇒ An absorber was put around the side and the bottom of the tank, and leaked water was absorbed.
- ⇒ The leakage was not stopped although the joint was tightened so the communication valve, which is connected to the adjoining tank, was opened to lower the water level of the tank.

- 12:15 PM The leakage was found
- 12:20 PM The tank has been isolated (communication valve was “fully closed”)
- 12:45 PM Water transfer from the underground reservoir No.6 to G6 area tank was suspended
- 12:50 PM The incident was reported
- 3:00 PM – 3:45 PM The joint of the flange was tightened
- 4:20 PM – 4:22 PM Communication valve was opened
- 4:35 PM The leakage was stopped
