# **Falling of the Inside Door of the Large Carry-in Entrance in Unit 6 Reactor Building <Causes and Measures>**

## **<Overview>**

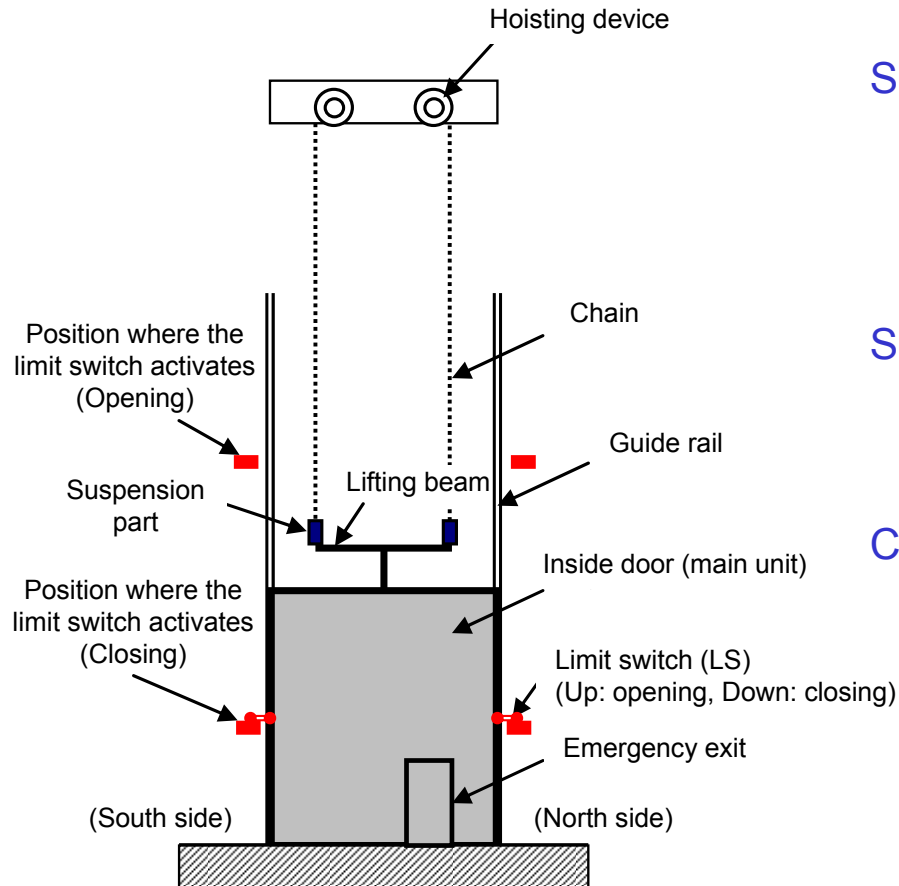
Figure-2 Outline of the large carry-in entrance (inside door) (View from the inside of the building)

- Dimension: Width approx. 4.9m x Height approx. 5.8m x Thickness approx. 250mm
- Weight: Approx. 5 tons

- Operate by “open”, “close” and “stop” button on the control board
- Two hoisting devices will be automatically stopped when the limit switches (LS) installed at both side of the inside door are activated

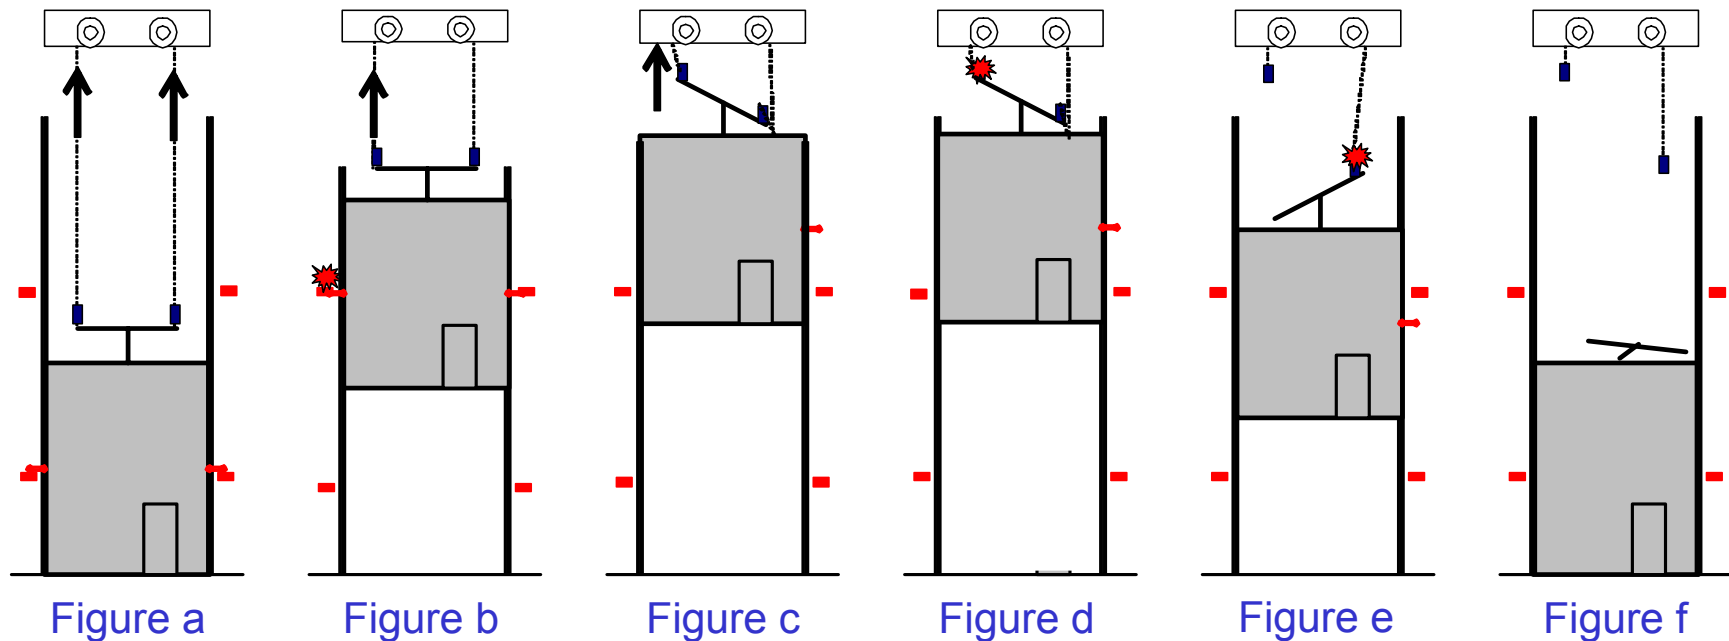
- The inside door became half suspended (Figure c), since the left hoisting device did not stop (Figure b) though the right hoisting device stopped at normal position where the limit switch activates.
- Though the half suspended inside door swayed and getting caught with the guide rail, the left hoisting device kept hoisting (Figure c). Therefore, the left suspension part became broken (Figure d). Impact of the falling broke the right suspension part (Figure e), and the whole body of the inside door fell down (Figure f).

- The left hoisting device did not stop though the right hoisting device stopped at the normal position where the limit switch activates. (The limit switches installed at both side of the inside door are activated normally.)
- The inside door became half suspended and getting caught with the guide rail since only the left hoisting device kept hoisting.
- The suspension part of the half suspended inside door became broken, and the whole body of the inside door fell down.
- Though a worker sensed the abnormality of the situation and tried to operate a manual “stop” button on the control board, it did not function.

- A malfunction occurred to the controller which receive a stop signal and stop the hoisting device.  
(The cause of the malfunction is estimated to be its internal deterioration as the result of the site investigation, since no damage was found on the controller.)
- There was no way to stop the hoisting device automatically after the inside door passed through the stop position where the limit switch activates.
- The hoisting device kept operating until the suspension part became broken.
- There was no way for the worker to stop the inside door going up.  
(The “stop” button did not operate due to the malfunction of the controller.)

- Replacement of the control board with a new one
- Detailed inspection to be conducted when the inside door is used after having been out of use for a long time period

- Excess winding-up prevention function in the hoisting device
- Overload stop function
- Installation of an emergency stop button
