## Investigation of Radioactive Material

**TEPCO will start investigation of a material under the request from the Ministry of the Environment, which was found during a disposal work of earthquake disaster debris by the Ministry of the Environment, and was brought to Fukushima Daiichi NPS.**

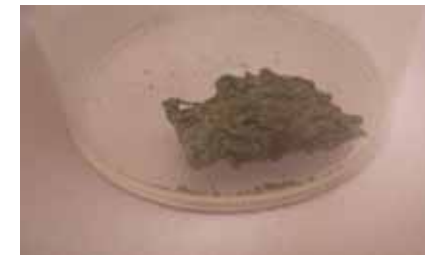
Situation when the material was found: A hot spot (high dose point) was found during the radiation measurement at a disposal work of earthquake disaster debris. As a result of detailed survey to identify the location, the material was sampled.

Surface	30cm
$\gamma$ ray	105 $\mu$ Sv/h	23 $\mu$ Sv/h
$\beta \gamma$ ray	3400 $\mu$ Sv/h	26 $\mu$ Sv/h

Surface concentration of contamination : More than 100,000 cpm

Size: Debris of length approx. 3cm x width approx. 1.5cm x thickness approx. 0.5cm

The material

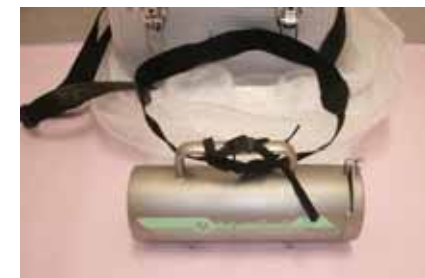
Container of the material  
(Fukushima Daiichi NPS)
