# Investigation of Radioactive Materials

July 8, 2013

Tokyo Electric Power Company

## TEPCO will start investigation of materials under the request from the Ministry of the Environment, which was found during a disposal work of earthquake disaster debris by the Ministry of the Environment, and was brought to Fukushima Daiichi NPS.

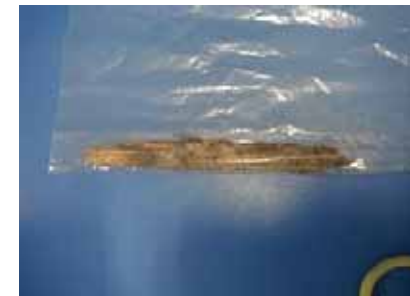
The material B

Surface
A	250 $\mu$ Sv/h
B	105 $\mu$ Sv/h

Size of B: Length approx. 16cm x width approx. 2cm x thickness approx. 0.5cm
