Investigation of Radioactive Materials

July 8, 2013

Tokyo Electric Power Company

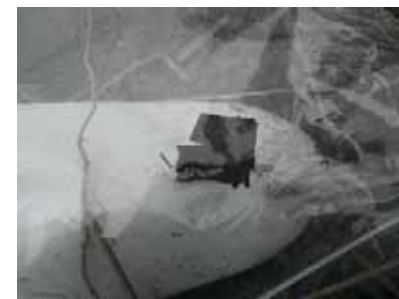
The material A

Size of A: Length approx. 2cm x width approx. 2cm x thickness approx. 0.1cm

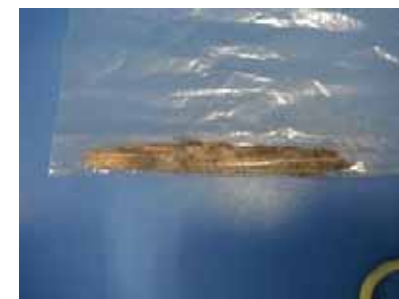
The material B

Size of B: Length approx. 16cm x width approx. 2cm x thickness approx. 0.5cm
