# Results of Soundness Inspection of Unit 2 TIP Guide Pipe (1st Day)

July 8, 2013

Tokyo Electric Power Company

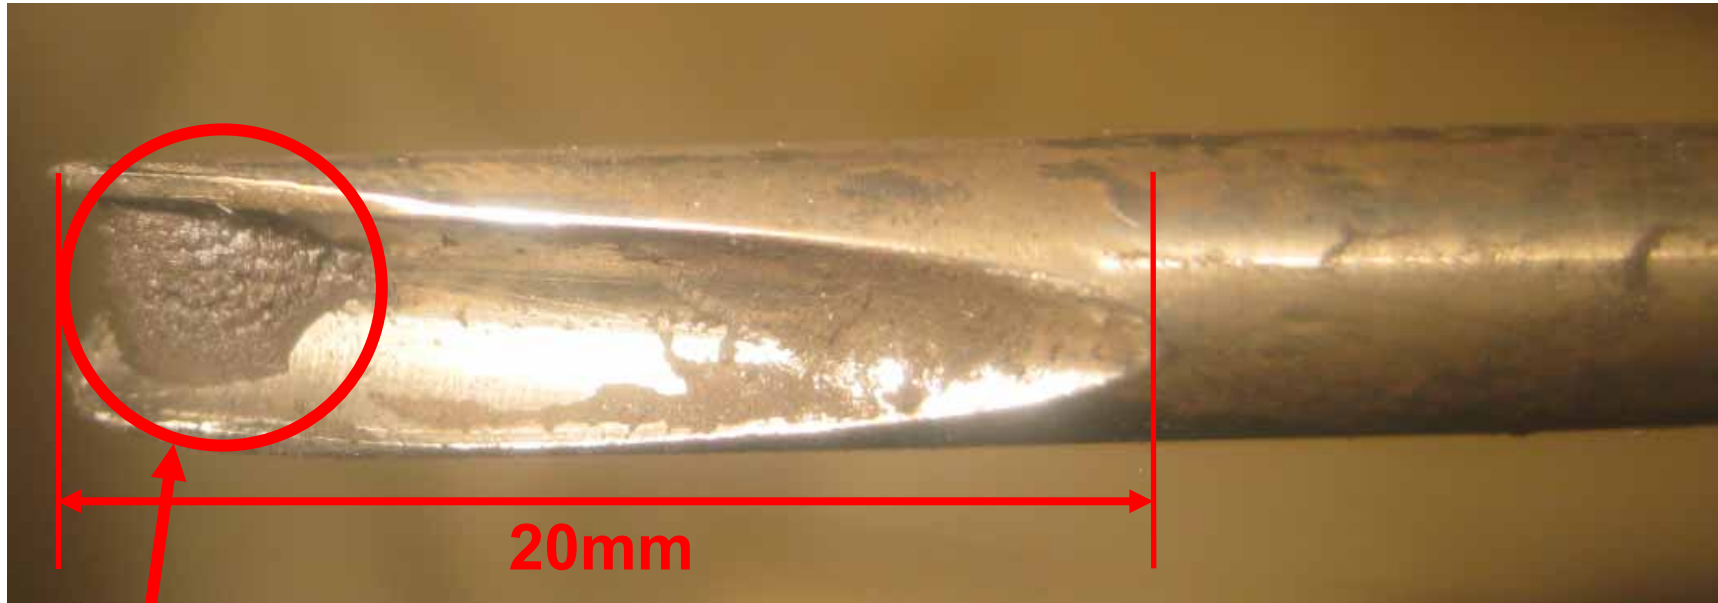
### ■ Dummy TIP cable head

- After the dummy TIP cable was pulled out, attached substances were found on the head.  
 $\gamma$  -ray: 5.0mSv/h,  $\beta$  - and  $\gamma$  -rays: 200mSv/h
