Results of Soundness Inspection of Unit 2 TIP Guide Pipe (3rd Day)

July 10, 2013

Tokyo Electric Power Company

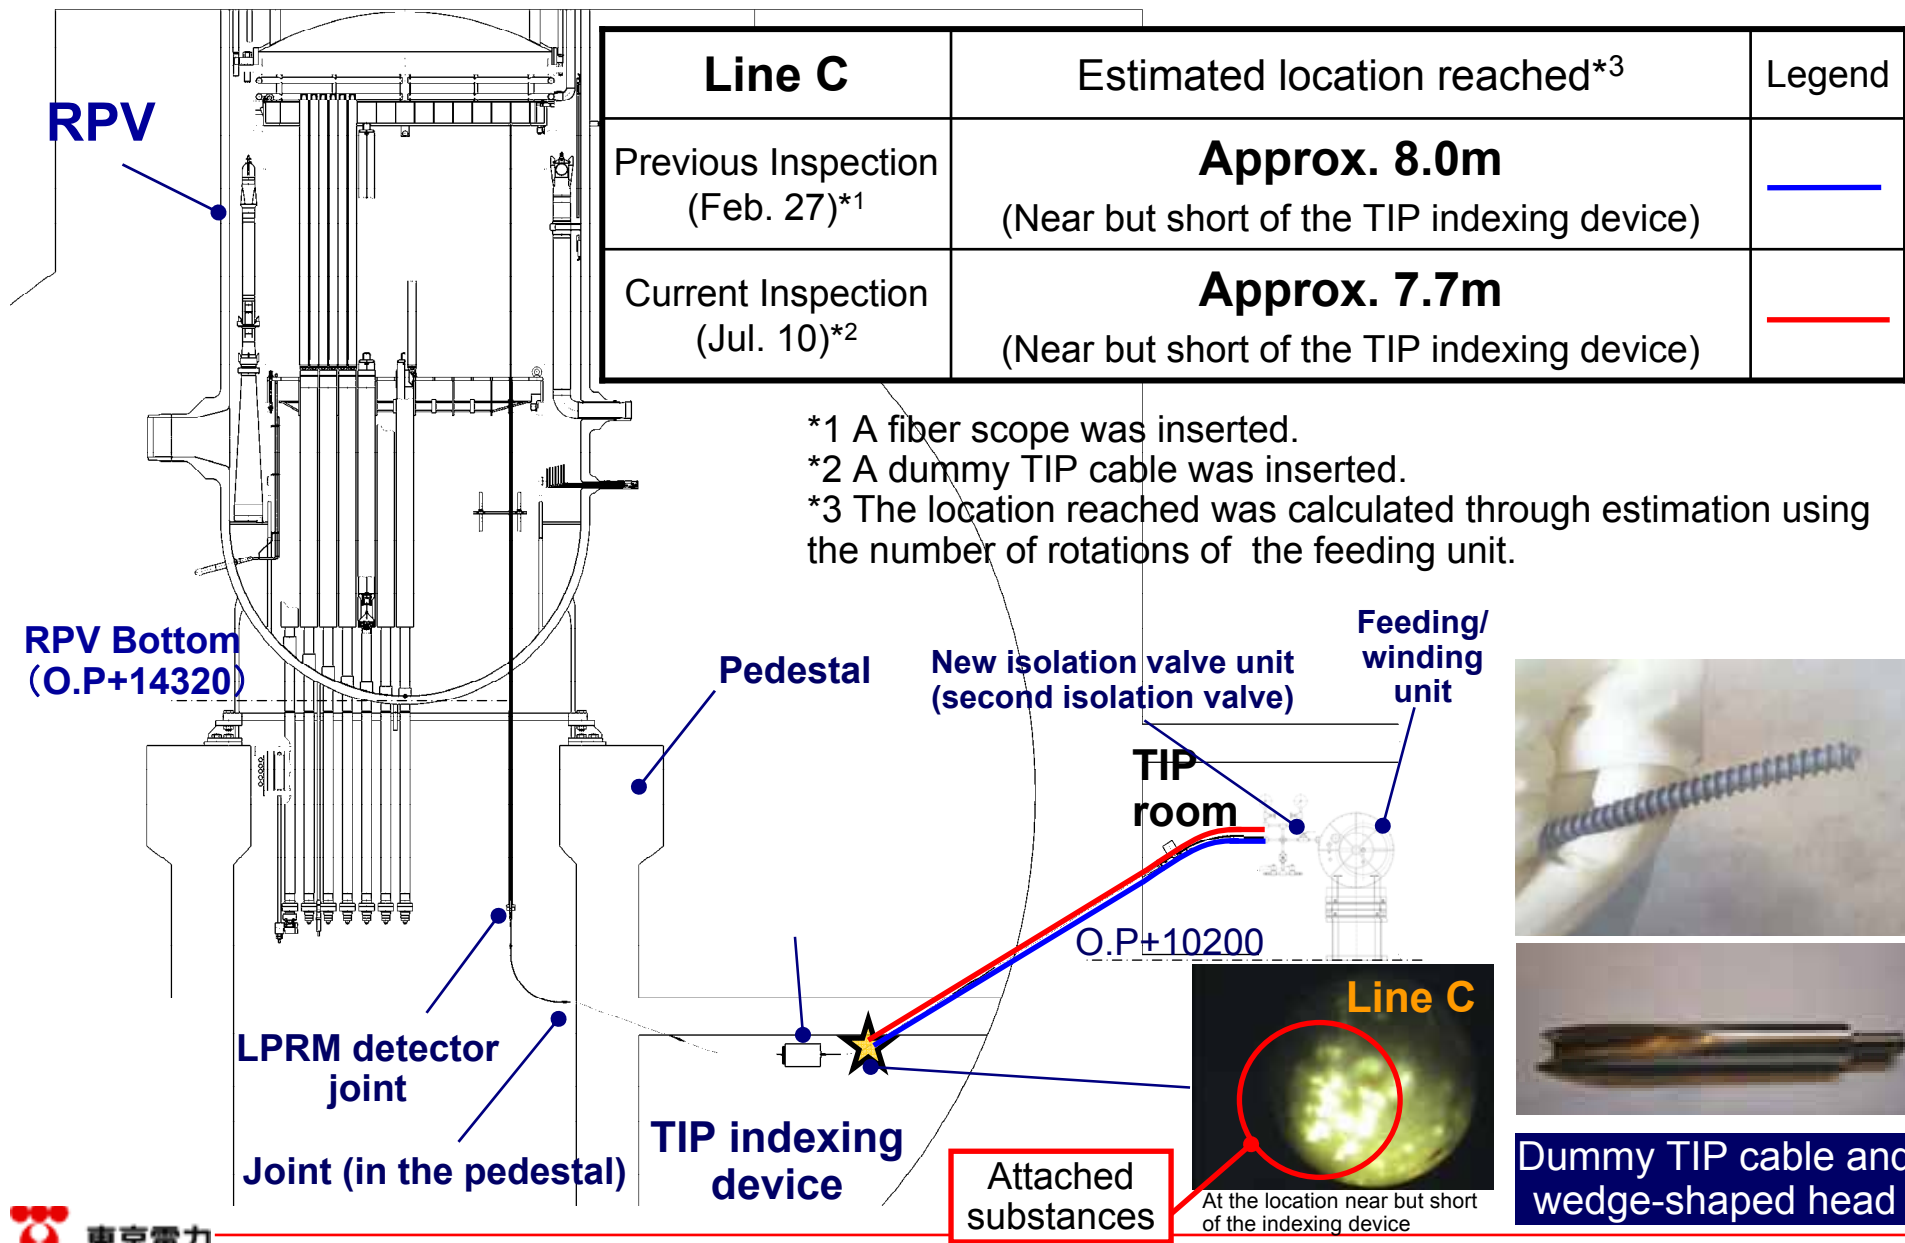
1-1. Contents of Work

- Radiation exposure received by workers
Highest dose: 0.60mSV (Planned dose: 3mSV)
- Results
 - The dummy TIP cable was inserted and reached approx. 7.7m from the second isolation valve inlet flange of Line C. Insertion of the cable became impossible at about the same location as in the previous inspection.
 - After the dummy TIP cable was pulled out, attached substances were found on the head.
(γ -ray: 50.0mSv/h, β - and γ -rays: 200mSv/h)
 - Inspection of Line C was completed. Inspection of Line A will be conducted tomorrow.

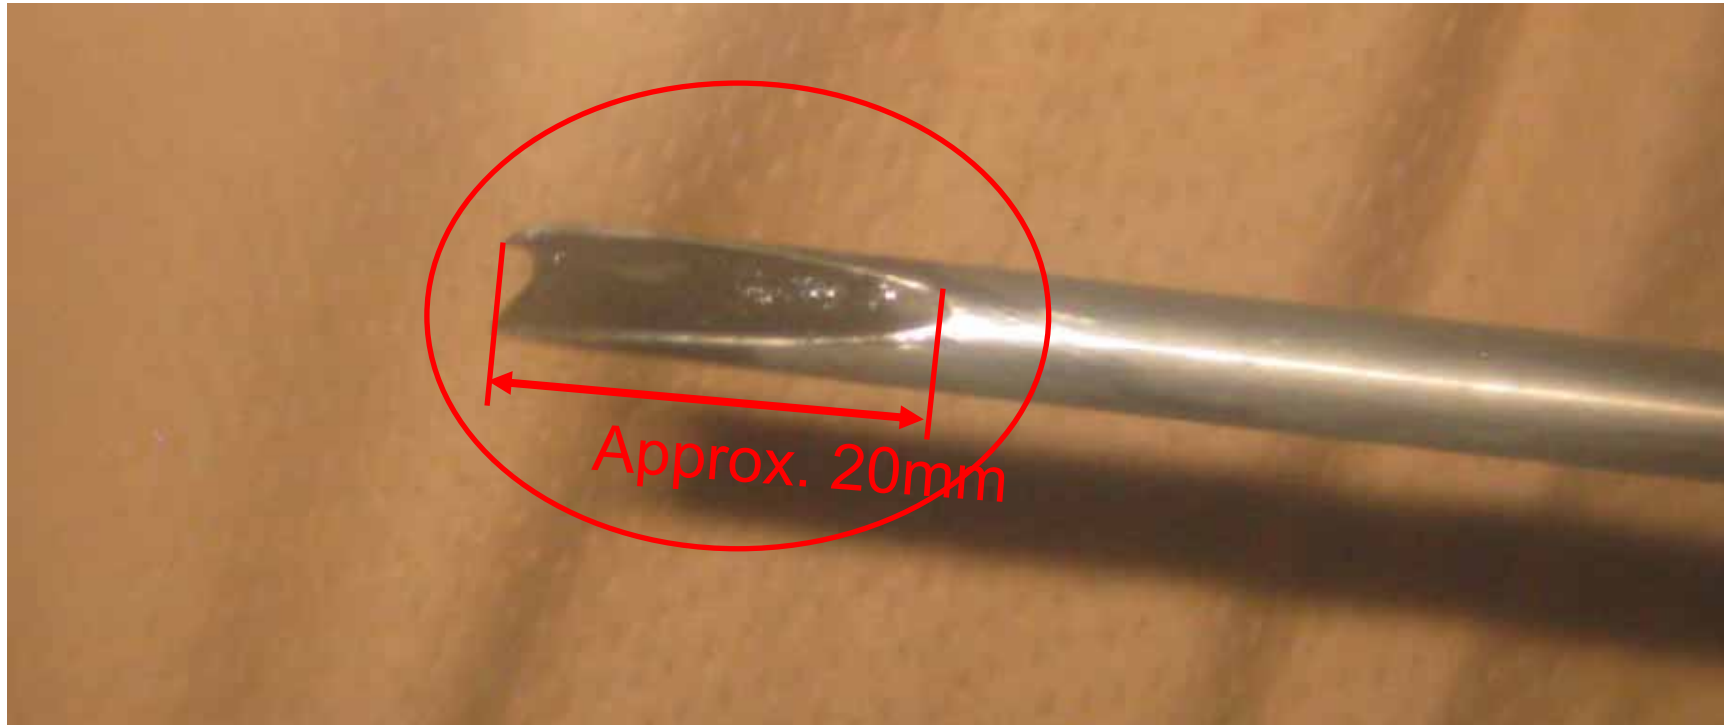
■ Dummy TIP cable head

- After the dummy TIP cable was pulled out, attached substances were found on the head.
 γ -ray: 50.0mSv/h, β - and γ -rays: 200mSv/h
