**Sampling Survey Results of  
Unit 3 Trench Vertical Shaft A at  
Fukushima Daiichi Nuclear Power Station**

**July 11, 2013**

**Tokyo Electric Power Company**

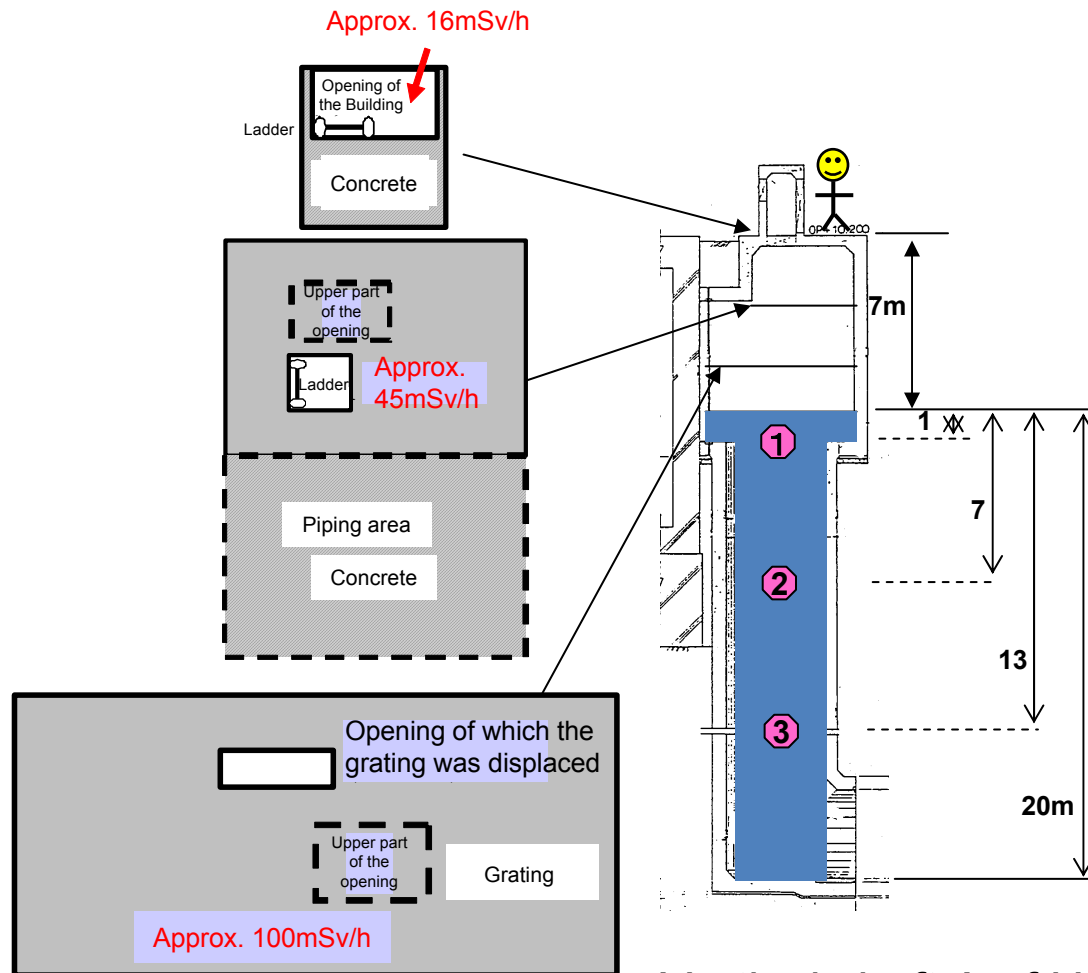
Vertical shaft A of Unit 3

- Investigated on July 10, 2013
- Analyzed on July 11, 2013
- Water was sampled by a vacuum water sampler
- Sampled at 3 points categorized by water depth (Water depth: Approx. 1, 7, 13m)
- Radiation exposure dose = 0.49mSv/person

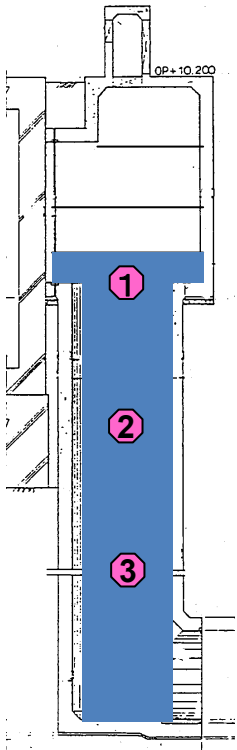
Vertical shaft A of Unit 3

Location (water depth)	Saline (ppm)	Cs134 (Bq/cm <sup>3</sup> )	Cs137 (Bq/cm <sup>3</sup> )	Remarks
① ( 1m)	11,000	5.0 x 10 <sup>4</sup>	1.0 x 10 <sup>5</sup>	I-131 and Co-60 was both ND (<From 10 <sup>2</sup> )
② ( 7m)	7,500	3.4 x 10 <sup>4</sup>	6.9 x 10 <sup>4</sup>	Same as above
③ (13m)	7,000	3.1 x 10 <sup>4</sup>	6.2 x 10 <sup>4</sup>	Same as above
