# Results of Additional Work in Soundness Inspection of Unit 2 TIP Guide Pipe

July 19, 2013

Tokyo Electric Power Company

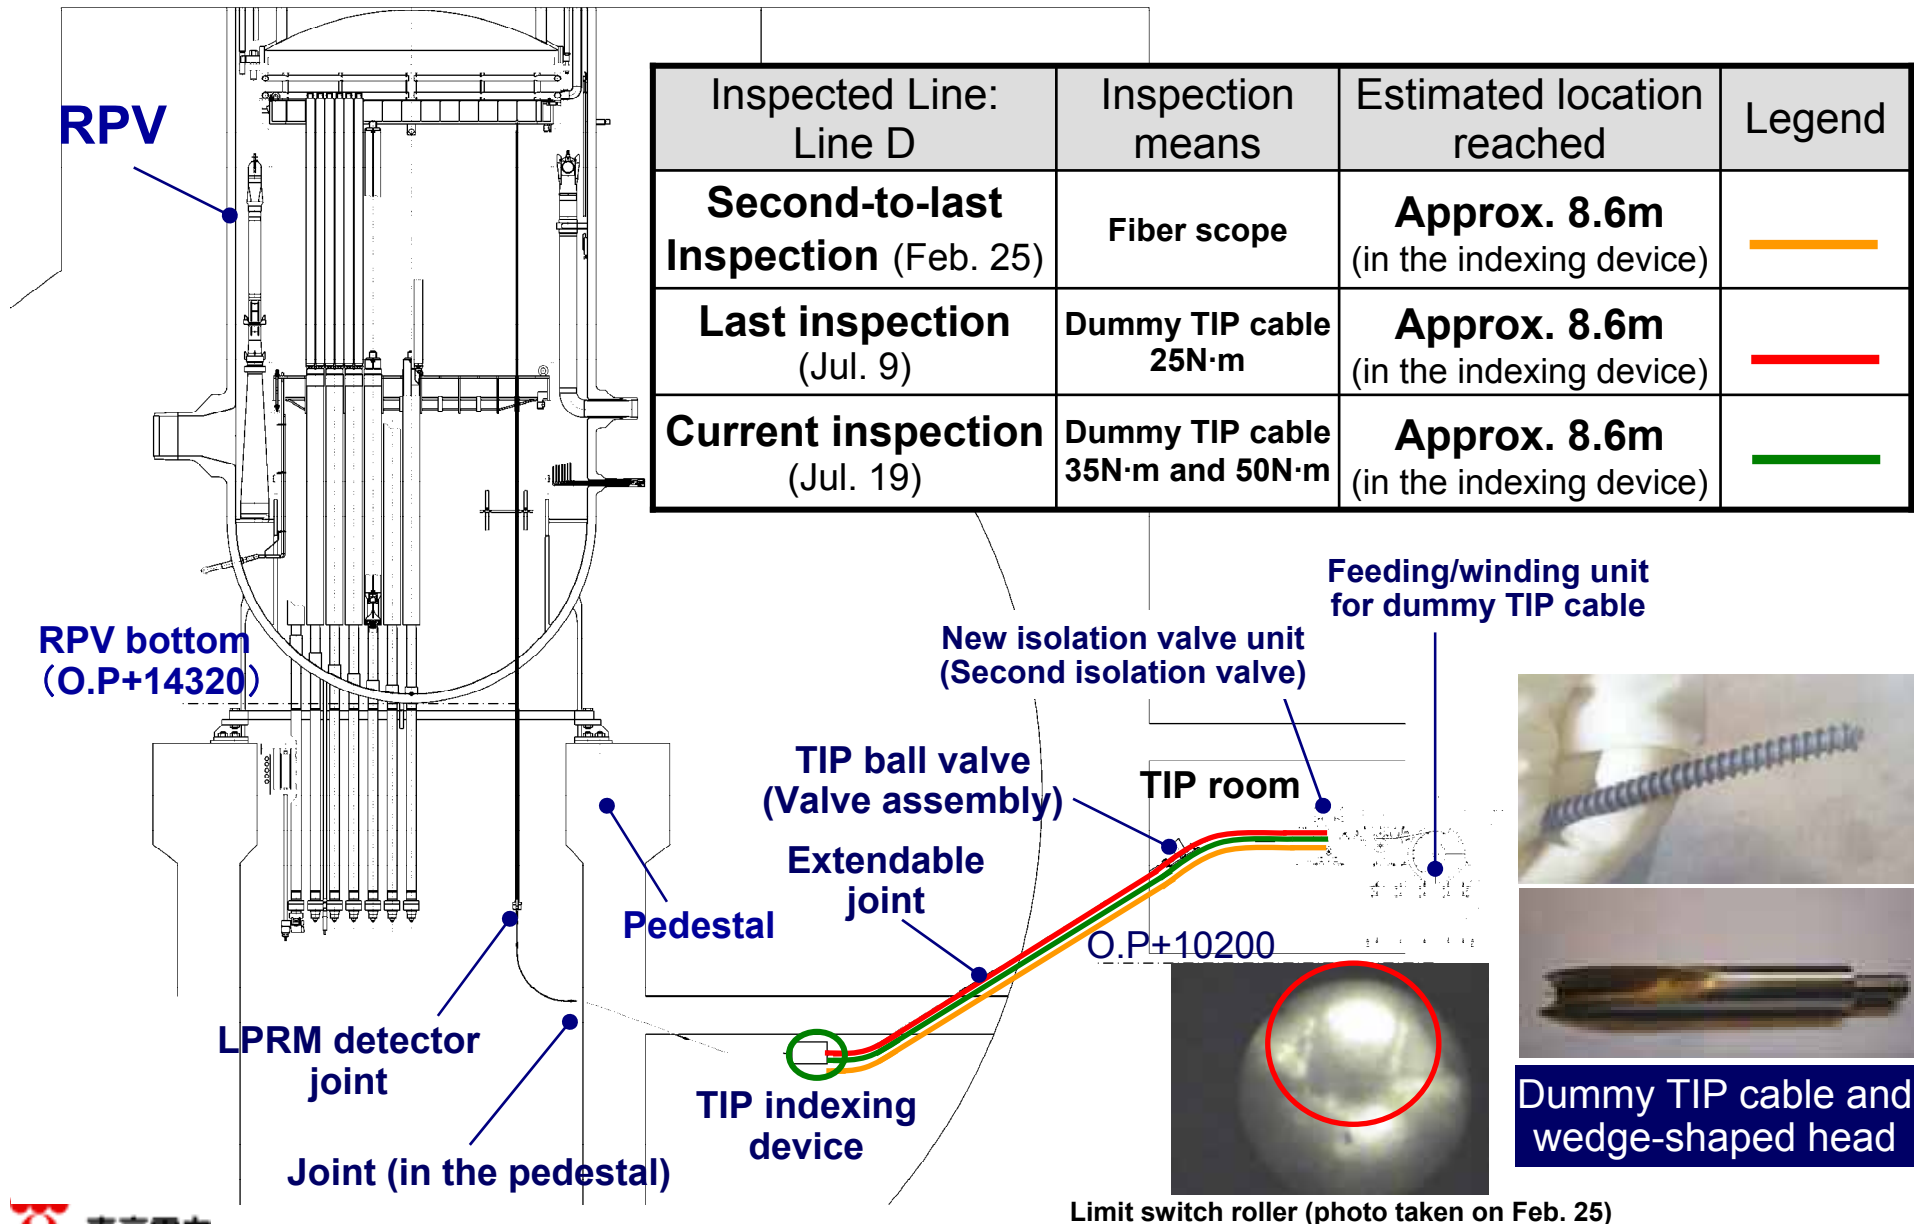
# 1-1. Result (Location Reached)

- The dummy TIP cable was inserted at 35N·m and 50N·m from the second isolation valve inlet flange of Line D. As in the case of the last inspection, further insertion of the cable became impossible when it reached approx. 8.6m.
- Attached substances were found all over the head of the dummy TIP cable. This made it clear that there are substances attached behind the limit switch.  
( $\gamma$ -ray: 95.0mSv/h,  $\beta$ - and  $\gamma$ -rays: 120.0mSv/h)
- We also conducted inspection using a fiber scope. However, it became impossible to further insert the fiber scope when it reached the extendable joint. Therefore, we were not able to determine the conditions of the limit switch roller.

As we were not able to go beyond the indexing device, we gave up inspection using the current method, and will consider our next course of action.

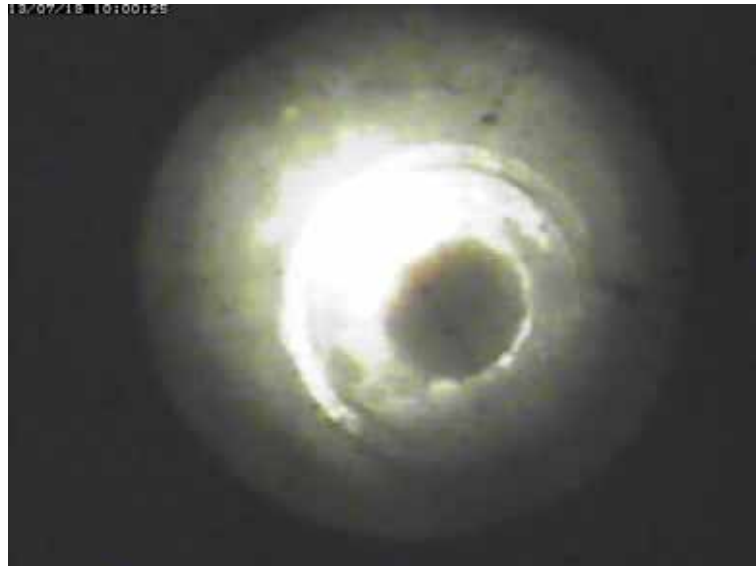
Extendable joint

Further insertion of the fiber scope became impossible possibly because the fiber scope head came into contact with the end surface inside the extendable joint since the gap inside the extendable joint was enlarged when the dummy TIP cable was inserted earlier.

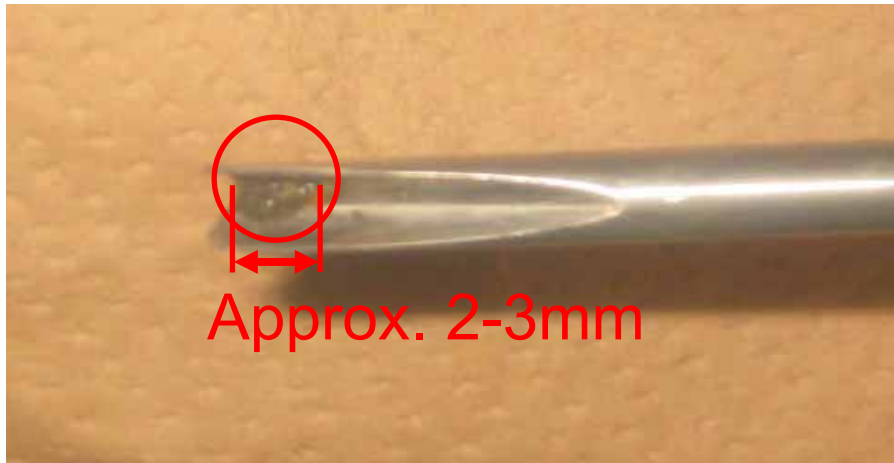
(July 9)

- After the dummy TIP cable was pulled out, attached substances were found on the head.

$\gamma$ -ray: 14.0mSv/h

$\beta$ - and  $\gamma$ -rays: 30mSv/h

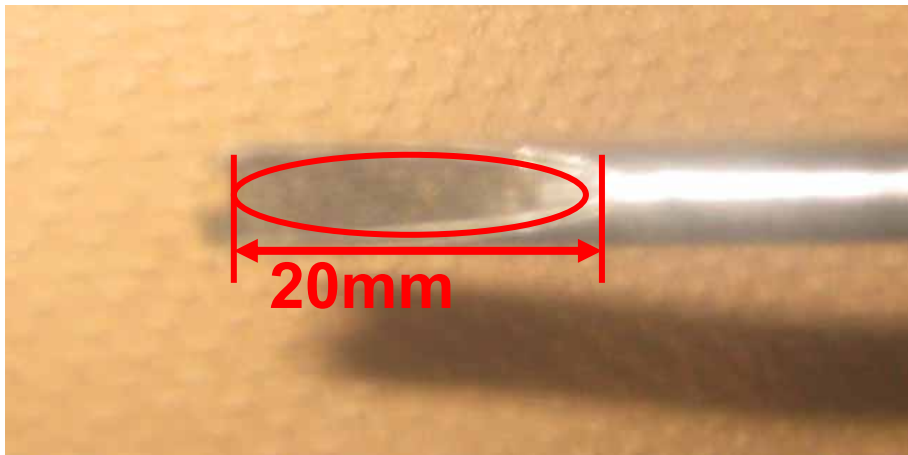
(July 19)

- After the dummy TIP cable was pulled out, attached substances were found all over the head.

$\gamma$ -ray: 95.0mSv/h

$\beta$ - and  $\gamma$ -rays: 120.0mSv/h
