Approach to the ocean-side trench investigation at the Fukushima Daiichi Nuclear Power Station

July 26, 2013

Tokyo Electric Power Company

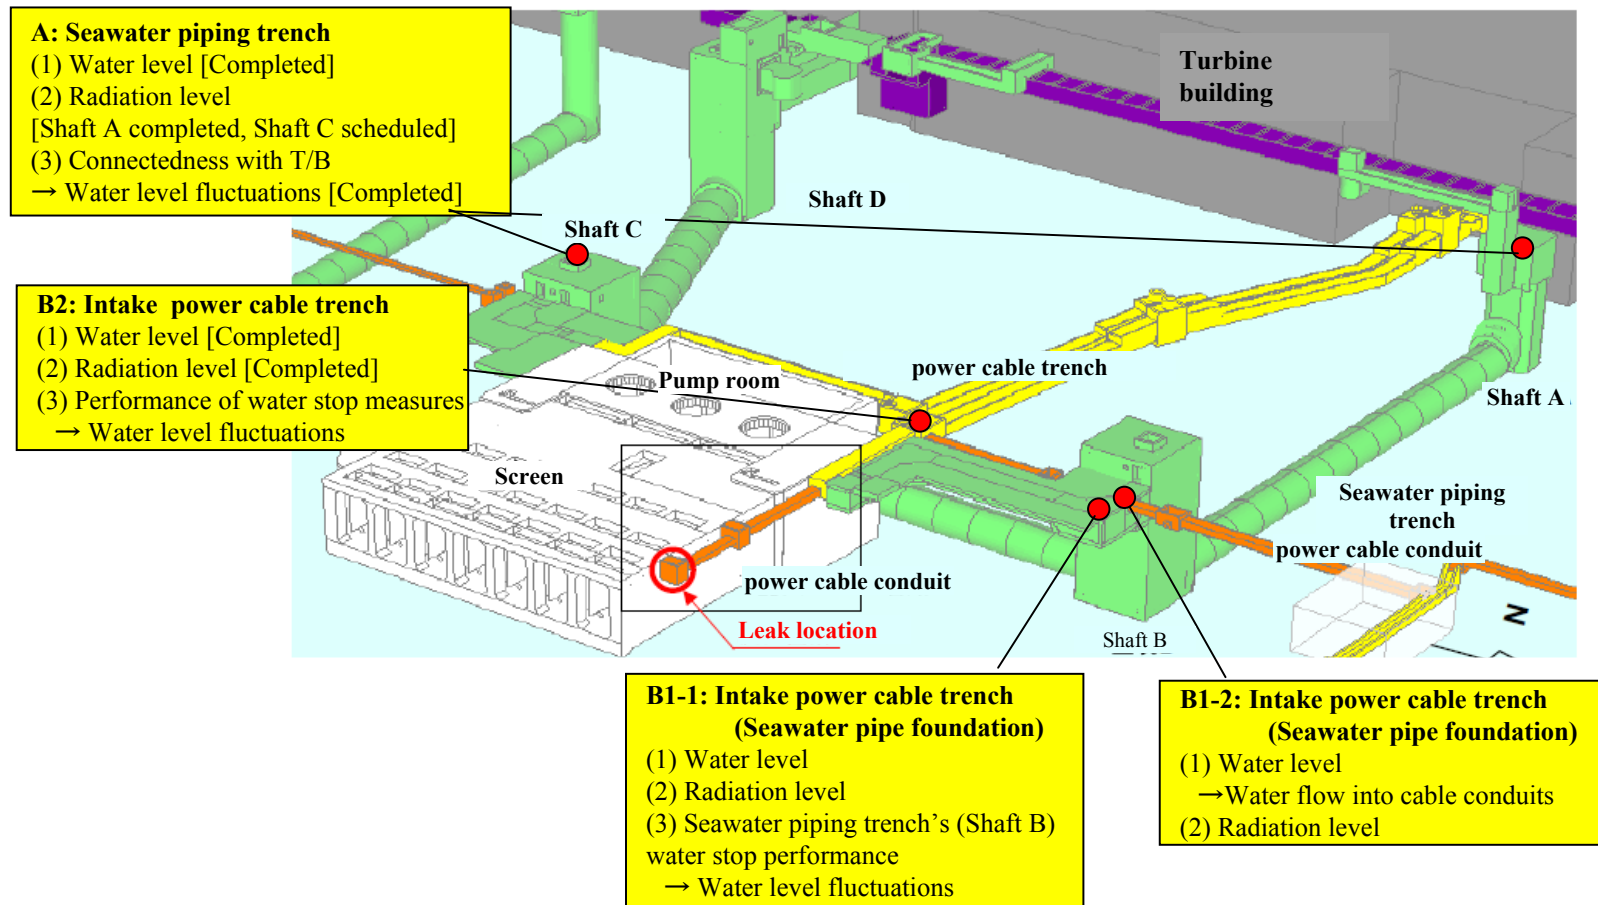
Main investigation items for Unit 2 trenches

- Unit 2 intake power cable trench: Analysis results on main gamma nuclides, all beta radiation and tritium (H-3)
(Sampling on July 17, 2013) <See B2 on page 4>

Location	Salinity (ppm)	Cs134 (Bq/cm3)	Cs137 (Bq/cm3)	All β (Bq/cm)	H-3 (Bq/cm3)
Unit 2 intake power cable trench	70	1.2×10^4	2.4×10^4	2.3×10^4	1.2×10^2

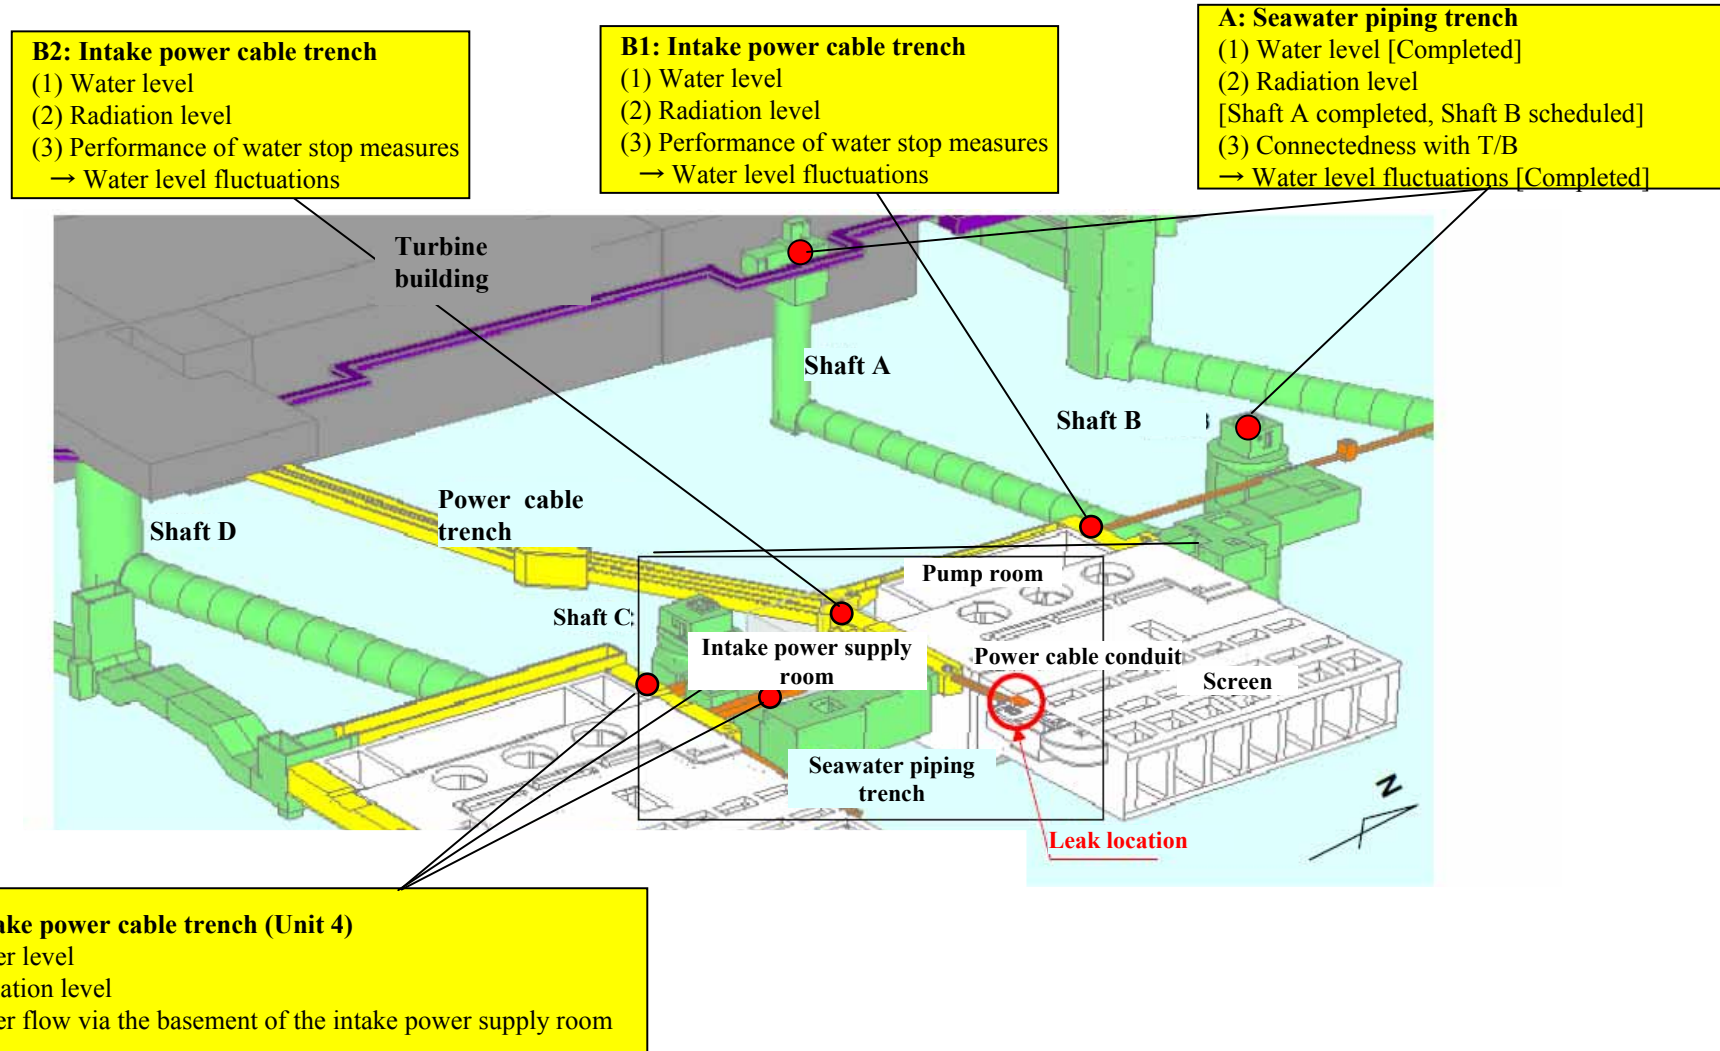
Main investigation items for Units 3 / 4 trenches

- Unit 3 seawater piping trench's shaft A: Analysis results on main gamma nuclides, all beta radiation and tritium (H-3)
(Sampling on July 10, 2013) <See A on page 5>

Location (water depth)	Salinity (ppm)	Cs134 (Bq/cm3)	Cs137 (Bq/cm3)	All β (Bq/cm3)	H-3 (Bq/cm3)
Unit 3 Shaft (1m)	11,000	5.0×10^4	1.0×10^5	6.7×10^5	1.2×10^4
// (7m)	7,500	3.4×10^4	6.9×10^4	5.7×10^5	9.7×10^3
// (13m)	7,000	3.1×10^4	6.2×10^4	5.3×10^5	6.0×10^3
