# Countermeasures against the Uplift of the Underground Reservoirs

August 21, 2013

Tokyo Electric Power Company

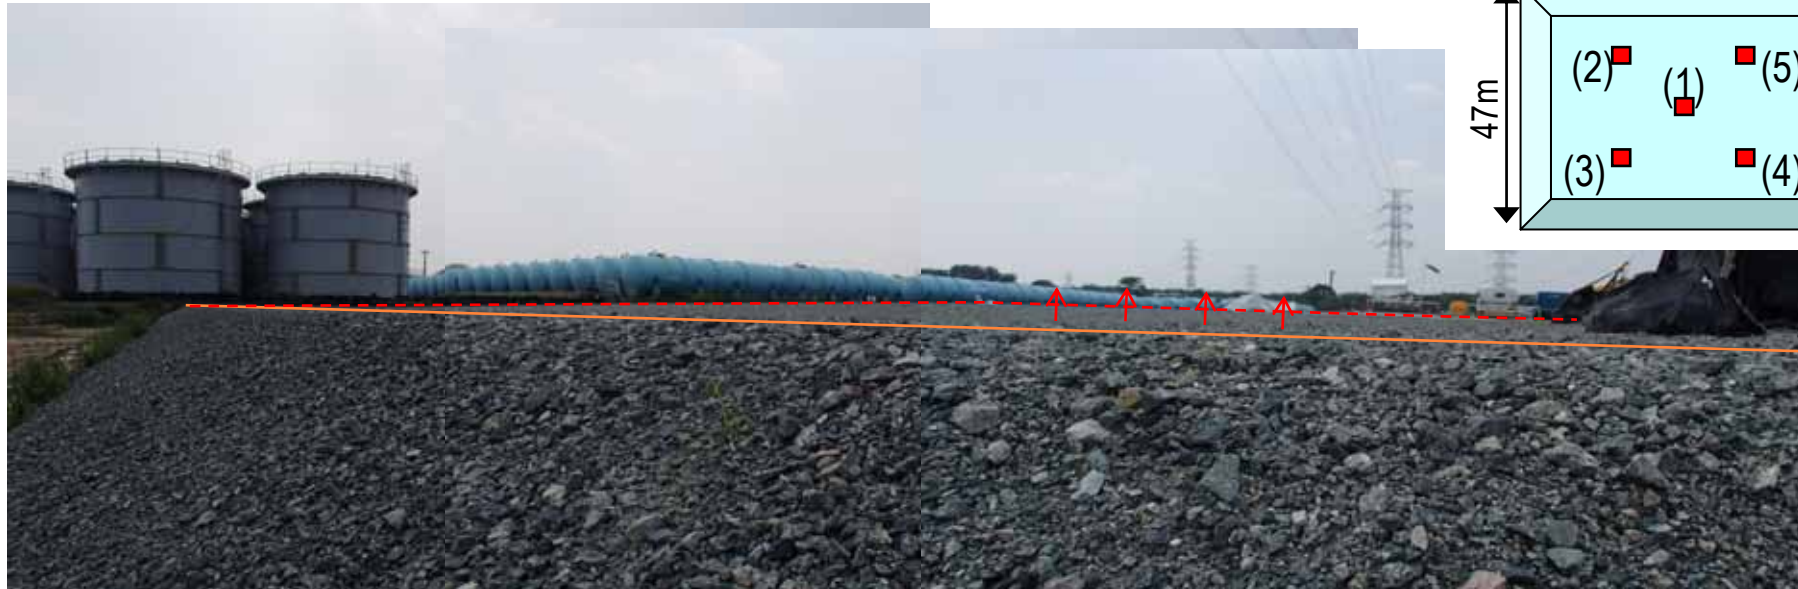
## 2-1. Chronological change of the uplift (Underground reservoir No.3)

- Uplift of max. approx. 40cm was detected on August 10 with the underground reservoir No.3.
- At present, no obvious progress is not detected.

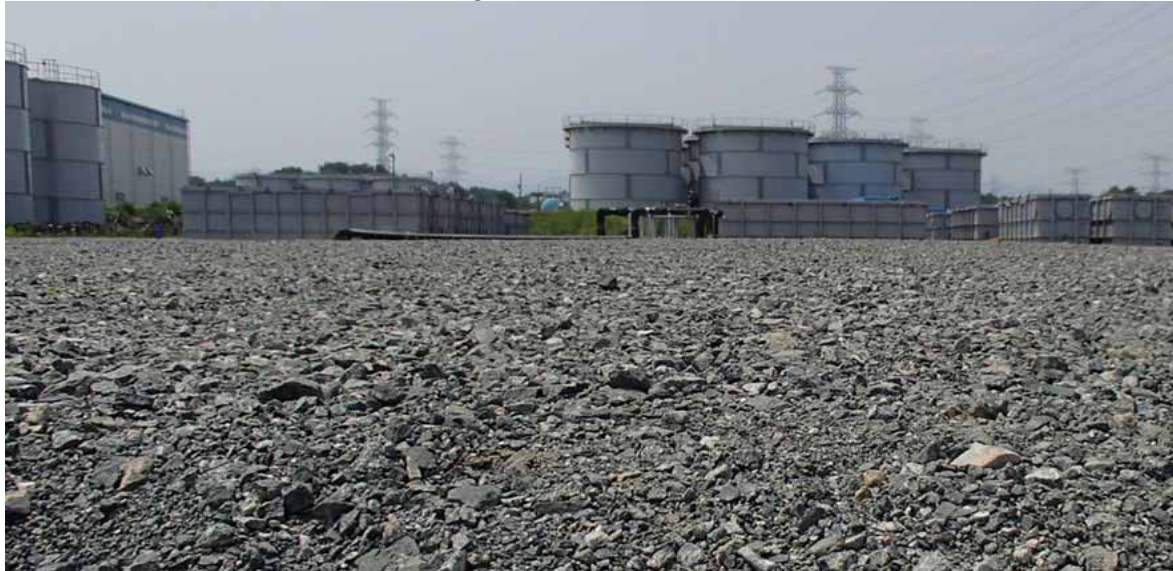
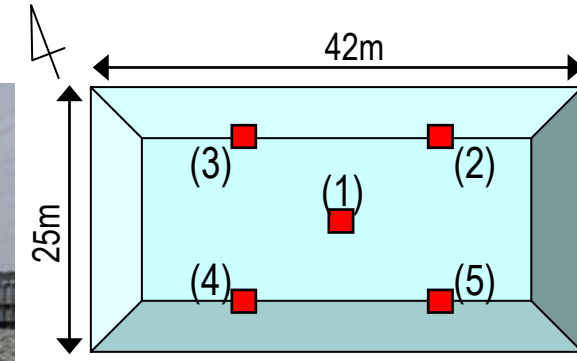
## 2-2. Chronological change of the uplift (Underground reservoir No.4)

- Uplift was detected on August 10 with the underground reservoir No.4 (approx. 15cm as of the measurement on August 11).
- At present, no obvious progress is not detected.

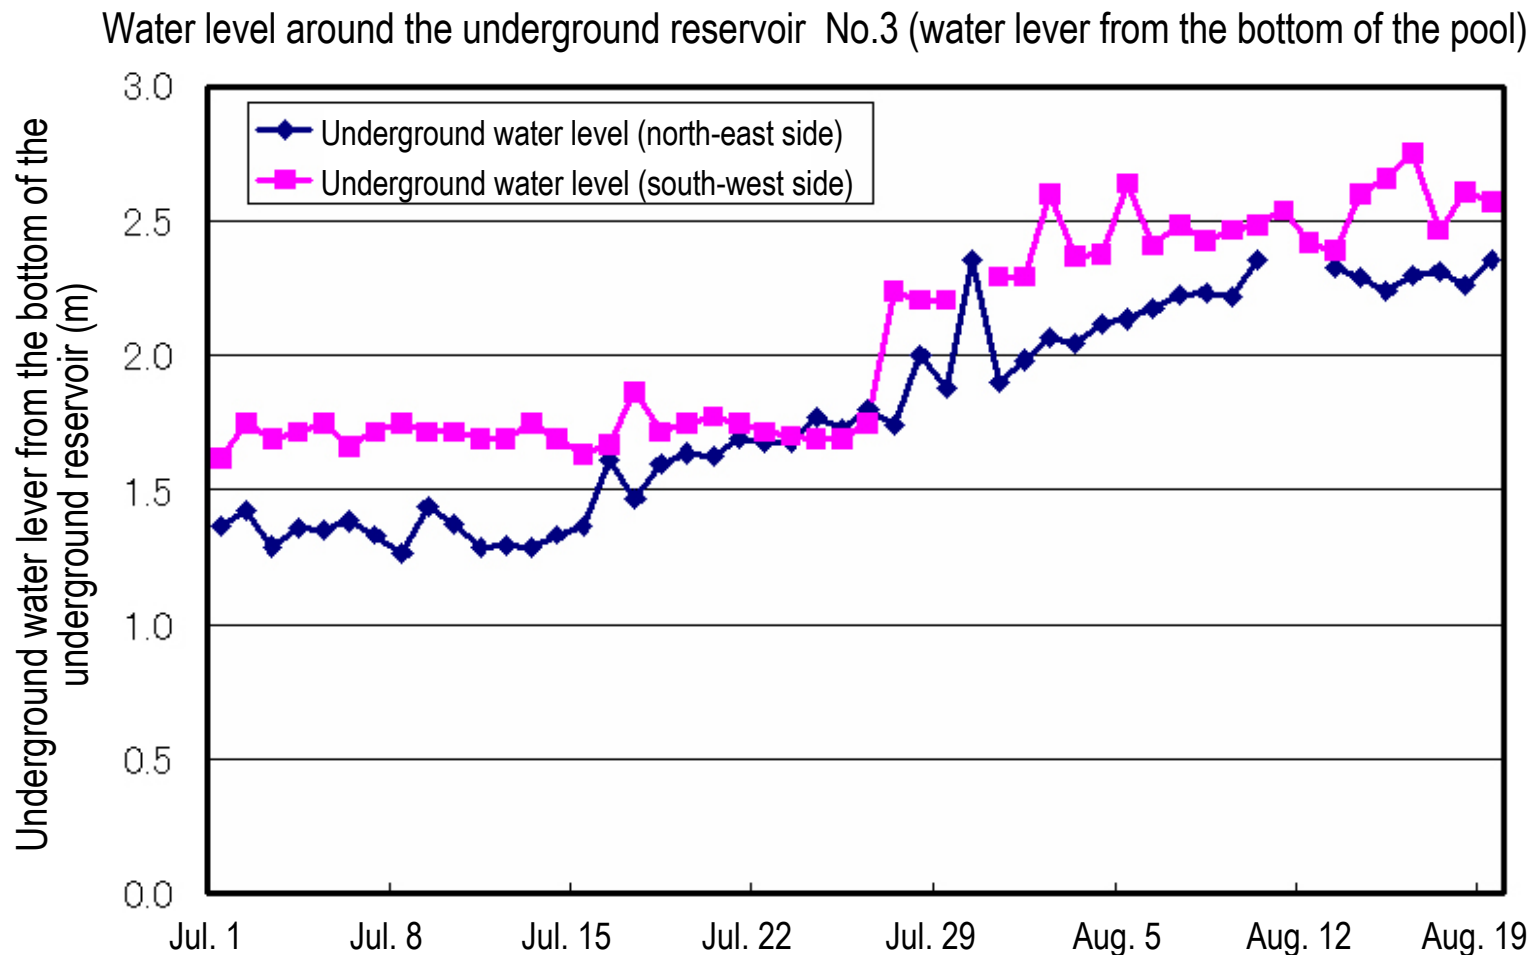
# 3-1. Chronological change of underground water level (Underground reservoir No.3)

- Since mid July, the underground water level around the underground reservoir has increased.
- The underground water level decreased on August 11. However, it repeated up and down from August 14 to 18.

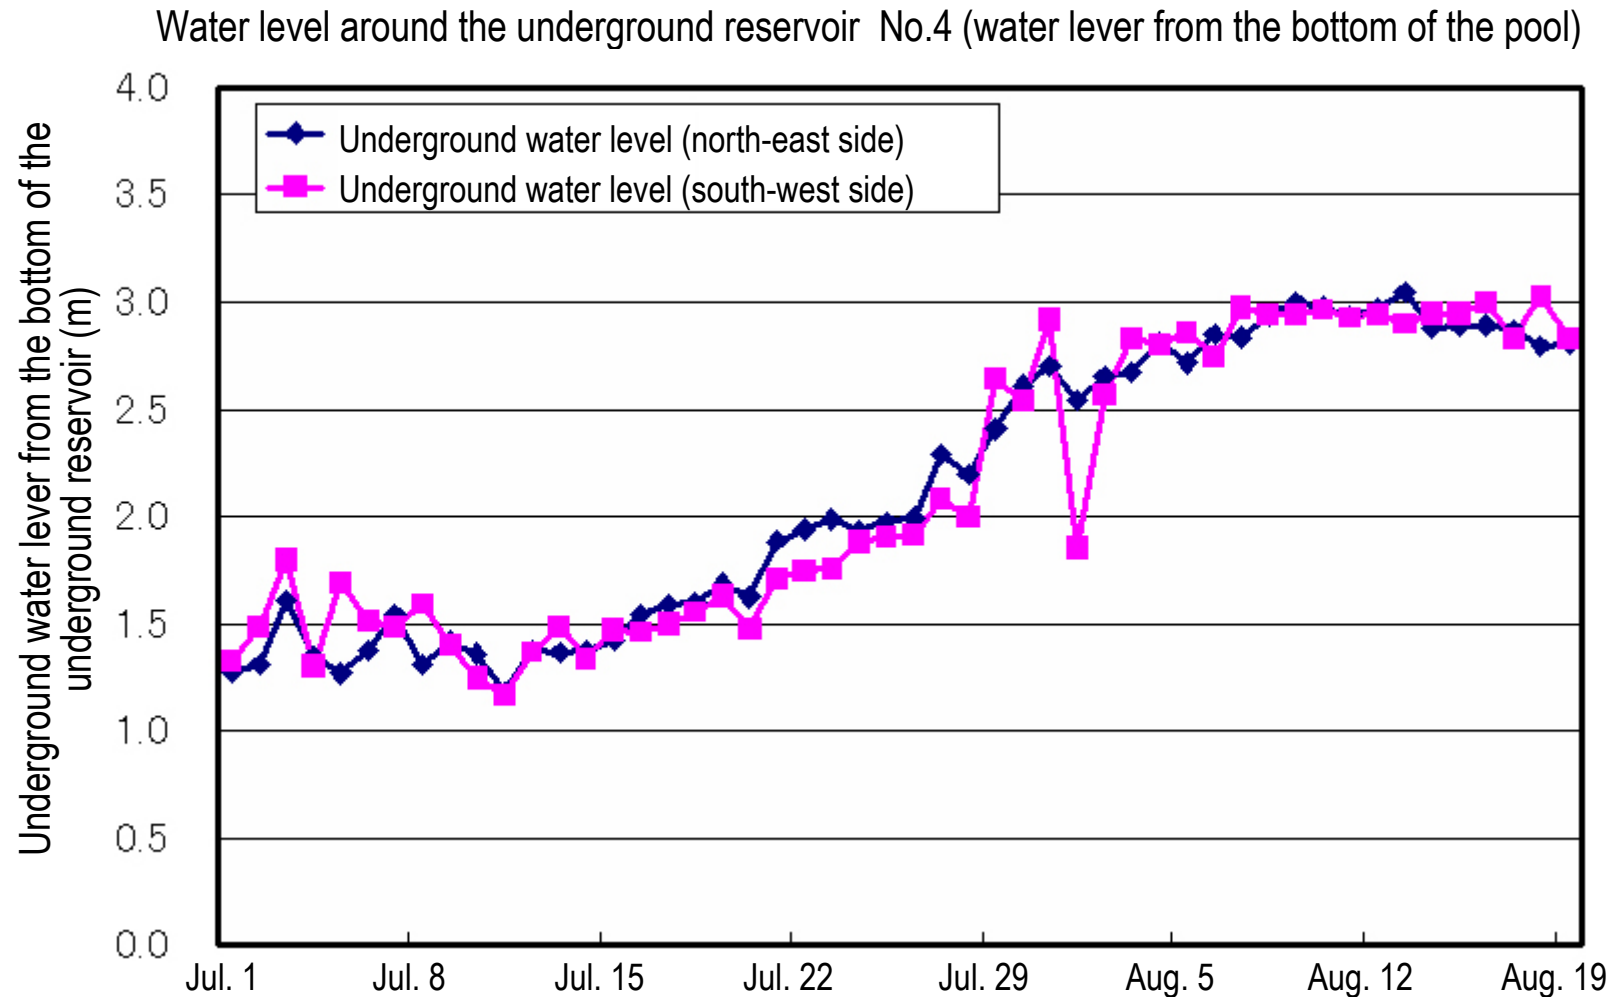
## 3-2. Chronological change of underground water level (Underground reservoir No.4)

- Since mid July, the underground water level around the underground reservoir has increased.
- The underground water level has been consistent at approximately 3m since August 10.

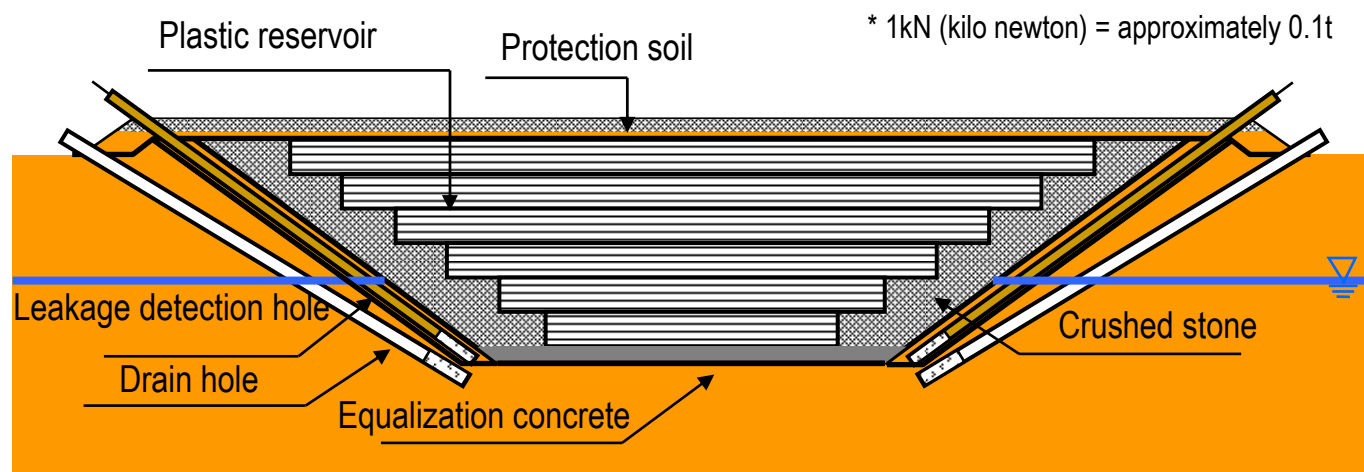
## 4. Initial estimate concerning the uplift

- The uplift was examined by regarding the underground reservoir as an integrated moving structure.
- Based on the weight of the underground reservoir, it is estimated that uplift of 3.2m or more and 4.4m or more will be generated with the underground reservoir No.3 and No.4, respectively.

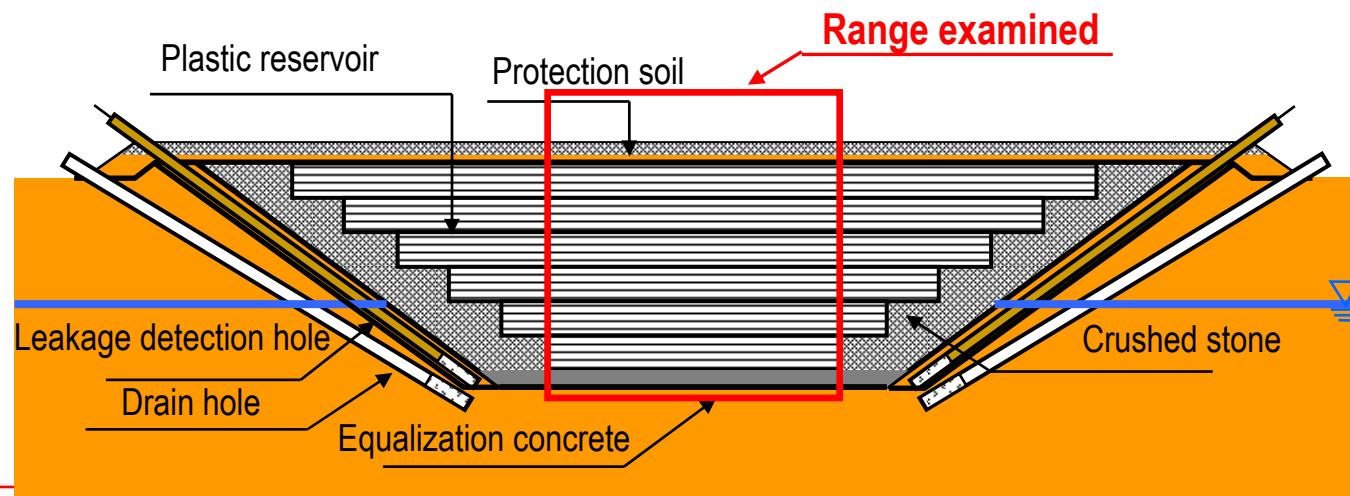
## 5. Load added on to eliminate the uplift

- The recent uplift was detected mainly at the center around which there was no weight of crushed stone.
- To resolve this issue, weight required to eliminate the uplift was calculated in the range where there was no crushed stone (within the red frame) (calculated by the unit area).
- Based on the groundwater water level, **70cm and 80cm of crushed stone** will be added for equalization to the **underground reservoir No.3 and No.4**, respectively (However, the layer thickness will be re-examined depending on the condition).

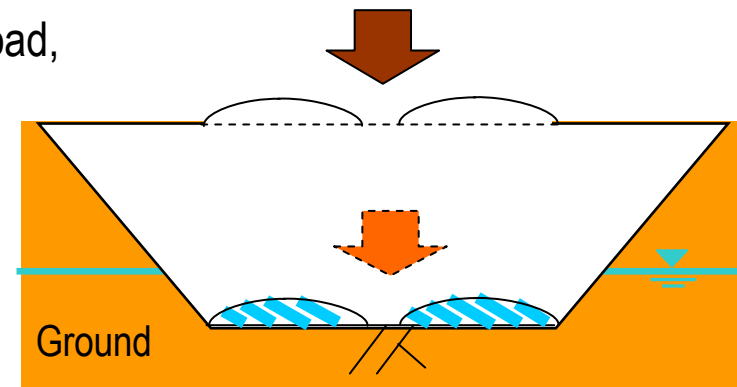
Load applied by adding crushed stone

If the underground water is not collected, there is a concern that the accumulated underground water may move and generate new uplift.

[Purpose] Underground water estimated to be accumulated between the ground and the reservoir will be discharged and, by adding load, new uplift will be prevented.

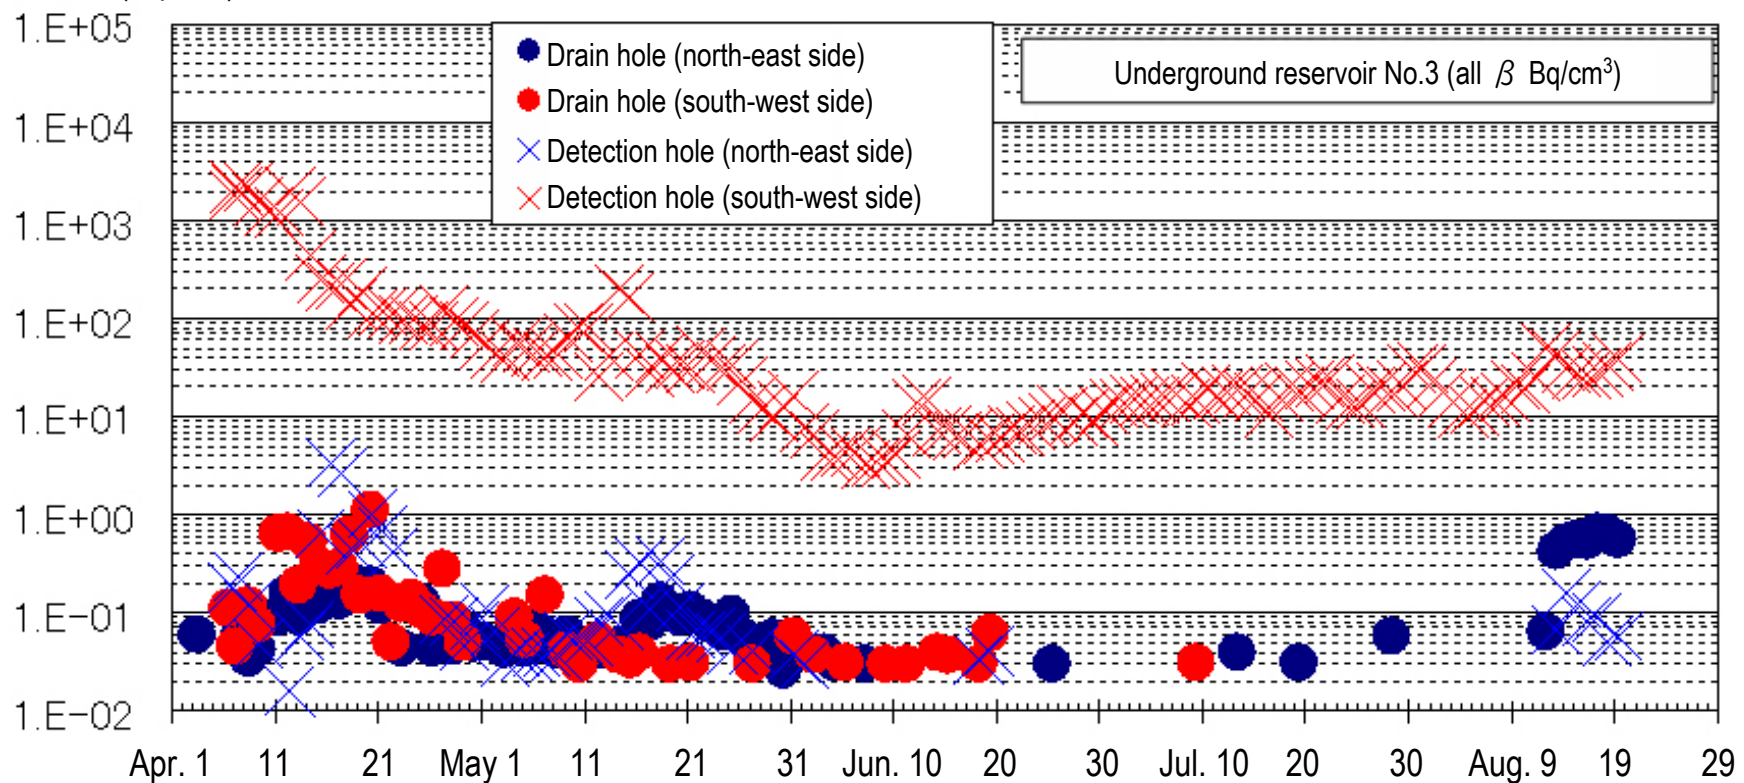
Measurement results of all  $\beta$  related to the drain and detection holes of the underground reservoir No.3 (Bq/cm<sup>3</sup>)

- There is no significant change in the analysis results related to all  $\beta$  of the drain and detection holes from mid July to August 10. Therefore, no leak of contaminated water is recognized caused by uplift.
- Since August 12, all  $\beta$  density has been detected on the north-east side. As of August 19, the density was at  $5.7E-01(\text{Bq}/\text{cm}^3)$  at the drain hole.
- As there was no significant progress in the uplift, it is estimated that this is not new leak caused by any uplift, but the impact of groundwater collection from the drain hole (on the north-east side) from August 11 to 12.
