Current progress in the investigation of the H4 Area water leakage

Aug 24, 2013

Tokyo Electric Power Company

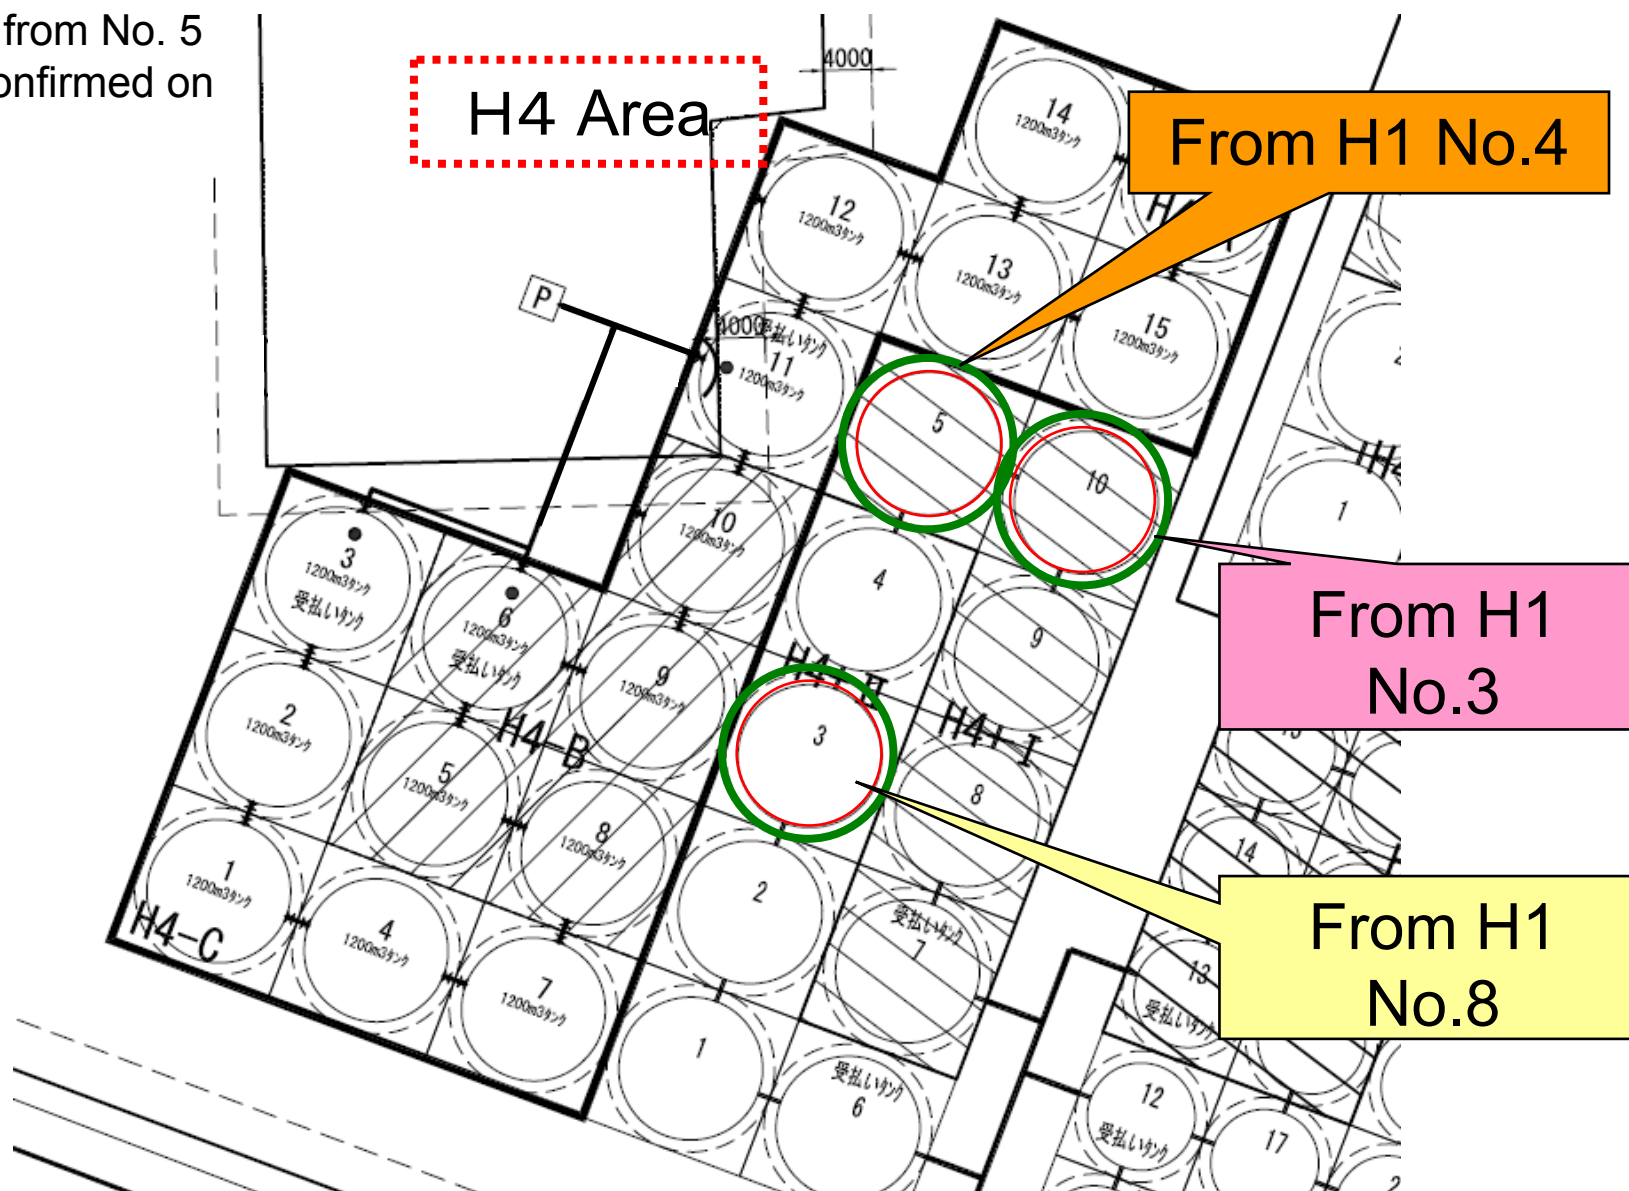
Location of Tanks moved from H1 Area to H4 Area

● Leakage from No. 5 Tank was confirmed on August 19.

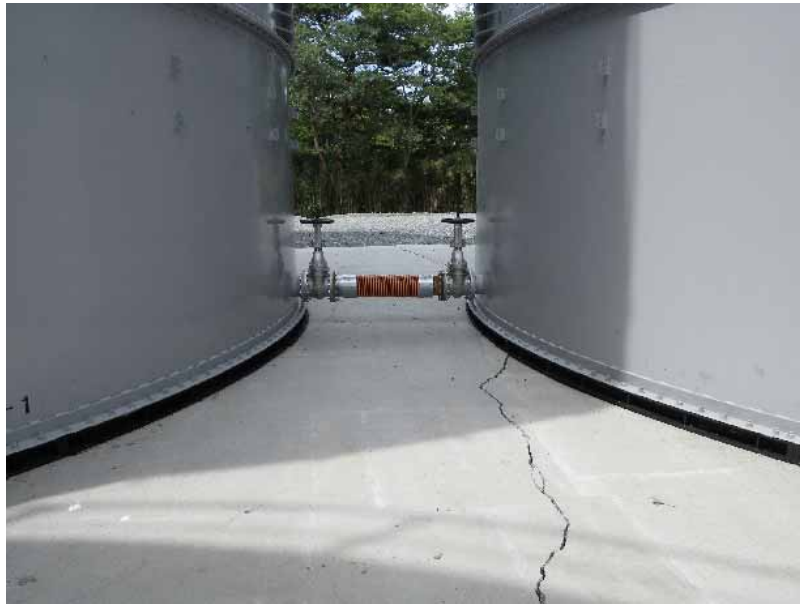
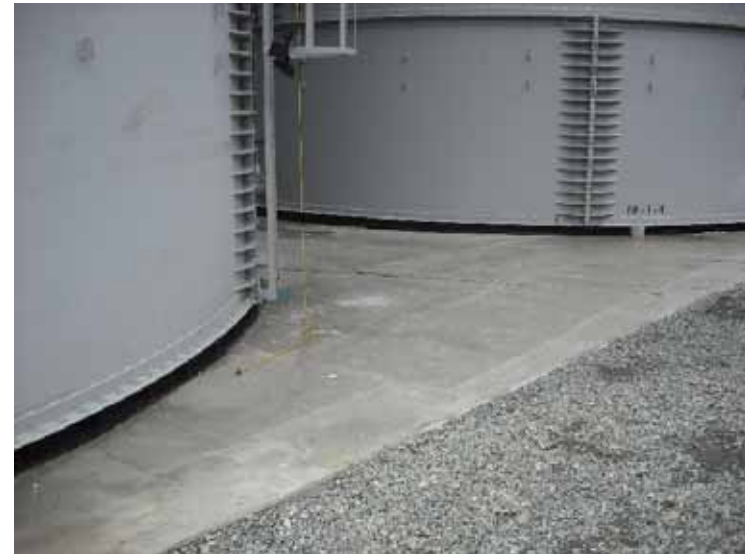
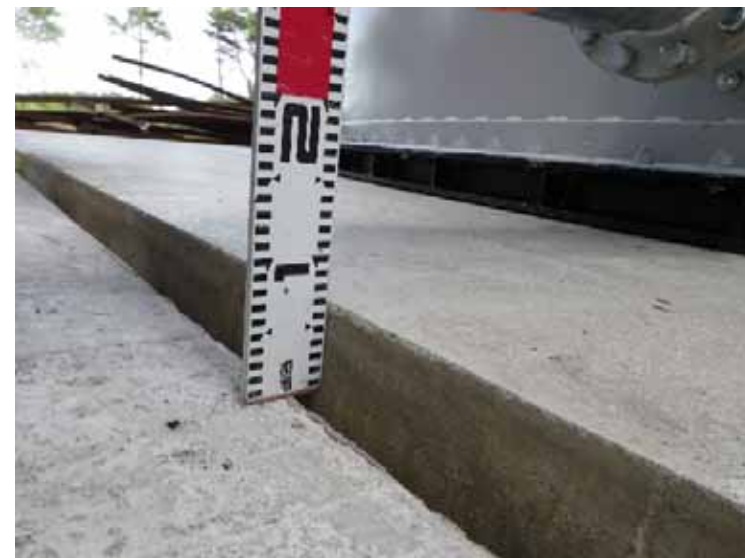
Groundwork of H1 Area

- **Jun 16**, Start of installation of the vertical cylindrical steel tanks (capacity of each is 1000m³) in the H1 area
- **Jul 19**, While filling three tanks with water as a test, their substructures partially sank by approx. 20cm at the north-east of the H4 area
