# Results of the Sixth Soundness Inspection of Unit 4 Reactor Building at Fukushima Daiichi Nuclear Power Station

August 28, 2013

Tokyo Electric Power Company

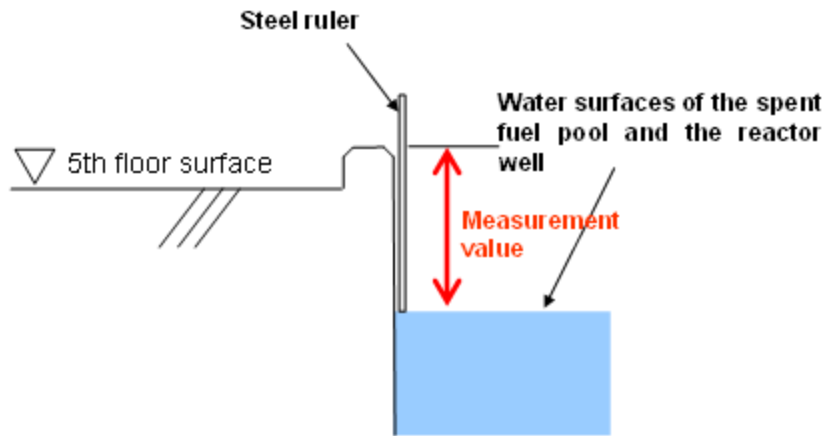
Measurement method\*1

Considering that the water level measurement values on the four corners were about the same, it has been concluded that the 5th floor surface and the water surfaces of the spent fuel pool and the reactor well are parallel and the building is not tilted similarly to the past results.

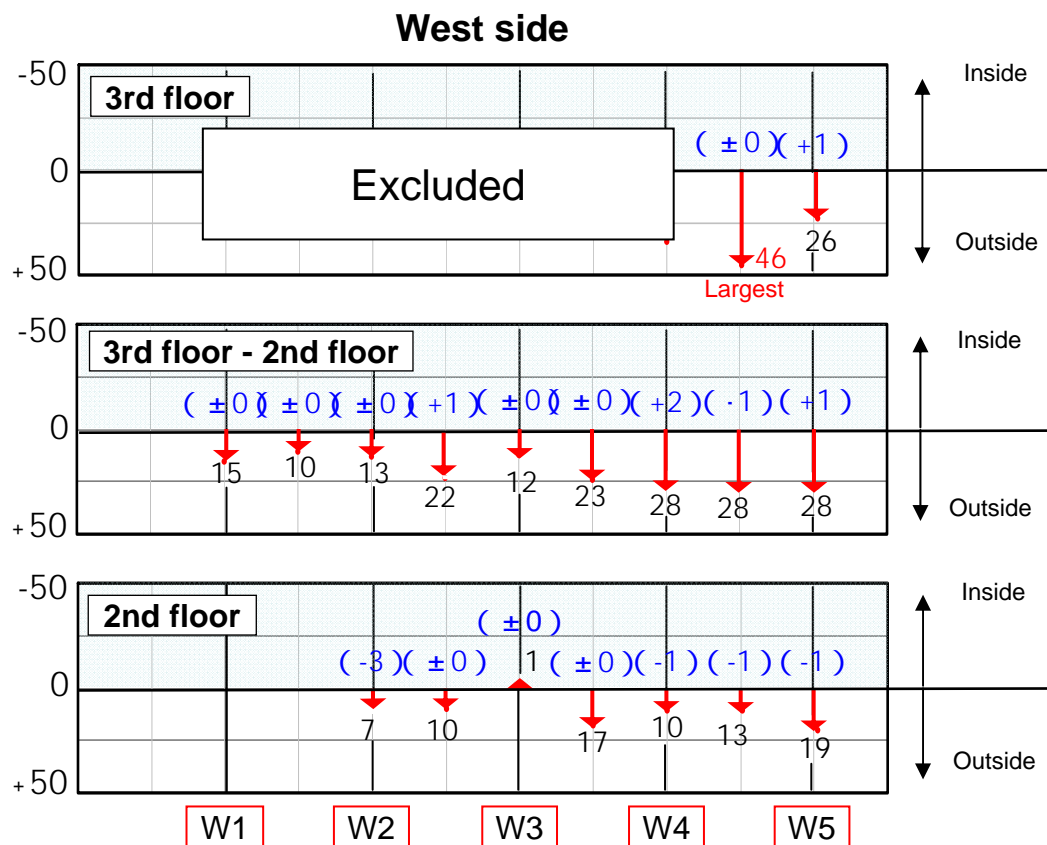
### Horizontal difference\*1 calculation results (Unit: mm)

- The horizontal differences measured this time were about the same as those in the first to fifth inspections, and the deformation characteristics on the measurement points were also similar.

- The small difference from the previous measurement results may be due to factors such as error of the optical equipment (Measurement error of  $\pm 2\text{mm}$  may cause approx. 4mm (Max.) error in horizontal difference) and thermal expansion of concrete (thermal expansion coefficient: Approx.  $7-13 \times 10^{-6}/$  ) which may cause approx. 4-7mm error because of the difference of average monthly temperatures between May and August.

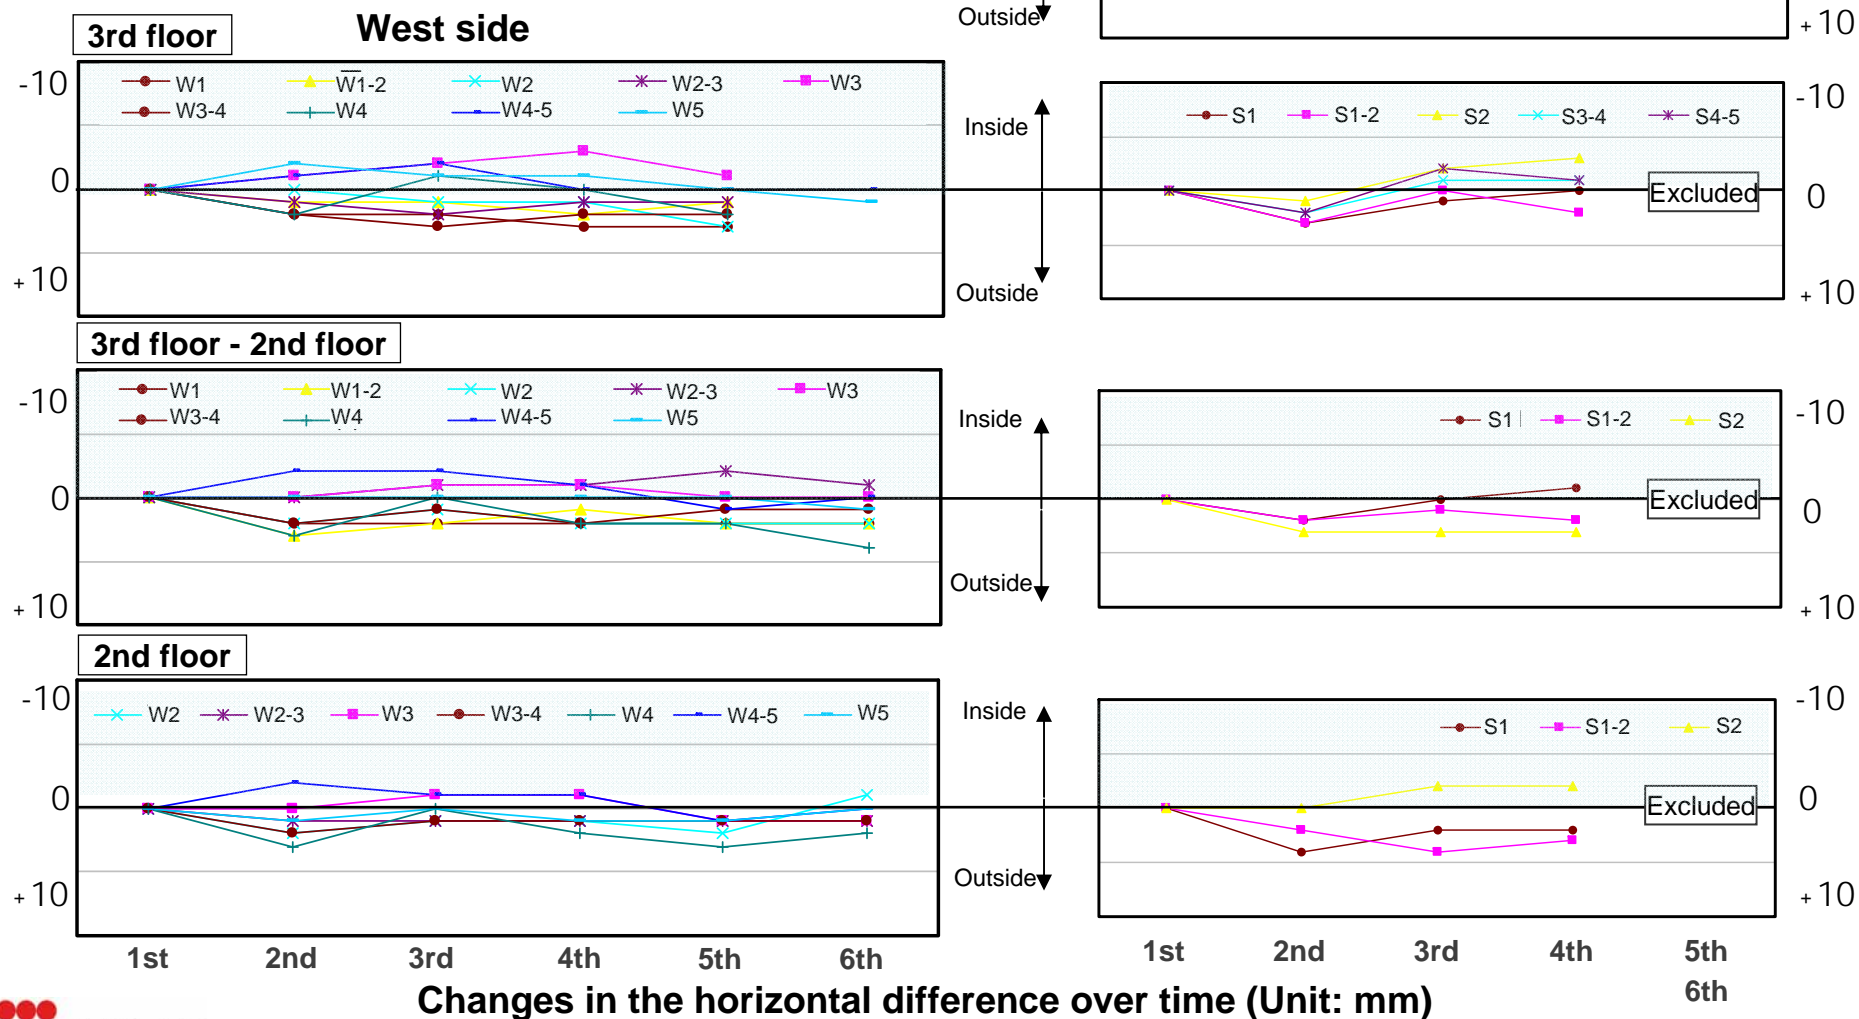
Based on the changes in the horizontal difference over time (from the first to sixth inspections), no tendency of building tilt was confirmed.

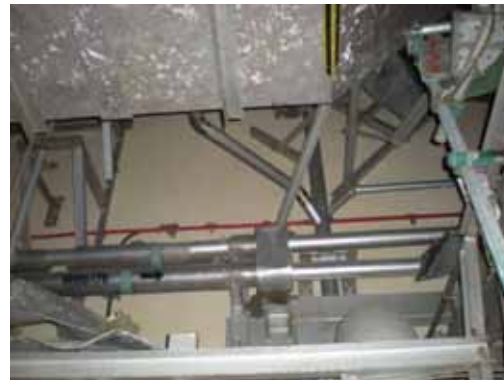
① West wall

Since no crack of a width of 1mm or more or with possible rebar corrosion was found as a result of visual inspection (similarly to the past results), it has been concluded that there is no hazardous deterioration of structural durability.

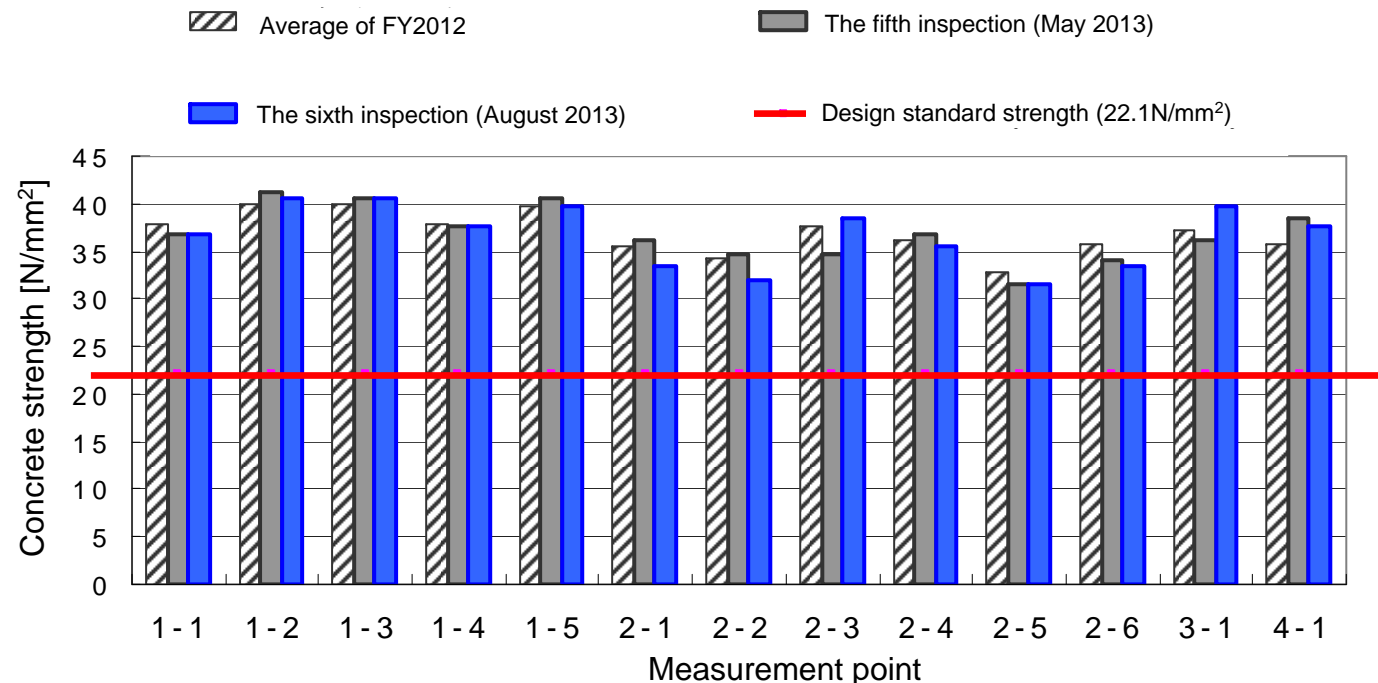
### Concrete strength evaluation results

As a result of measurement, the concrete strengths on all the measurement points were above the design standard (22.1N/mm<sup>2</sup>) similarly to the past results. The concrete strength is considered to be about the same as the past results taking into considerations the error of Schmidt Hammer\*1 and that the measurement points were set at slightly different locations from the previous ones.

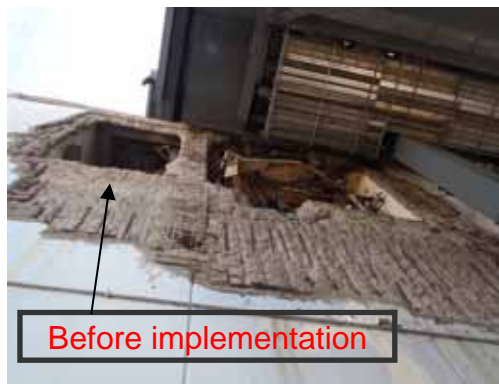
Photo 1: Before implementation of the measures

Since the concrete surface of the posts, beams and walls in Unit 4 Reactor Building came off and rebar is partially visible due to the hydrogen explosion, corrosion prevention measure (spraying mortar onto the exposed parts after high-pressure washing) has been implemented for the purpose of ensuring the durability of the members starting since June 2013.
