Condition of the Bank Protection Area at Fukushima Daiichi Nuclear Power Station

<Reference>
September 9, 2013
Tokyo Electric Power Company

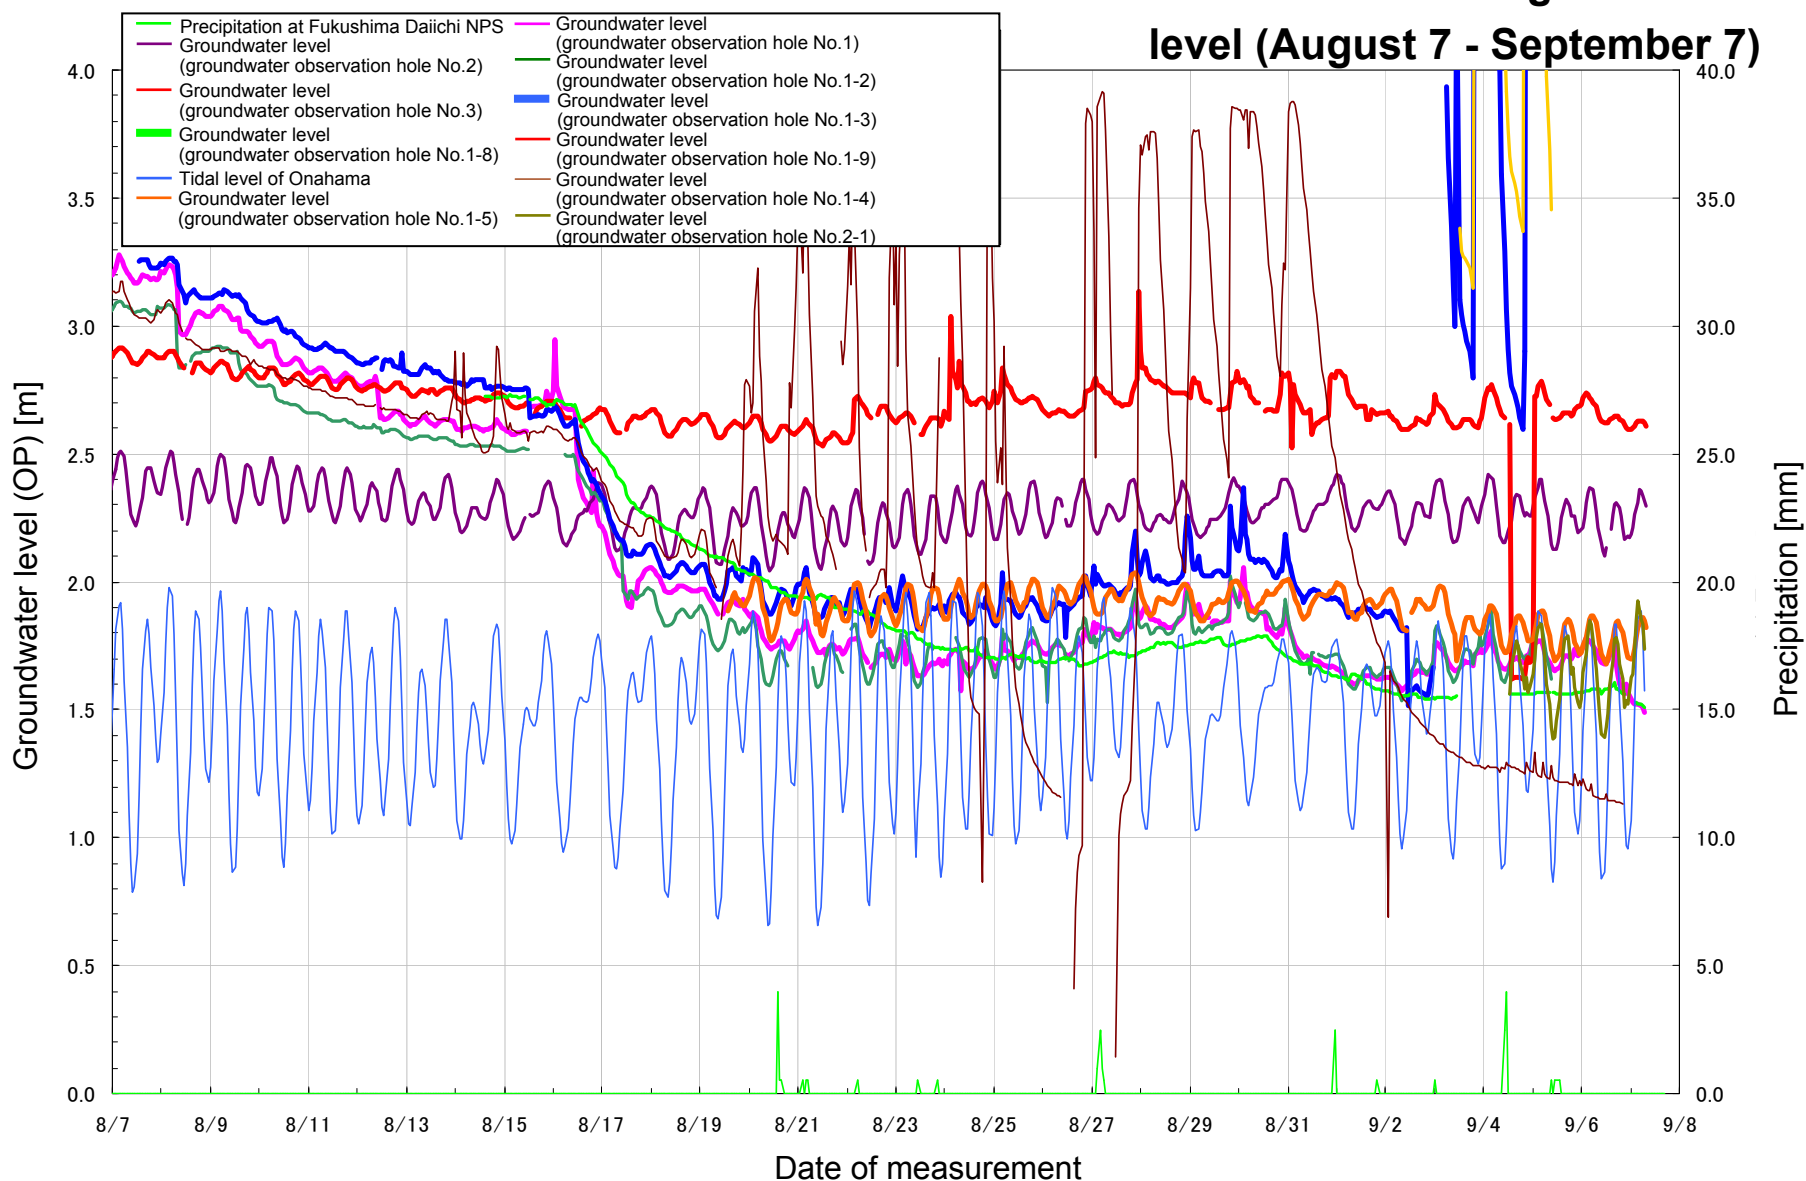
■ Transition of the groundwater level (August 7 - September 7)

* Automatic measurement data measured by water gauge

* No measurement can be performed at the groundwater observation hole No.1-3, since chemical has flowed into the hole. A water gauge has temporarily removed from the groundwater observation hole No.1-5 due to the ground improvement work.

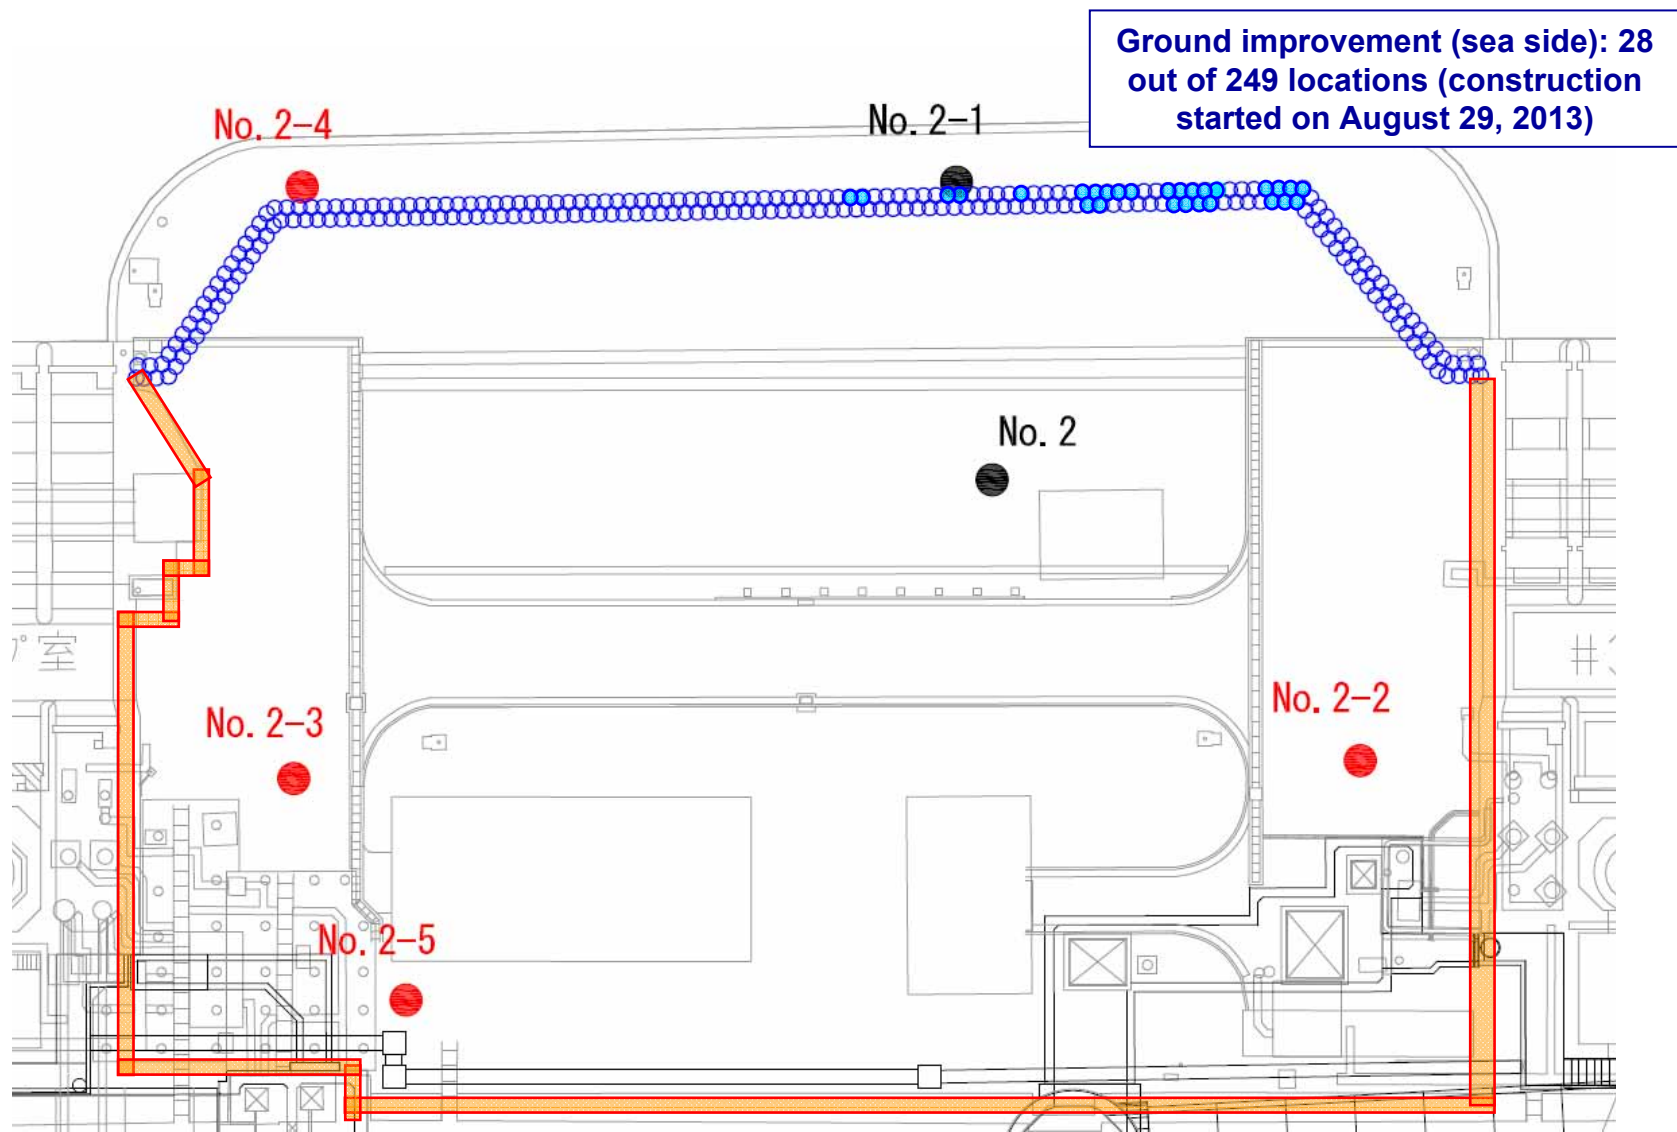
■Progress Status of Ground Improvement Construction between Unit 2 and 3 (As of the Morning on September 9)

* The range of the construction is subject to change depends on the site status.

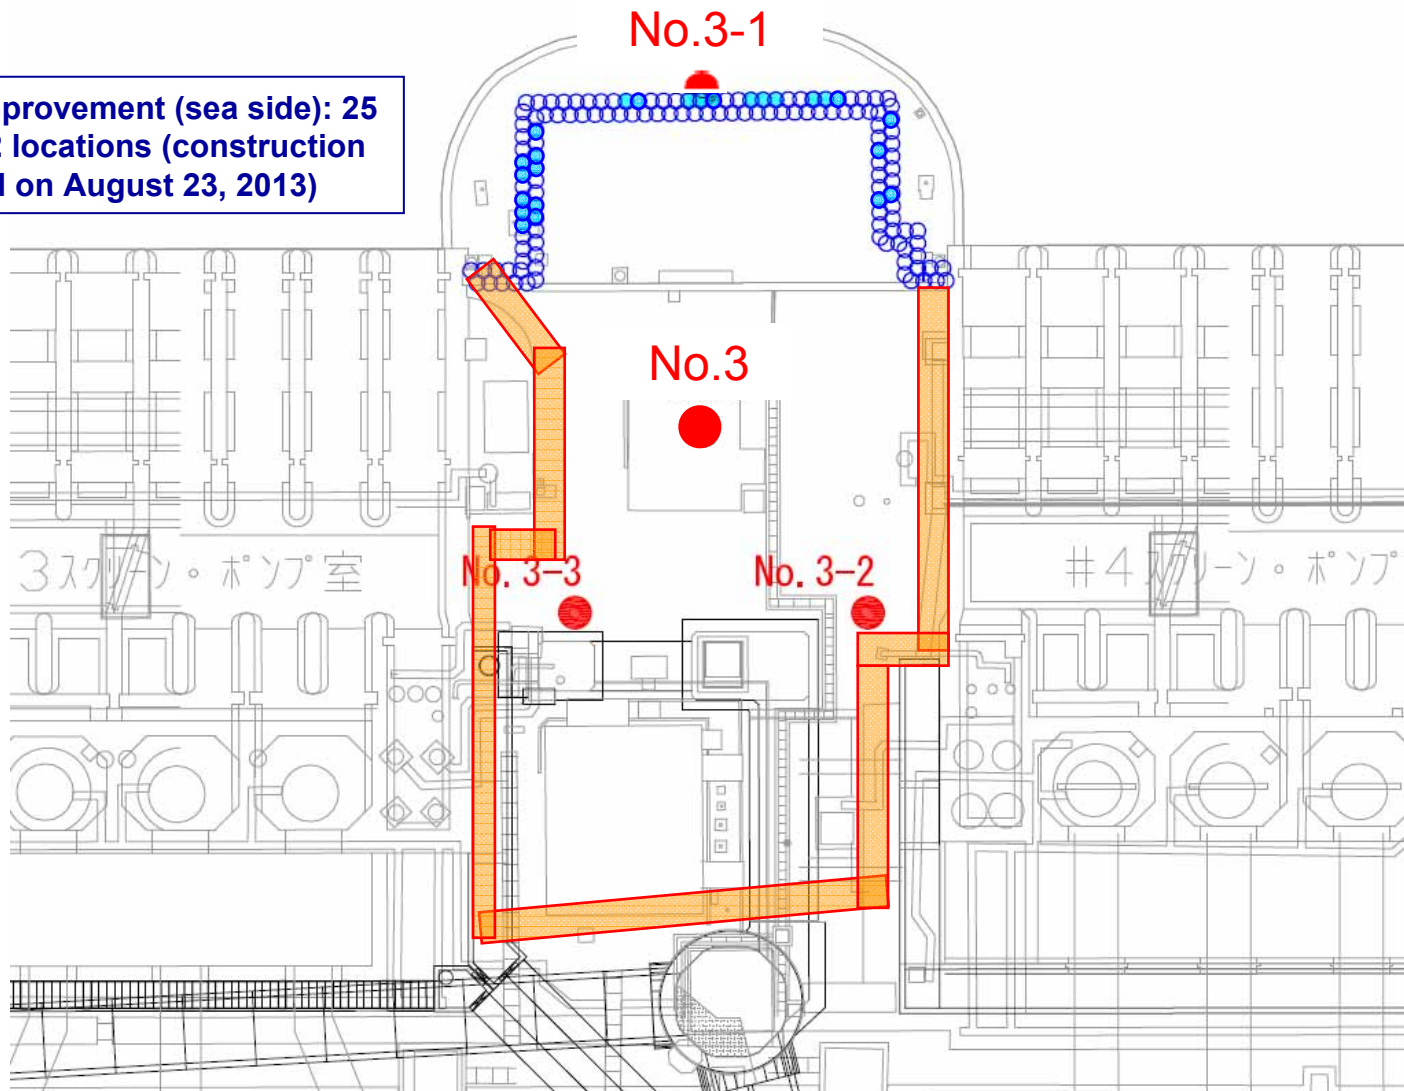
■Progress Status of Ground Improvement Construction between Unit 3 and 4 (As of the Morning on September 9)

Ground improvement (sea side): 25
out of 132 locations (construction
started on August 23, 2013)

*1 The range of the construction is subject to change depends on the site status.

*2 Groundwater observation hole No.3-1 will be not in use due to the ground improvement construction.
