Efforts for Decommissioning of Unit 1 to 4 Reactors in TEPCO Fukushima Daiichi Nuclear Power Station

September 13, 2013

Tokyo Electric Power Company, Inc.

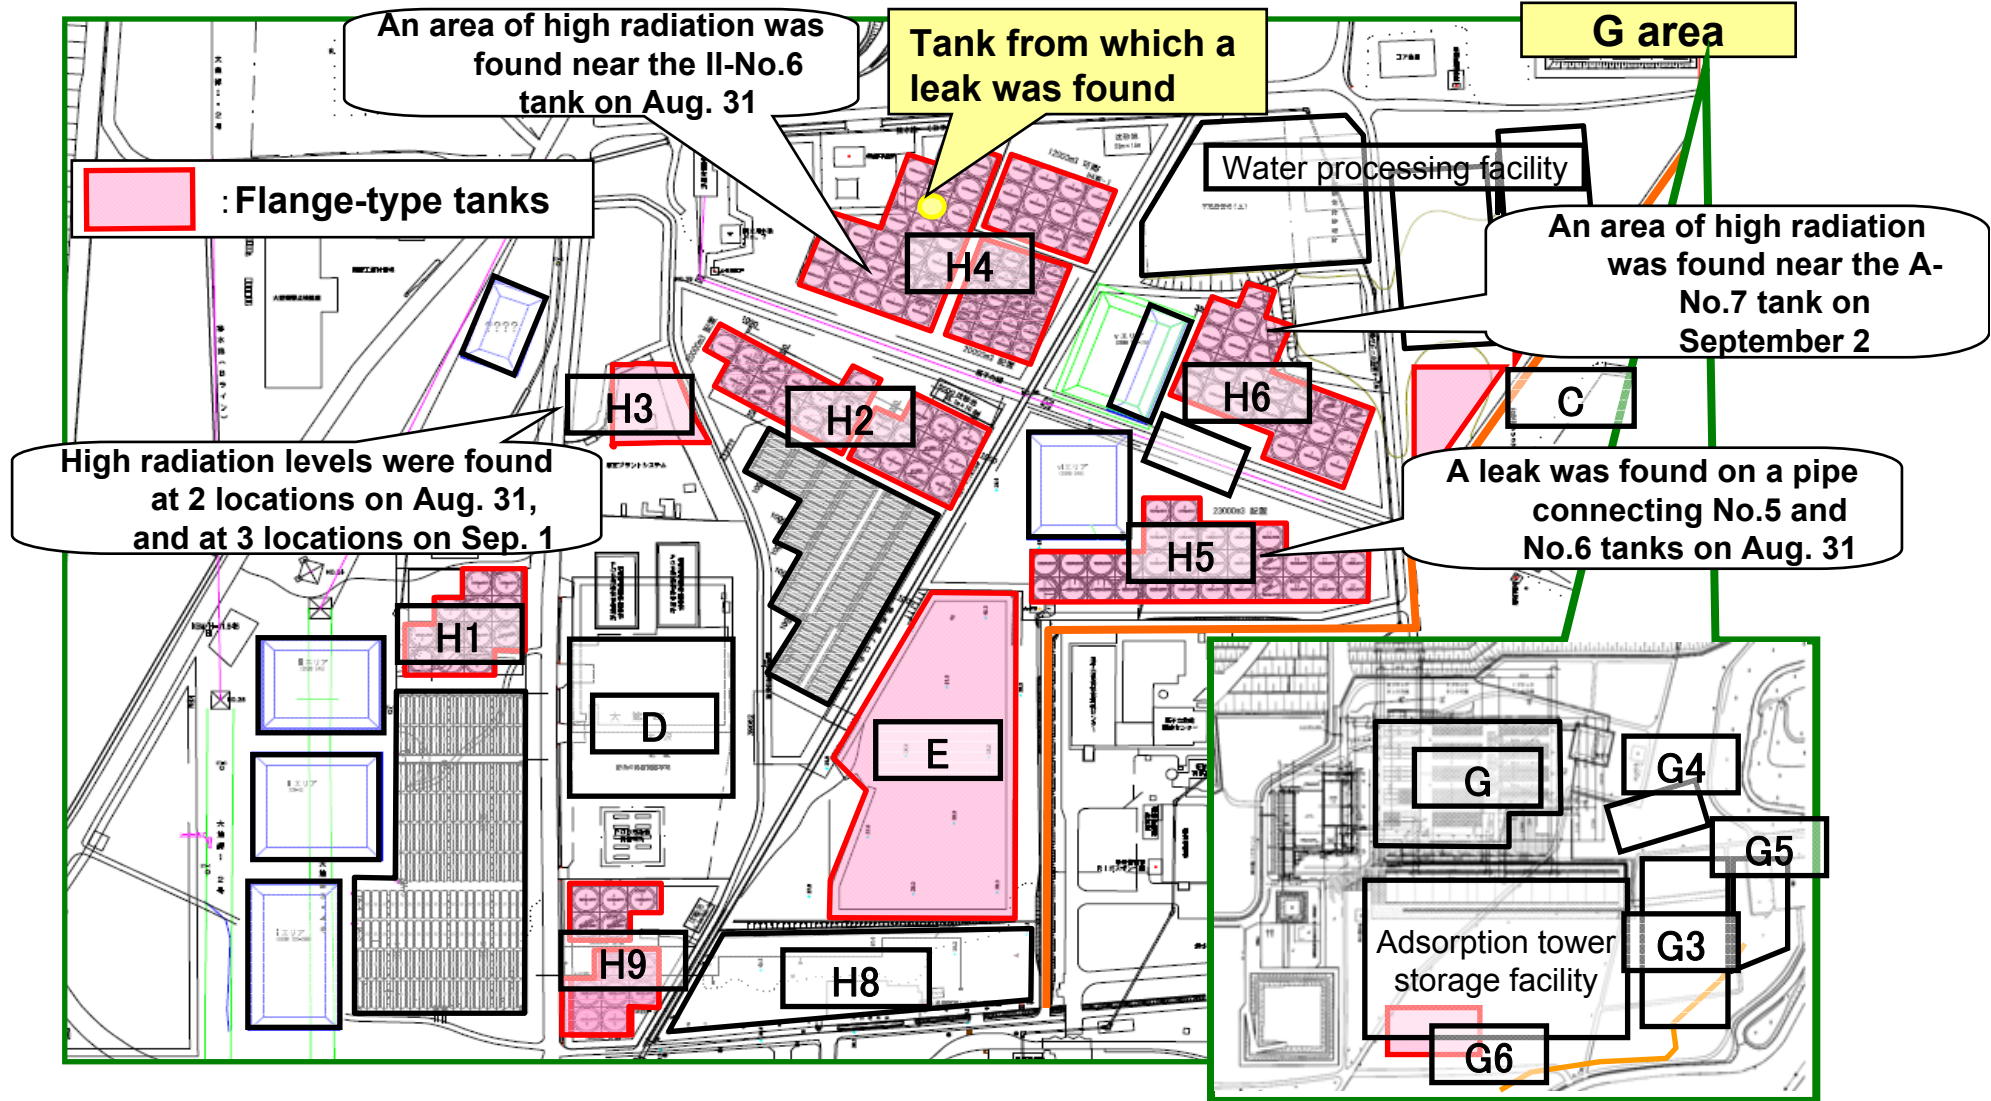
I. [2] Inspection of Tanks of the Same Type

Contaminated water leakage from a flange-type tank in H4 area was found. Among the approx. 930 storage tanks for contaminated water from Unit 1 to 4 reactors, approx. 300 tanks of the same type have already been installed.

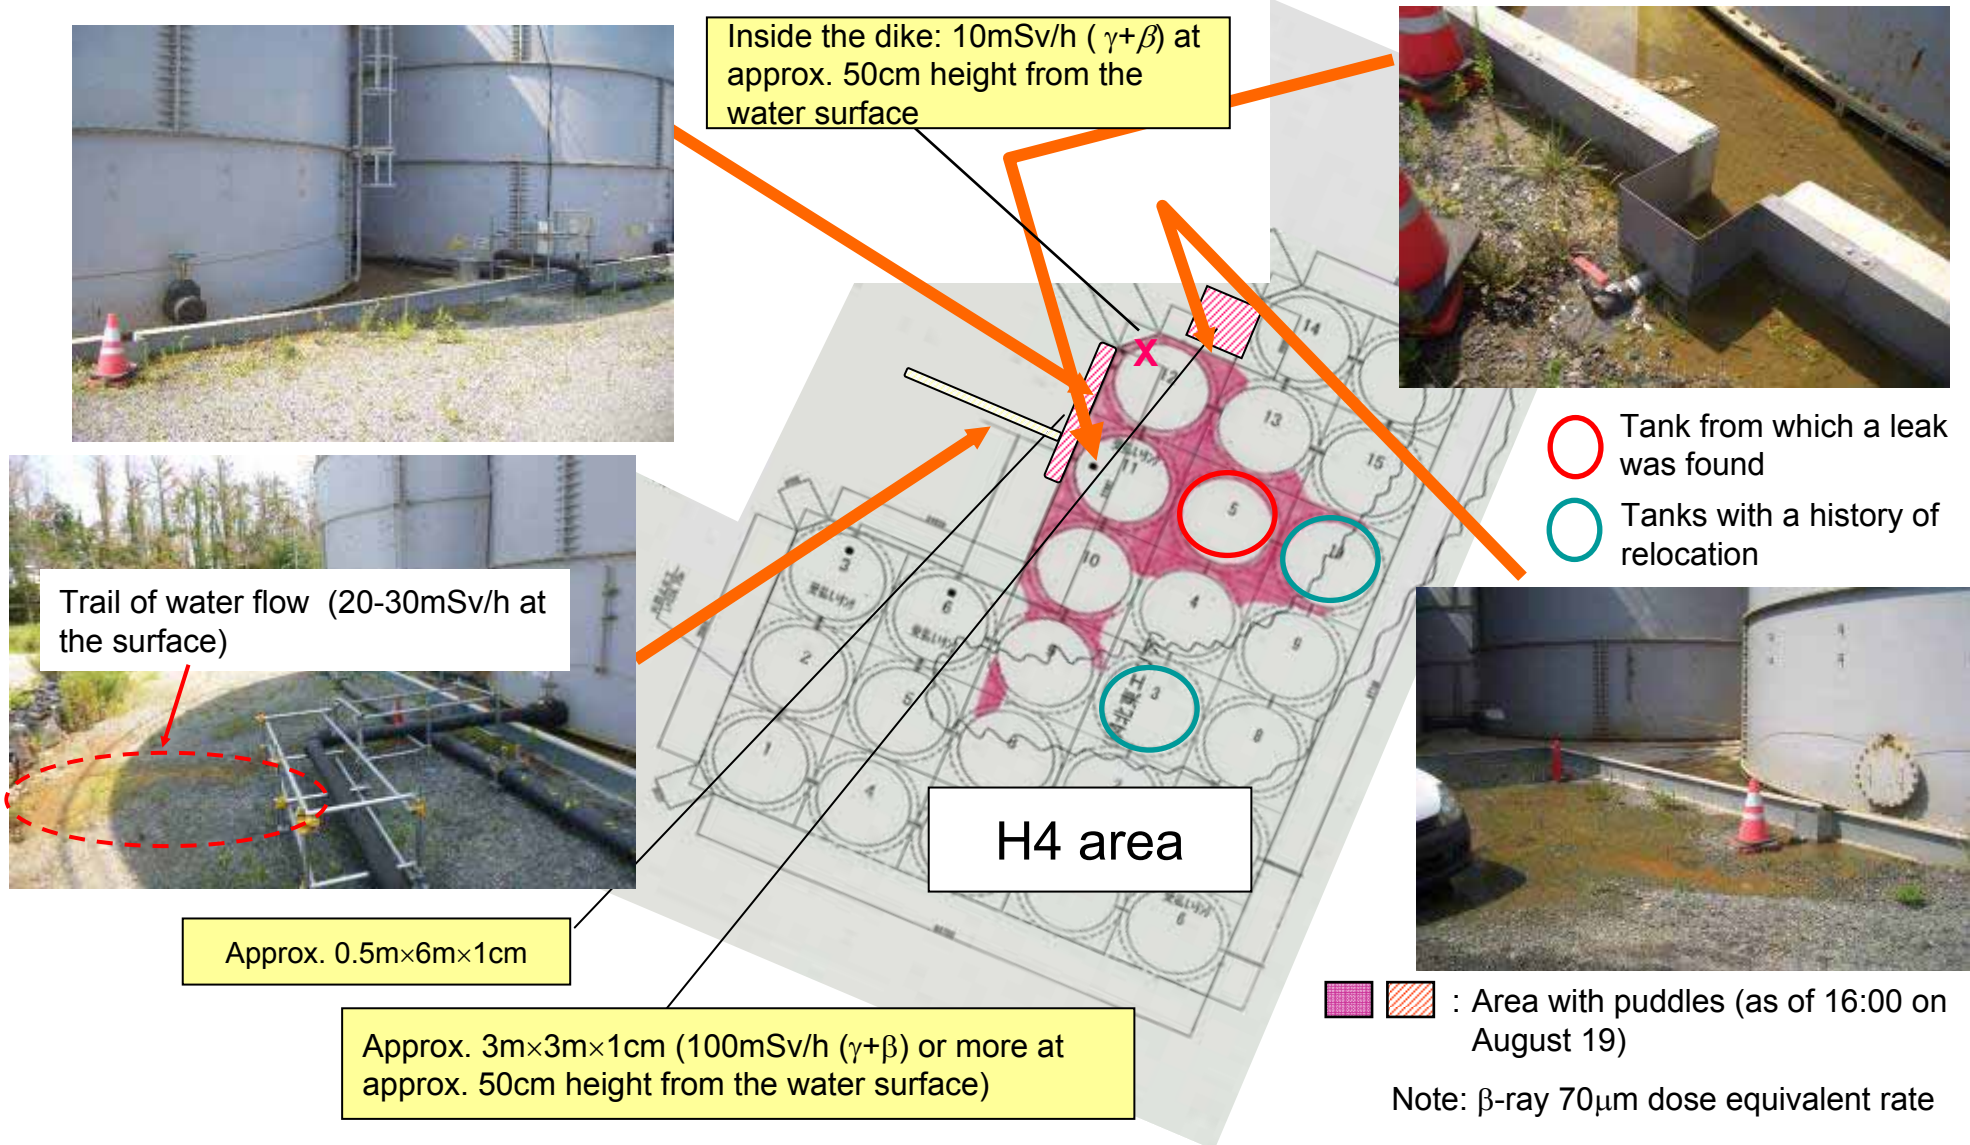
I. [2] Leakage from a Tank

Puddles were found near the steel tanks (flange-type) on August 19, 2013. It was found that water levels at one of the tanks had dropped (approx. 3m: equivalent to approx. 300t) on August 20, and the remaining water was transferred to other tanks (completed on August 21).

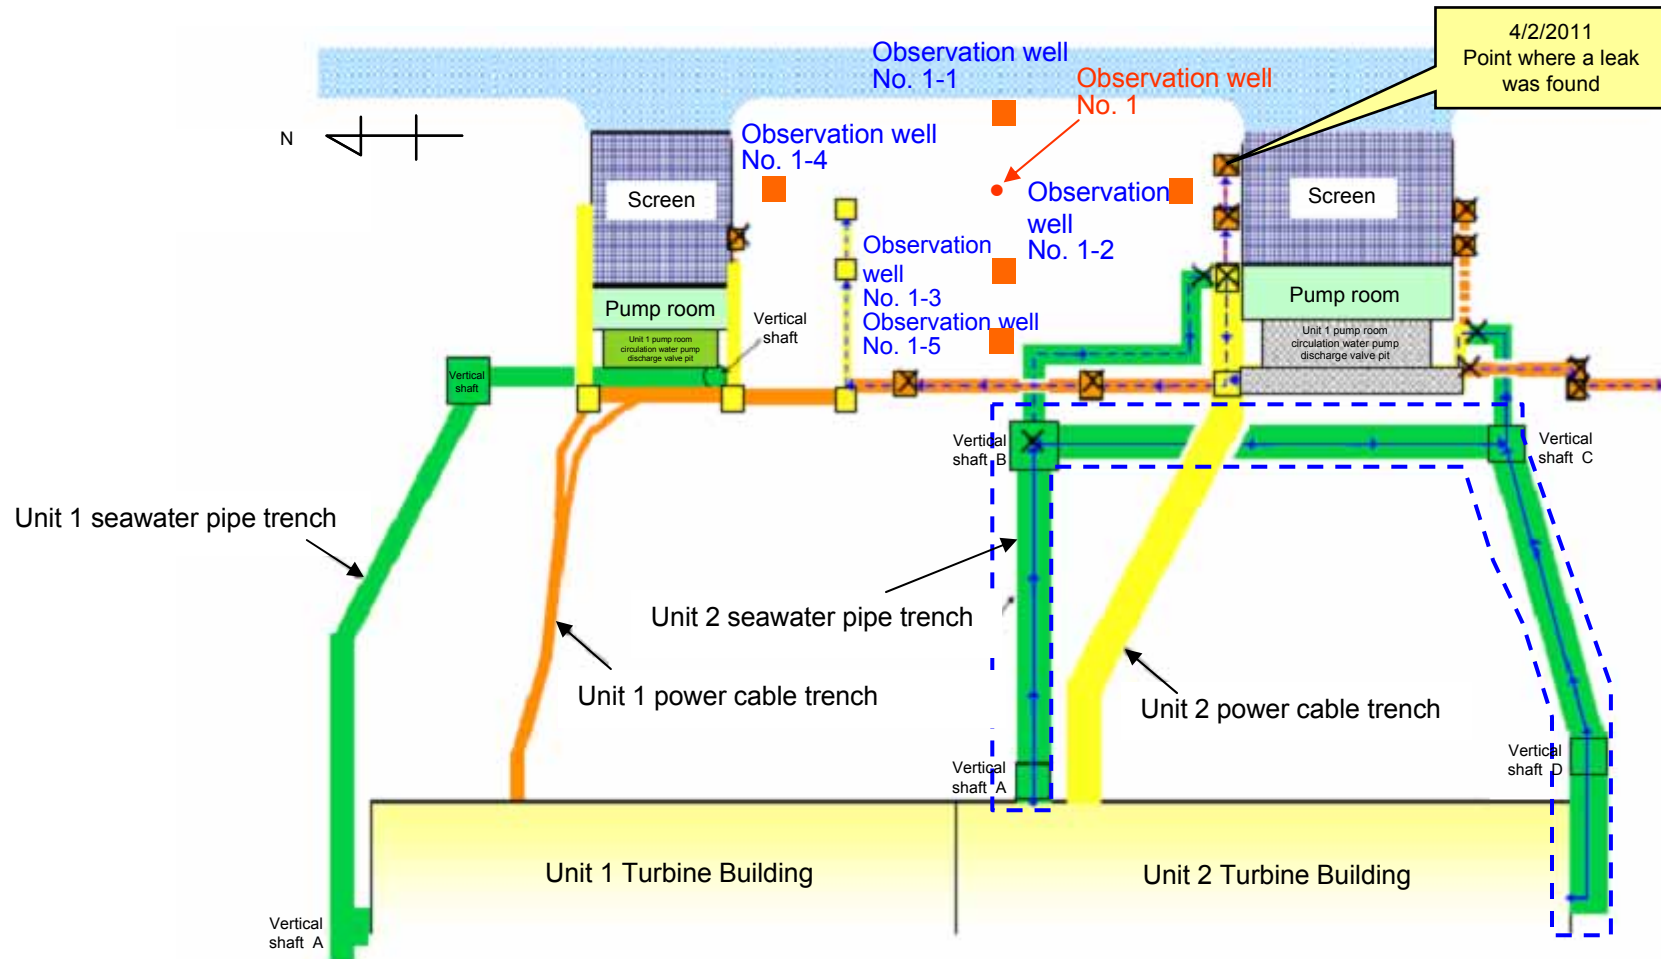
Immediately after the accident, highly contaminated water under the turbine buildings was discharged into the port through the underground trenches.

- Immediately after the accident, contaminated water accumulated in the buildings had outflowed into the ocean from water intake through trenches, etc.
 - Outflow was already stopped but contaminated water remains within the underground structure.
