Water Leakage from the Washing Tank of RO Apparatus for Unit 5 and 6 at Fukushima Daiichi NPS

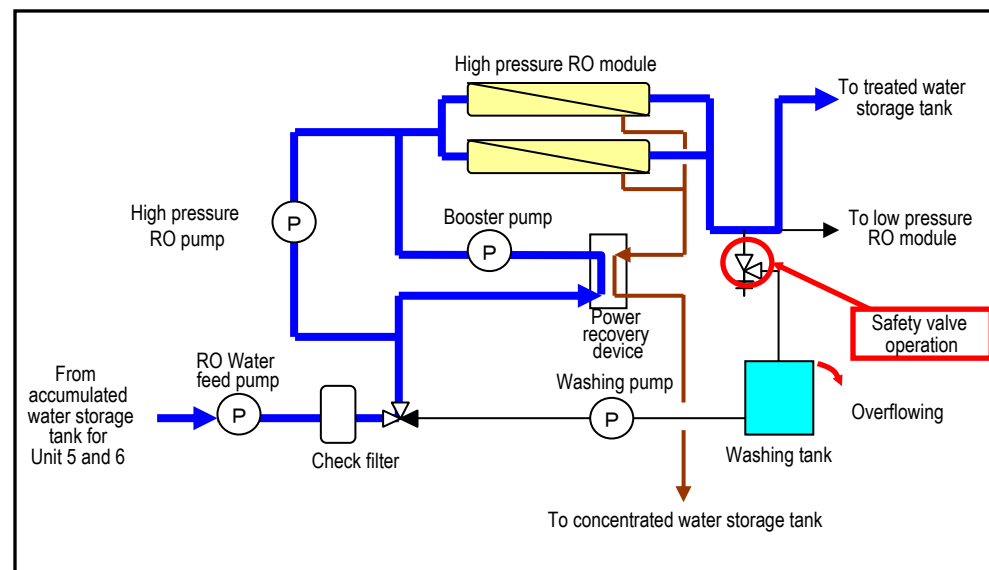
■ Structure overview of RO Unit

The point of overflowed (washing tank)

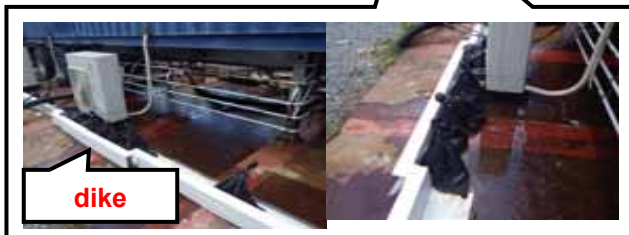
Appearance of RO Unit (vehicle-mount type)

Leakage outside the trailer
