Fracture Found on Steel Members (Diagonal Bracings) in the Intermediate Section of the Exhaust Stack for Units 1 and 2 at Fukushima Daiichi NPS

September 18, 2013

Tokyo Electric Power Company

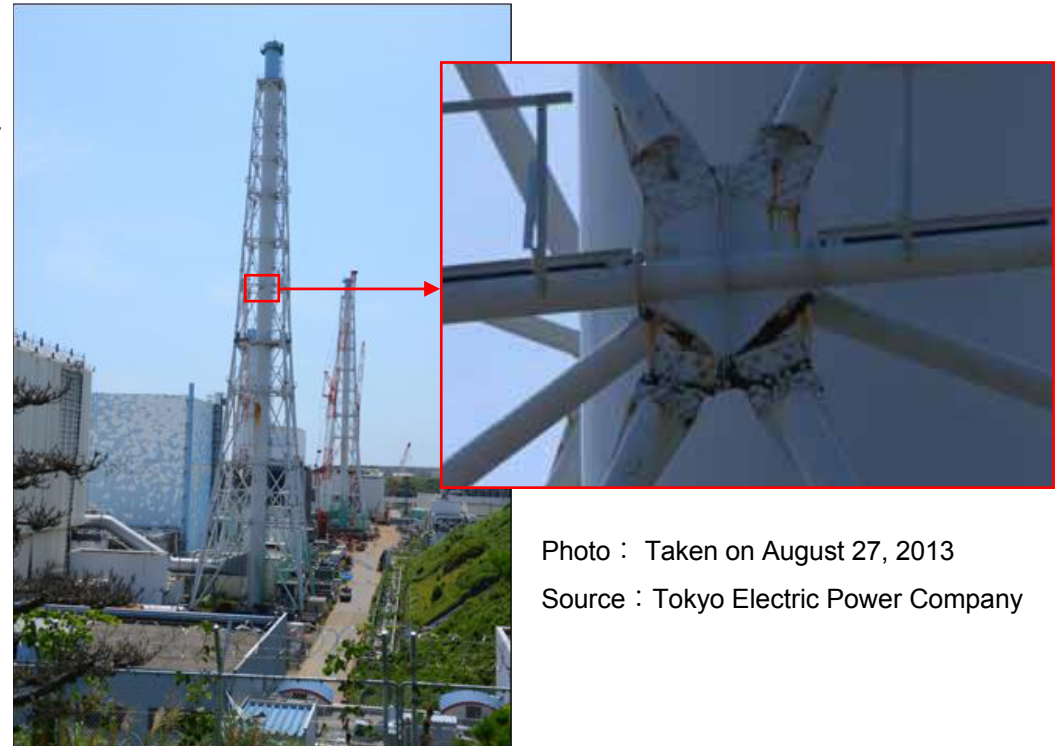
Photo : Taken on August 27, 2013

- We have been conducting an on-site inspection for seismic safety evaluation on the exhaust stack* for Units 1 and 2 at Fukushima Daiichi NPS. Today (on September 18, 2013), in the inspection, we found fracture on steel members (diagonal bracings) of the exhaust stack.
 - Although the main body and the principle members are estimated to be safe, we found fracture, fracture-like traces, and rust at 8 out of 440 points of the questioned exhaust stacks. We continue to monitor and analyze the situation.
 - The exhaust stack in question has been out of use.
- ## [Schedule in future]
- As high radiation dose is detected in the stack area, investigations will be performed after the details of investigations are examined.
