Condition of the Bank Protection Area at Fukushima Daiichi Nuclear Power Station

<Reference>
September 18, 2013
Tokyo Electric Power Company

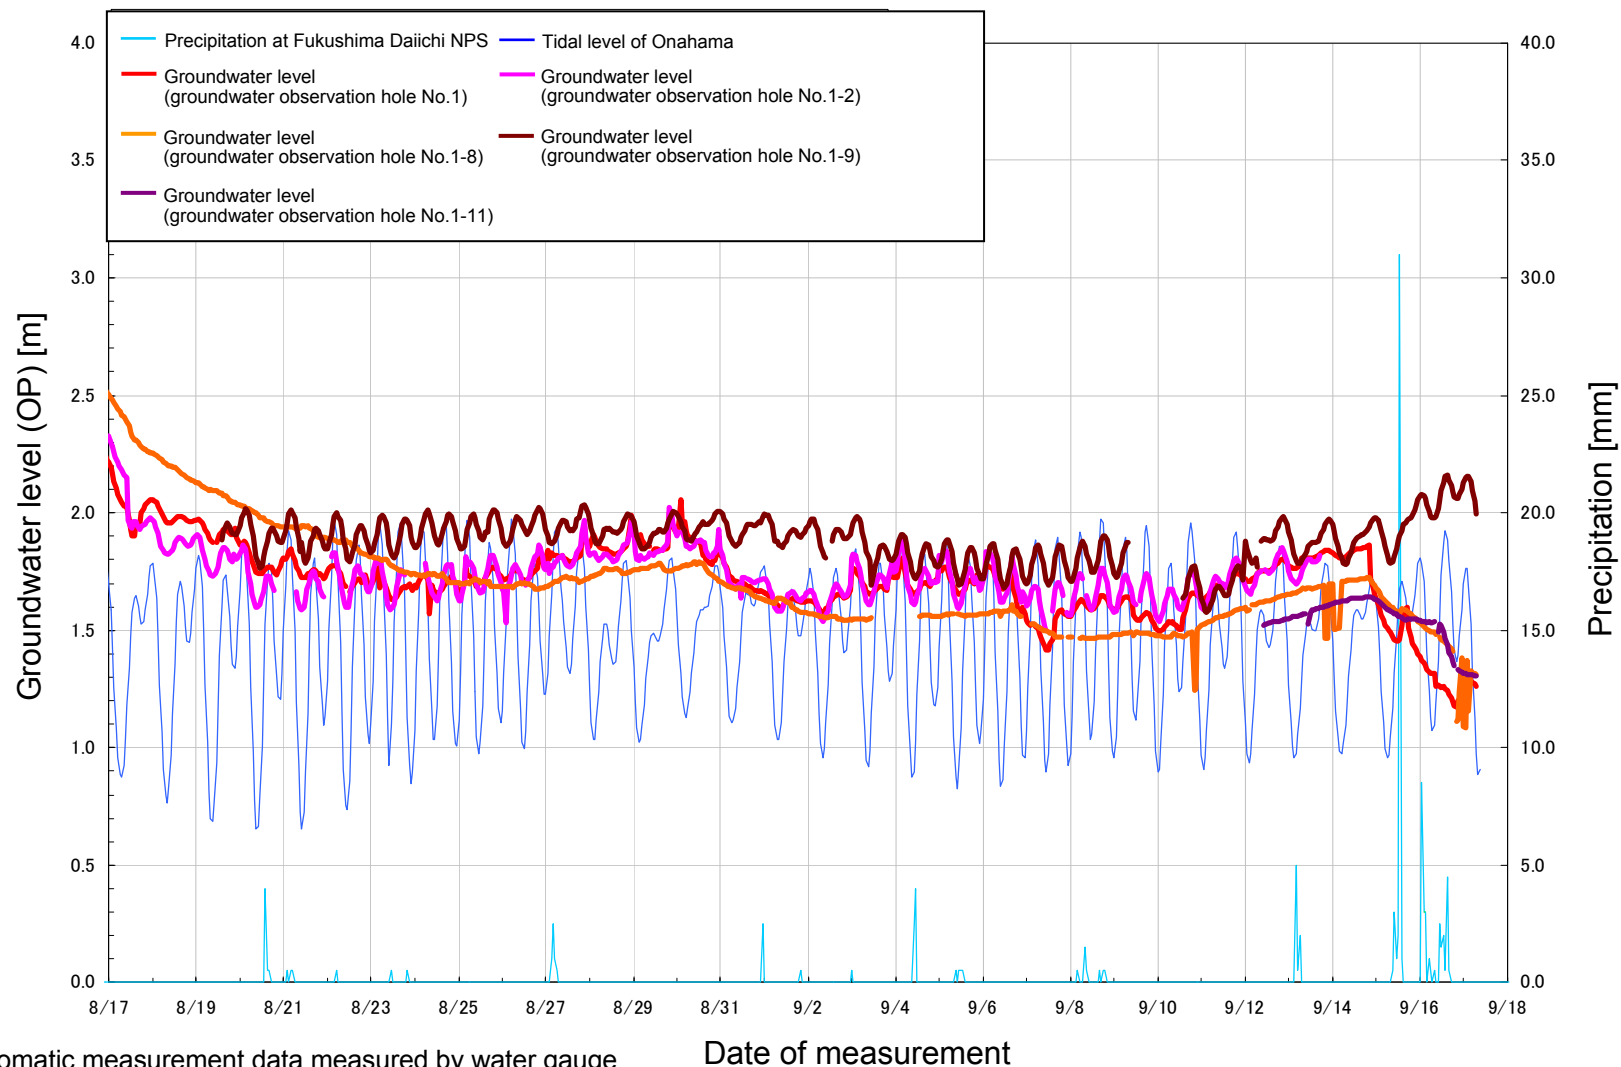
■ Transition of the groundwater level between Unit 1 and 2 (August 17 - September 17)

* No measurement could be performed at the groundwater observation hole No.1-3, since chemical has flowed into the hole. A water gauge has temporarily removed from the groundwater observation hole No.1-5 due to the ground improvement work. As for the ground observation hole No.1-9, there are some measurement results missing due to failure of the water gauge.

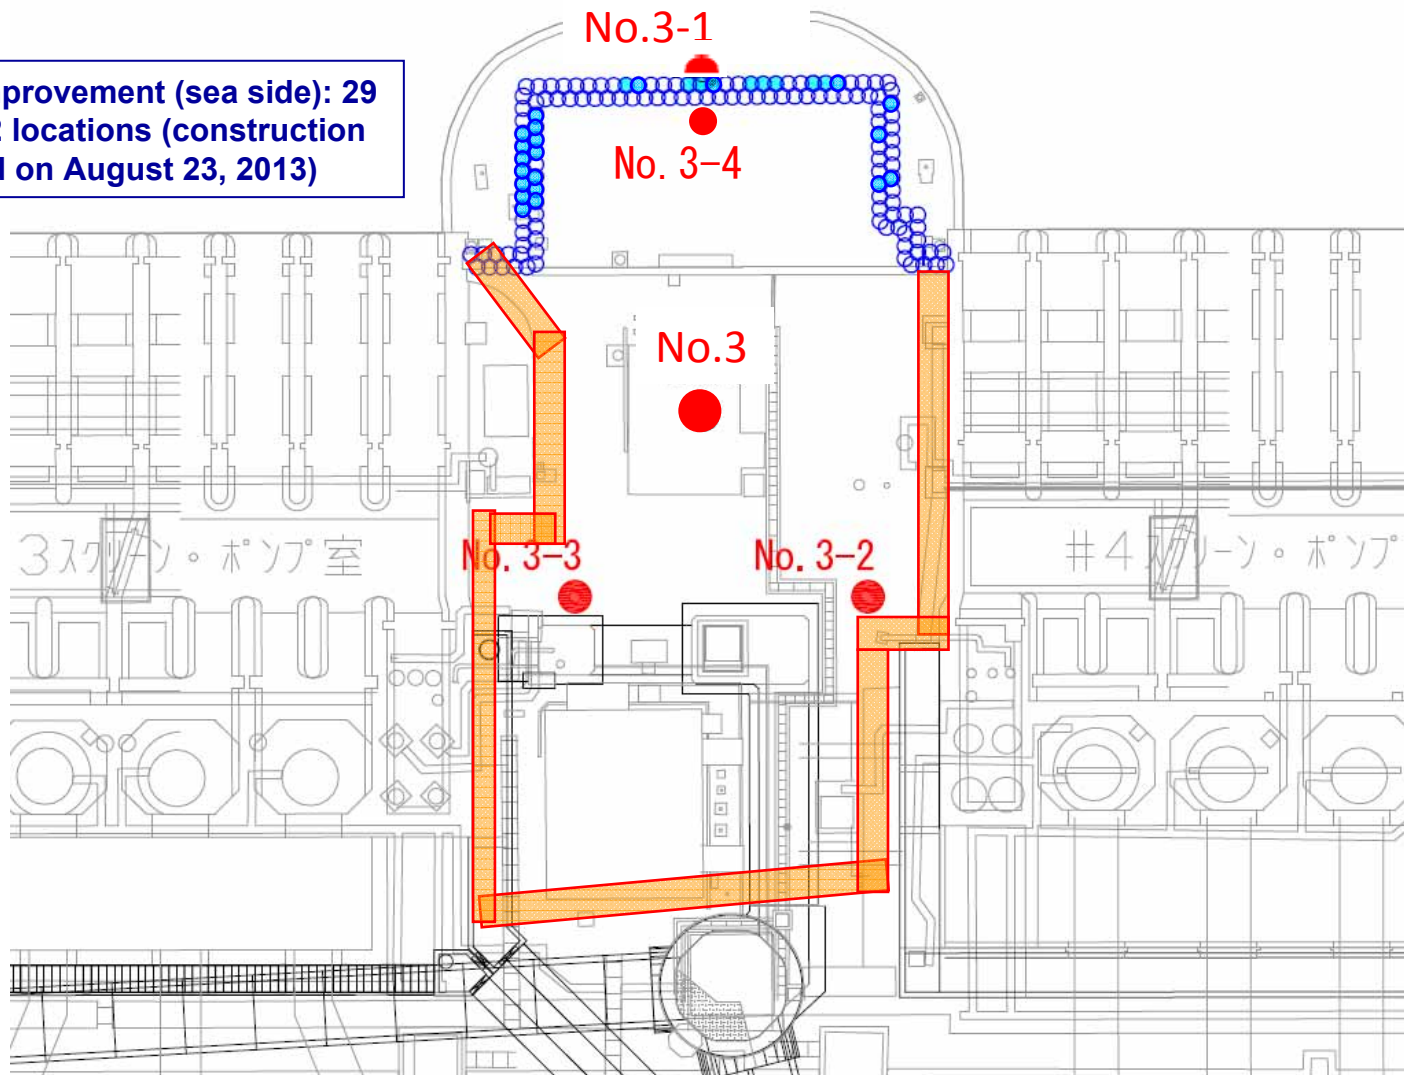
■Progress Status of Ground Improvement Construction between Unit 3 and 4 (As of the Morning on September 18)

Ground improvement (sea side): 29
out of 132 locations (construction
started on August 23, 2013)

*2 Groundwater observation hole No.3-1 will be not in use due to the ground improvement construction.
