Cause of and Countermeasures against Water Leakage from a Washing Water Tank in the RO Apparatus of Units 5 and 6 at Fukushima Daiichi NPS

<Reference>
September 24, 2013
Tokyo Electric Power Company

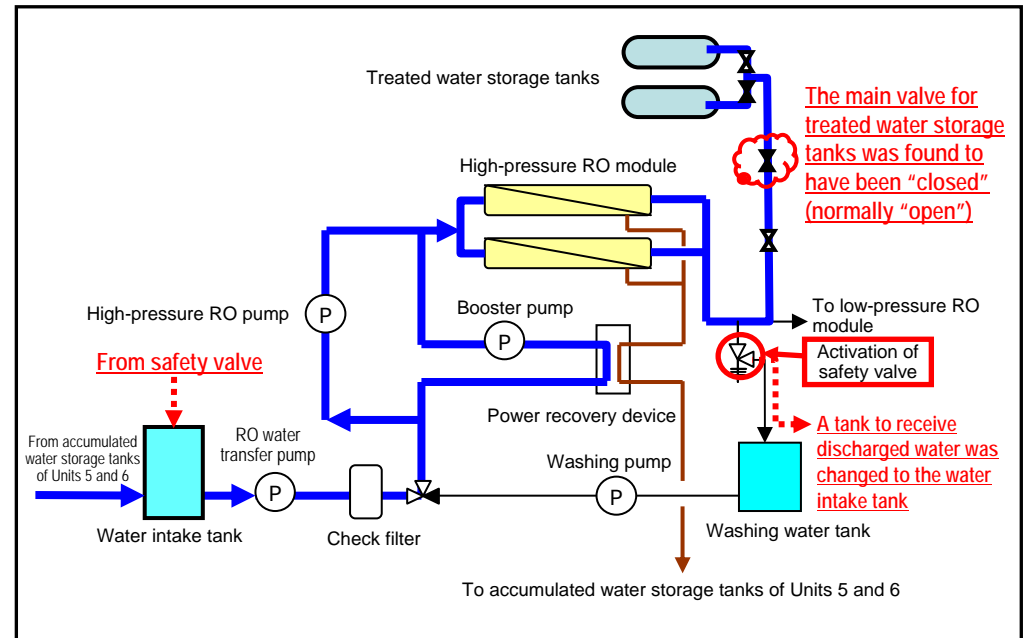
Schematic system diagram of an RO unit

- A worker who was conducting work nearby might have unintentionally touch the handle of the main valve of treated water storage tanks from the RO apparatus, and the valve might have been thereby closed.
- Since the main valve for treated water storage tanks is normally open, no one checked before the start of water transfer whether the valve was open.
- Water transfer from the RO apparatus to the treated water storage tanks was started under this condition. Therefore, the pressure at the exit side increased, and the safety valve was thereby activated. As a result, the washing water tank, which was receiving water, overflowed.

- An arrangement that enables prevention of water overflow from the washing water tank even when the safety valve is similarly activated is to be adopted, which circulates discharged water by feeding the discharged water to the RO apparatus's water intake tank located upstream, thereby preventing the water overflow.
- The handles of ball valves are to be detached from this valve and other similar valves that are operated normally "open" or "closed", and a warning notice is to be attached to each of them.
- The operation procedure is to be revised in such a manner as to require a worker to confirm that any valve included in the system is properly "open" or "closed" even in a case where the valve is usually not to be operated.
