Overflow of Water from the Notch Tank for H6 Area Located on the East of H5 Area at Fukushima Daiichi NPS (Follow-up Information)

<Reference>
October 2, 2013
Tokyo Electric Power Company

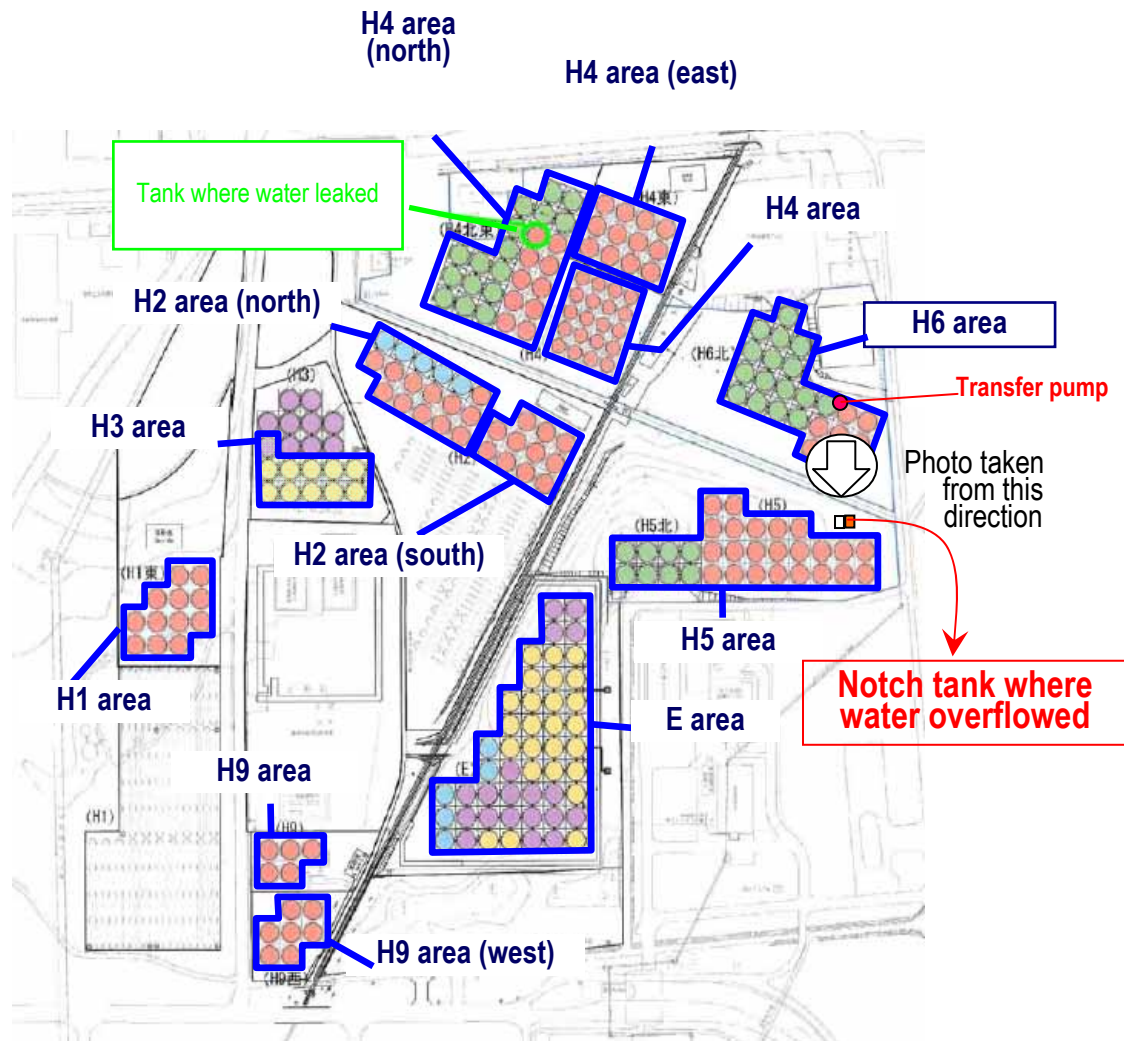
<Location and situation of the tank with water leak>

- Date : On October 1, 2013 (Tue.)
 - At 10:38, we activated the operation of the transfer pump from inside the dike at H6 area.
 - At 11:50, we found the water overflow from the notch tank for H6 area.

- At 12:10, we suspended the operation of the transfer pump, and found no more water overflow from the notch tank.
- Location: At the notch tank for H6 area on the east of H5 area

- Details : A TEPCO employee started transferring rainwater inside the dike at H6 area into H2 area (south), for the purpose of preparing for an approaching typhoon. The transfer hose should have been connected to H2 area (south), but actually was connected to the notch tank for H6 area. It caused the water overflow from the notch tank after activating the operation of the pump.

- Amount of overflow: Approx. 5m³
- Radioactive density (water analyses):
 - Inside the notch tank (sampled on Oct. 1) :Cs134 : 8.0Bq/L, Cs137 : 16Bq/L, all-β : 390Bq/L

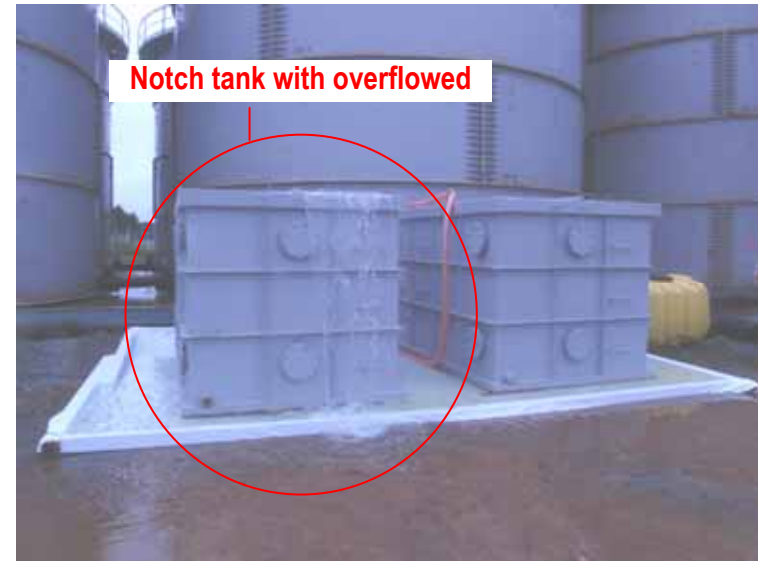
<Before suspending the pump>

Photo taken by Nuclear Regulatory Commission on October 1, 2013

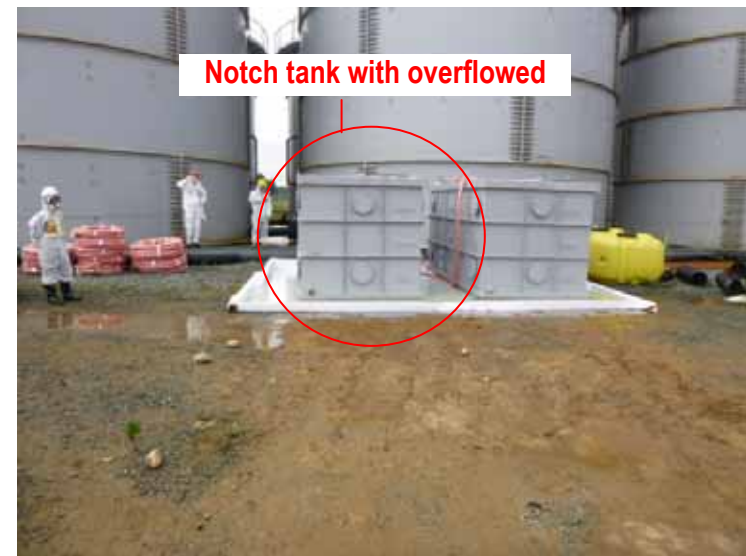
<After suspending the pump>

Photo taken by TEPCO on October 1, 2013

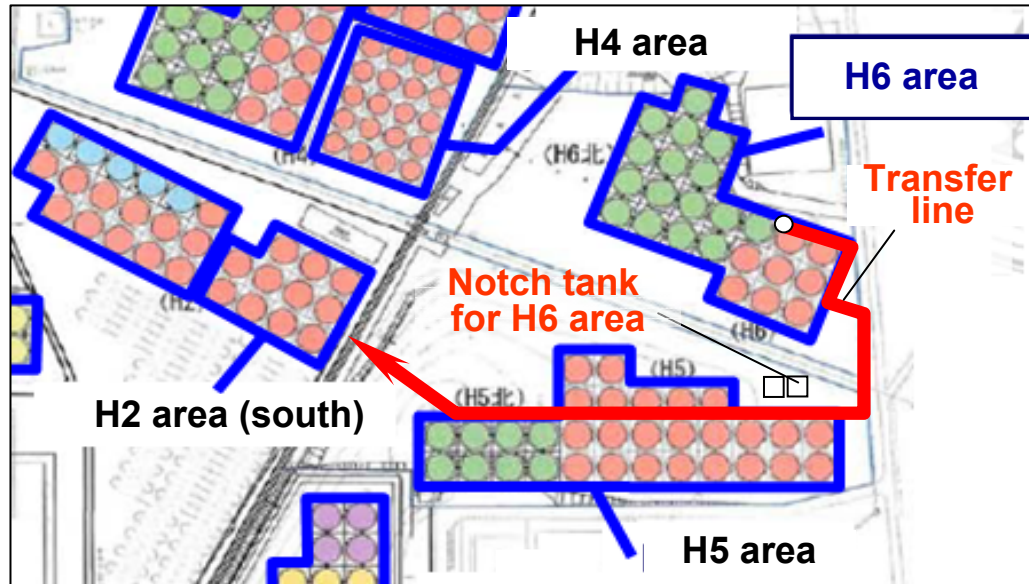
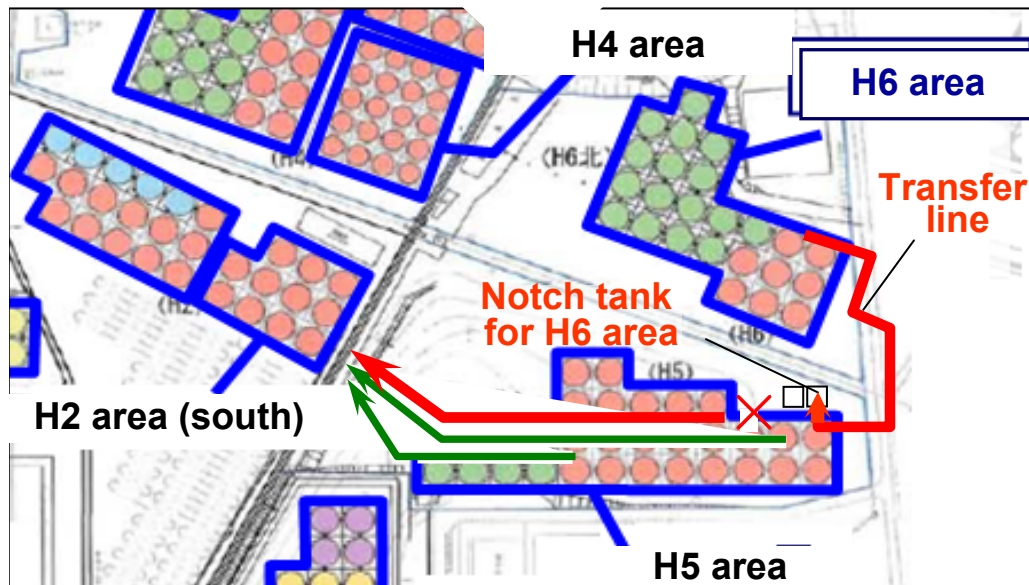
<Causal sequence>

- On October 1, we were planning to 1) transfer water from inside the dike at H6 area to H2 (south) area, and 2) install a transfer line connecting from inside the dike at H6 area to the notch tank for H6 area.

- TEPCO requested an associated company to install a transfer line connecting from inside the dike at H6 area to the notch tank for H6 area urgently.
- Upon the request by TEPCO, the associated company created a transfer line connecting to the notch tank for H6 area, namely, borrowed a part of the existing transfer line originally connecting to H2 (south) area, and changed the connecting direction. (At around 10:00 AM on October 1)

- We attribute this water leak to the shortage of communication on “work method” and “work schedule” between the associate company and TEPCO.
- Although configurations of the line formation prior to the transfer (from inside the dike at H6 area) and water leak from the line posterior to the activation of the pump were performed, it cannot be denied that there was misjudgment, for another two more lines connecting from inside the dike at H5 area (the two green lines in the map) were laid near the concerned transfer line.
