<Reference>
October 7, 2013
Tokyo Electric Power Company

Seismic Safety Evaluation of Fukushima Daiichi NPS Units 1 and 2 Exhaust Stack Having Damaged Components

Inspection of Units 1 and 2 Exhaust Stack

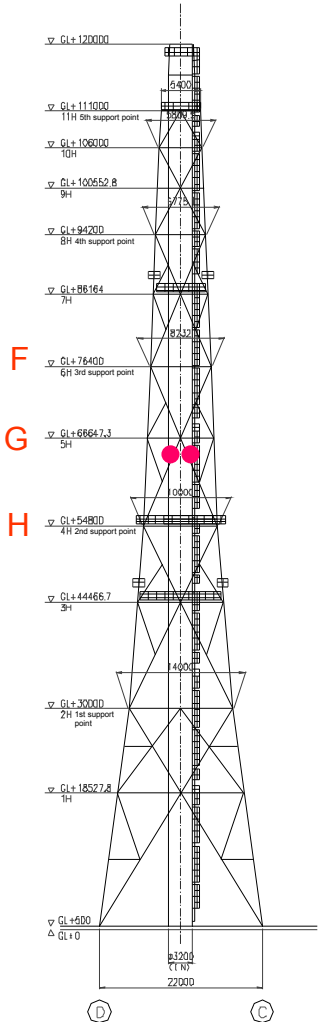
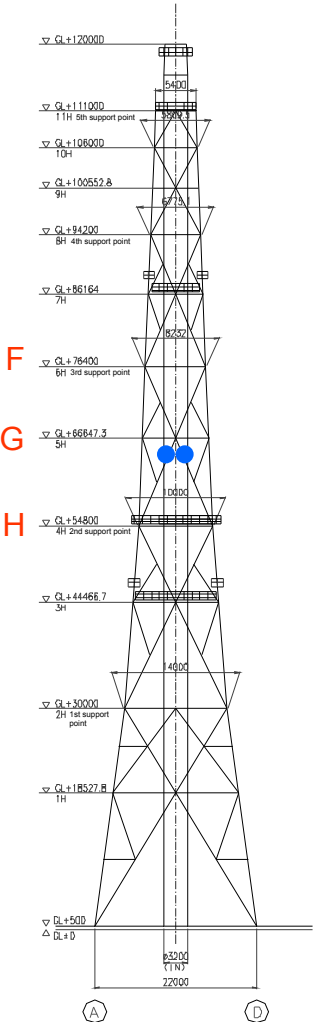
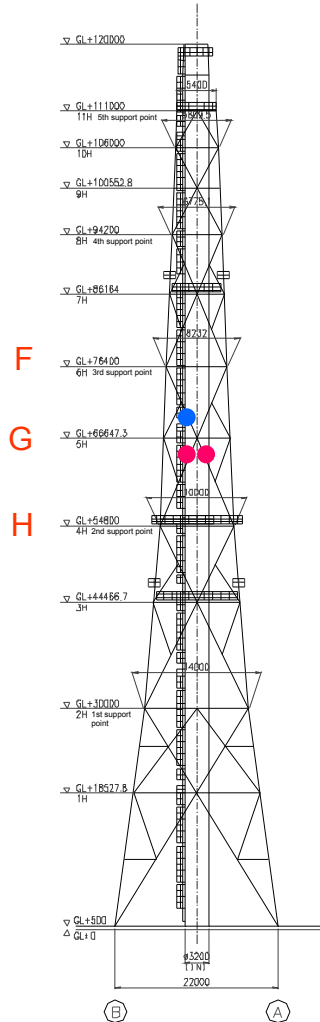
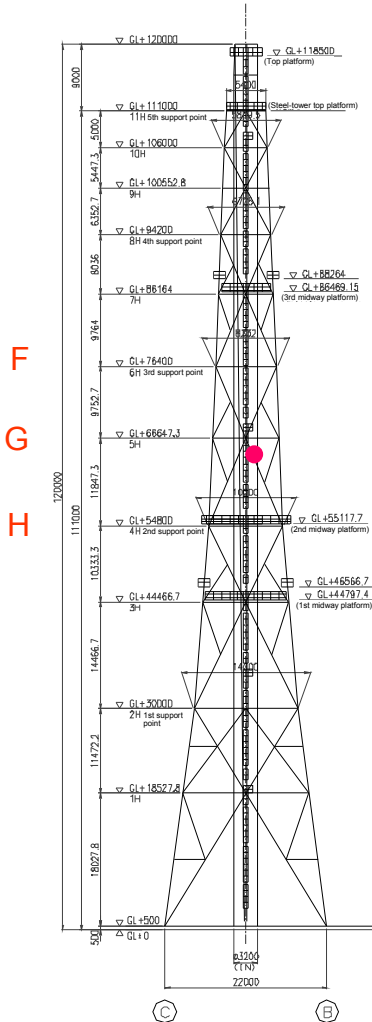
- Breakage: 5 locations (2 on the north side, 2 on the south side, and 1 on the west side)

- Deformation: 3 locations (2 on the east side and 1 on the south side)

All of the above locations are found at the joint sections of the diagonal bracings near 66 m above ground (O.P. +76 m).

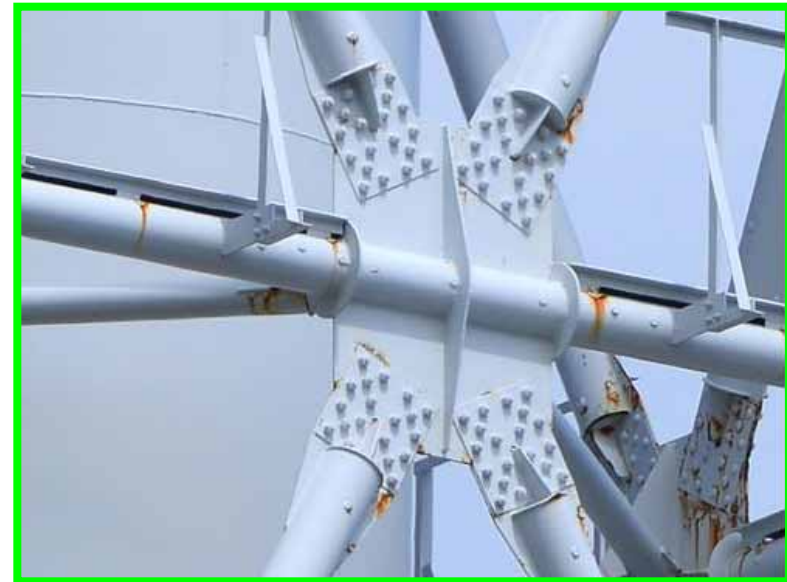
Example of a location judged sound

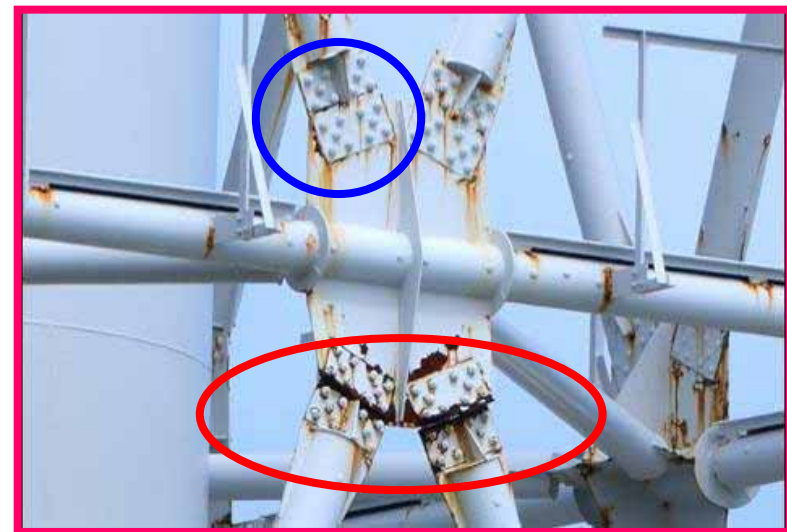
Examples of locations judged as those of breakage and of deformation

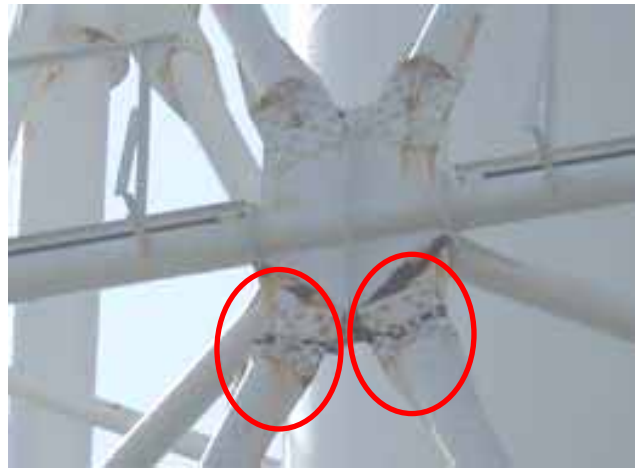
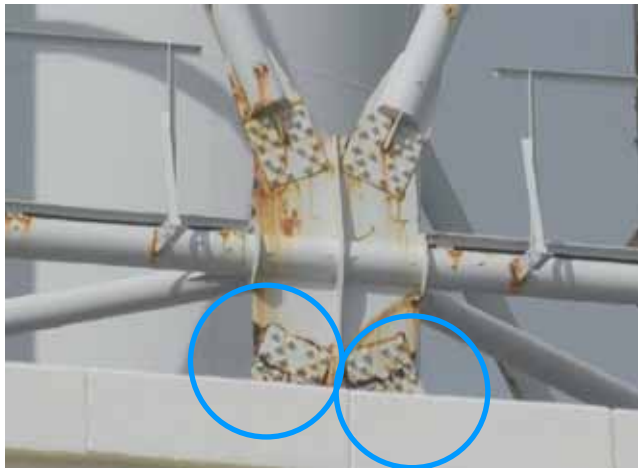
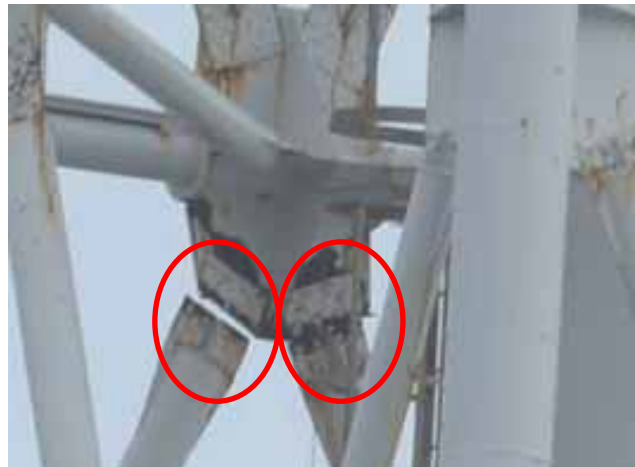
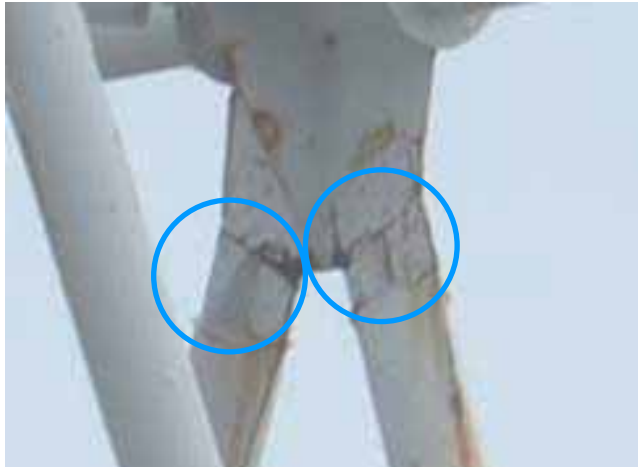
North side	East side
Outer side

Notes	Breakage is found at 2 locations in the lower side of the joint section 66 m above ground.	Deformation is found at 2 locations in the lower side of the joint section 66 m above ground.

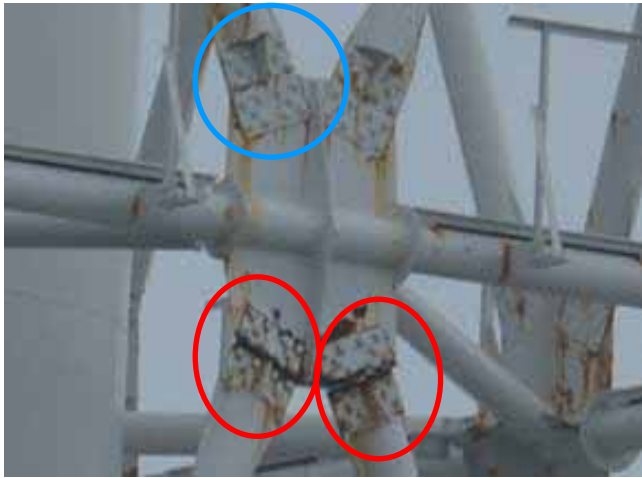
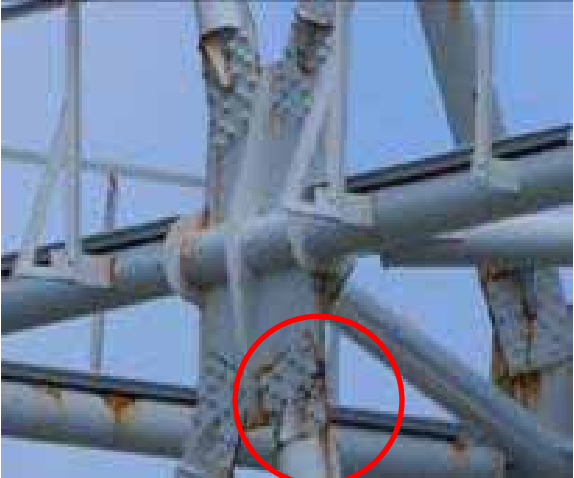
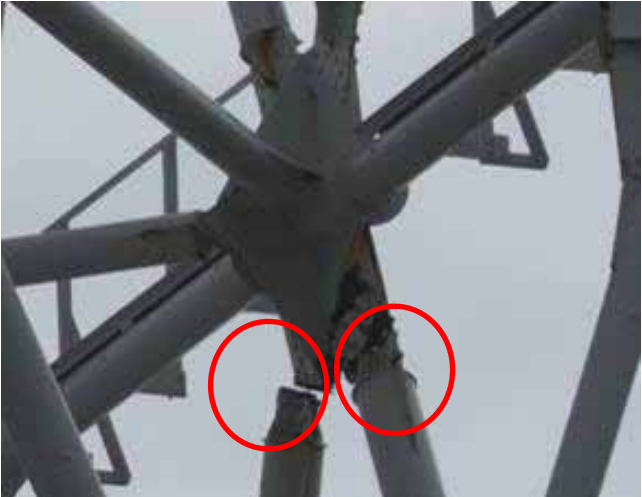
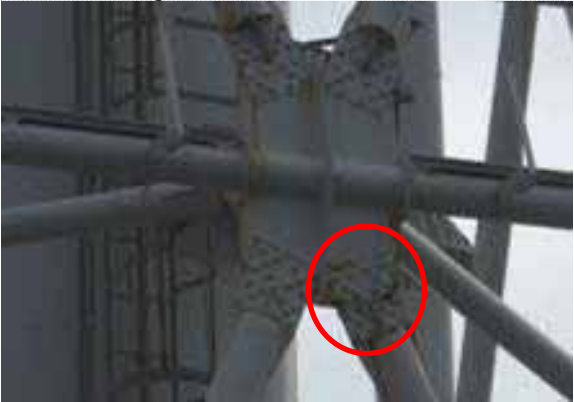
South side	West side
Outer side

<p>* It was difficult to take photos of the inner side of the west side, so we took this photo from a different angle.</p>

Notes	Breakage is found at 2 locations in the lower side and deformation at 1 location in the upper side of the joint section 66 m above ground.	Breakage is found at 1 location in the lower side of the joint section 66 m above ground.

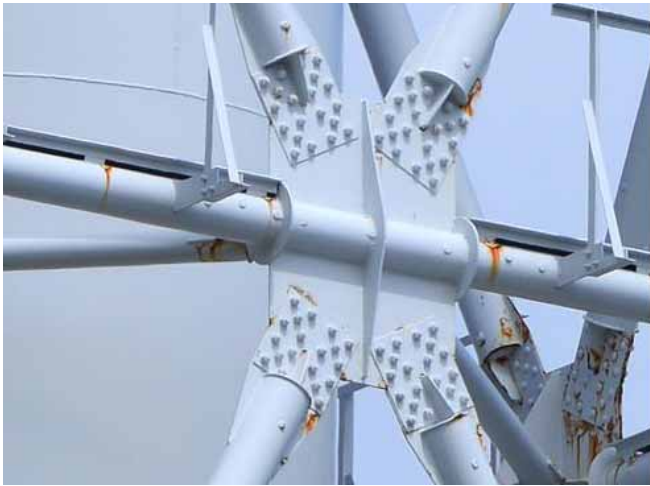
① South side (around 100 m above ground)
A joint section

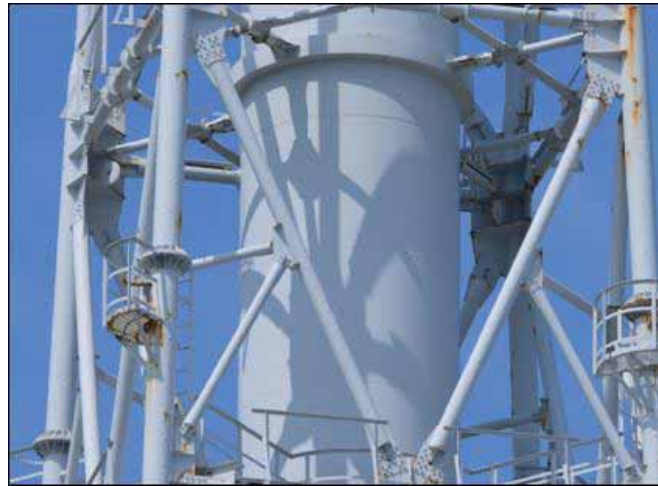
② East side (around 82-94 m above ground)
Stack shaft of the exhaust stack

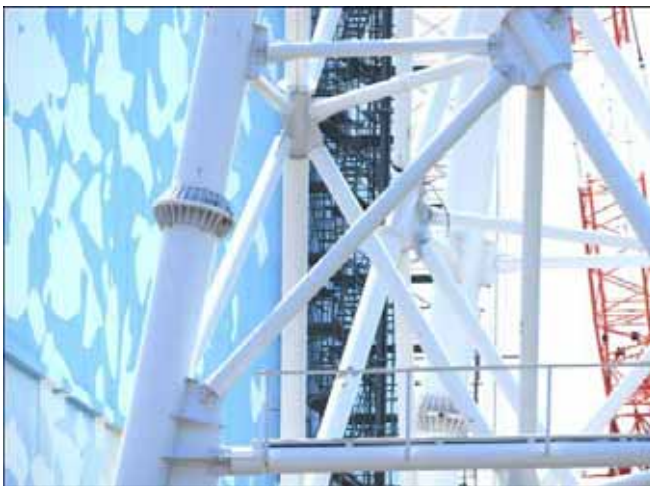
③ North side (around 19-30 m above ground)
A principal post and diagonal bracings

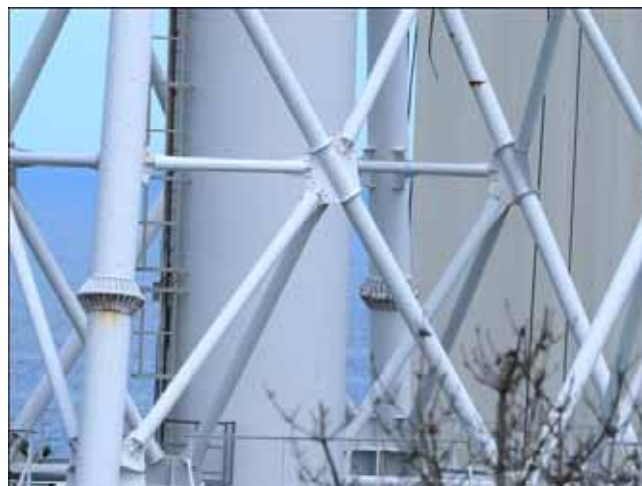
④ East side (around 19-30 m above ground)
Stack shaft of the exhaust stack

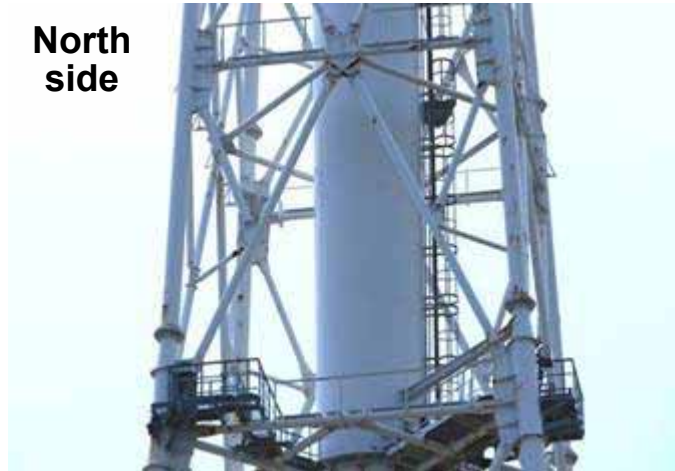
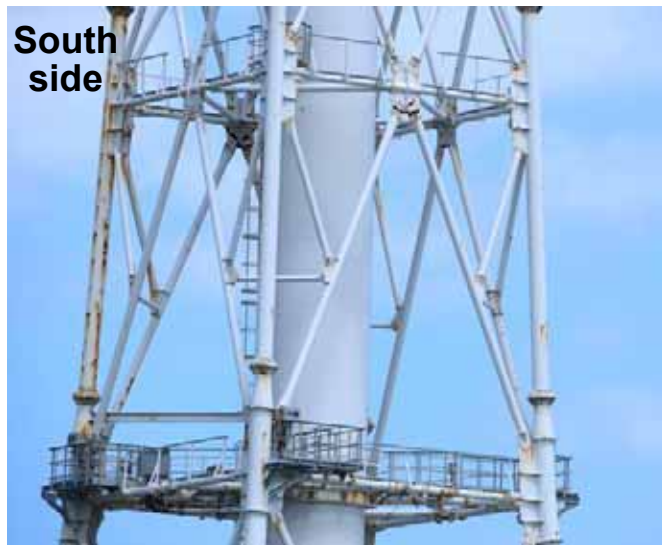
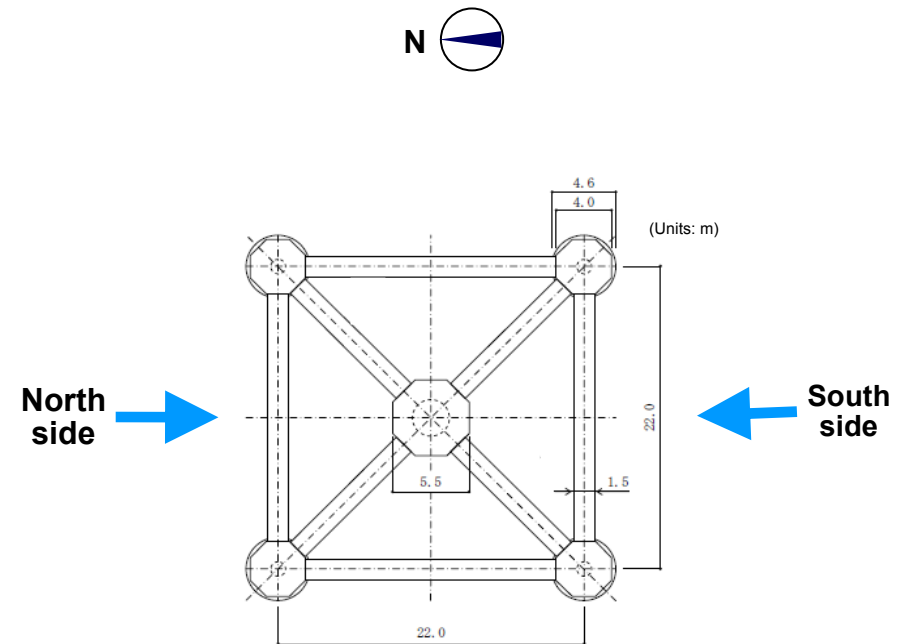
Inspection results [6] (Between levels G and H of the steel tower)

- Breakage was found at 5 locations between levels G and H of the steel tower.
- Deformation was found at 2 locations between levels G and H, and at 1 location between levels F and G, of the steel tower.
- With respect to the post base part, neither the steel tower nor the concrete foundation was in a bad condition.

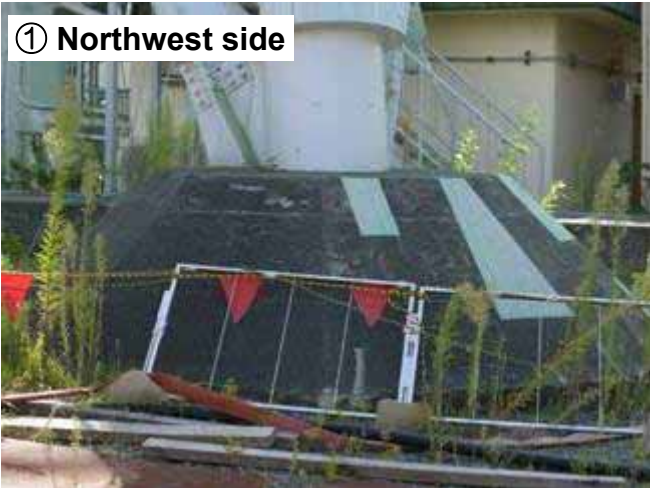
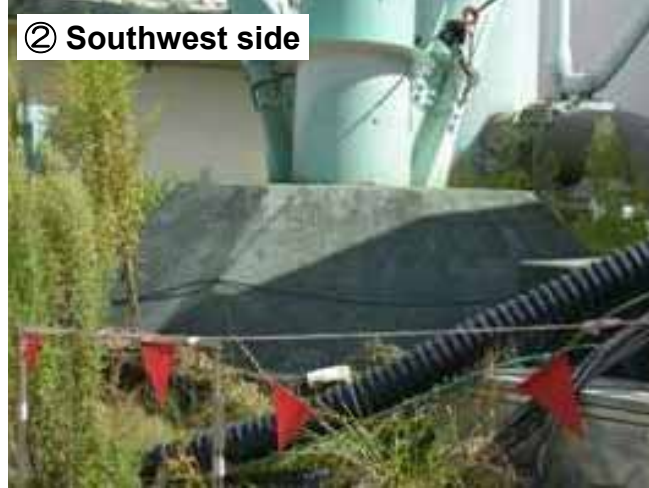
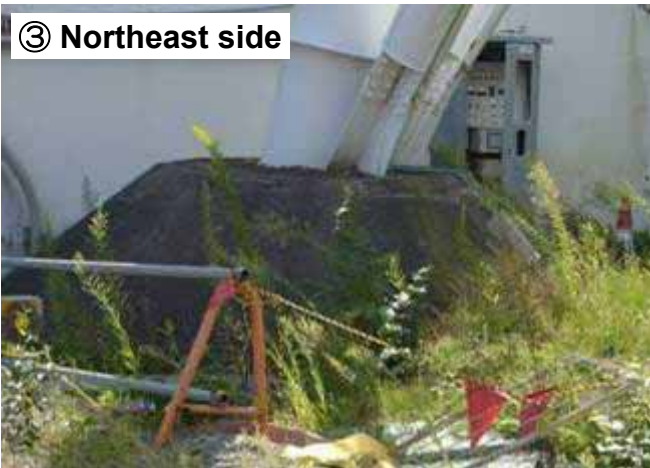
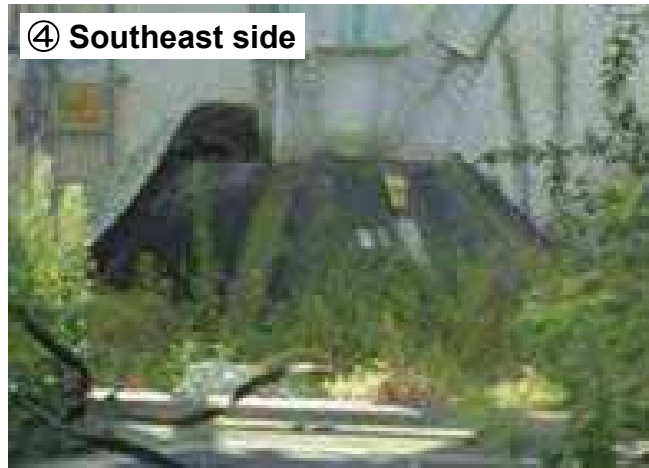
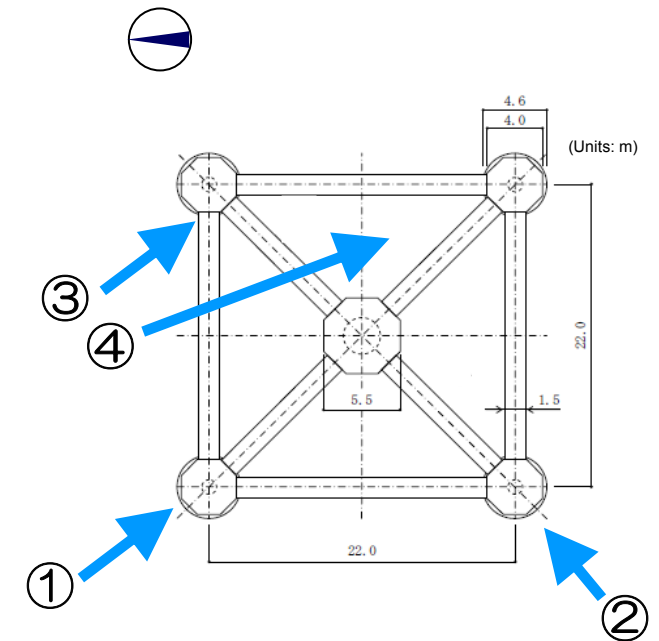
Inspection results [7] (Post base section)

With respect to the post base part, neither the steel tower nor the concrete foundation was found to be in a bad condition.

* The post base section's southeast side ④ is a high radiation dose spot, and was photographed from a road.
