Leakage of Water Accumulated inside a Dike and High Dose Rate Locations, Found in Tank Areas at Fukushima Daiichi NPS

<Reference>
November 11, 2013
Tokyo Electric Power Company

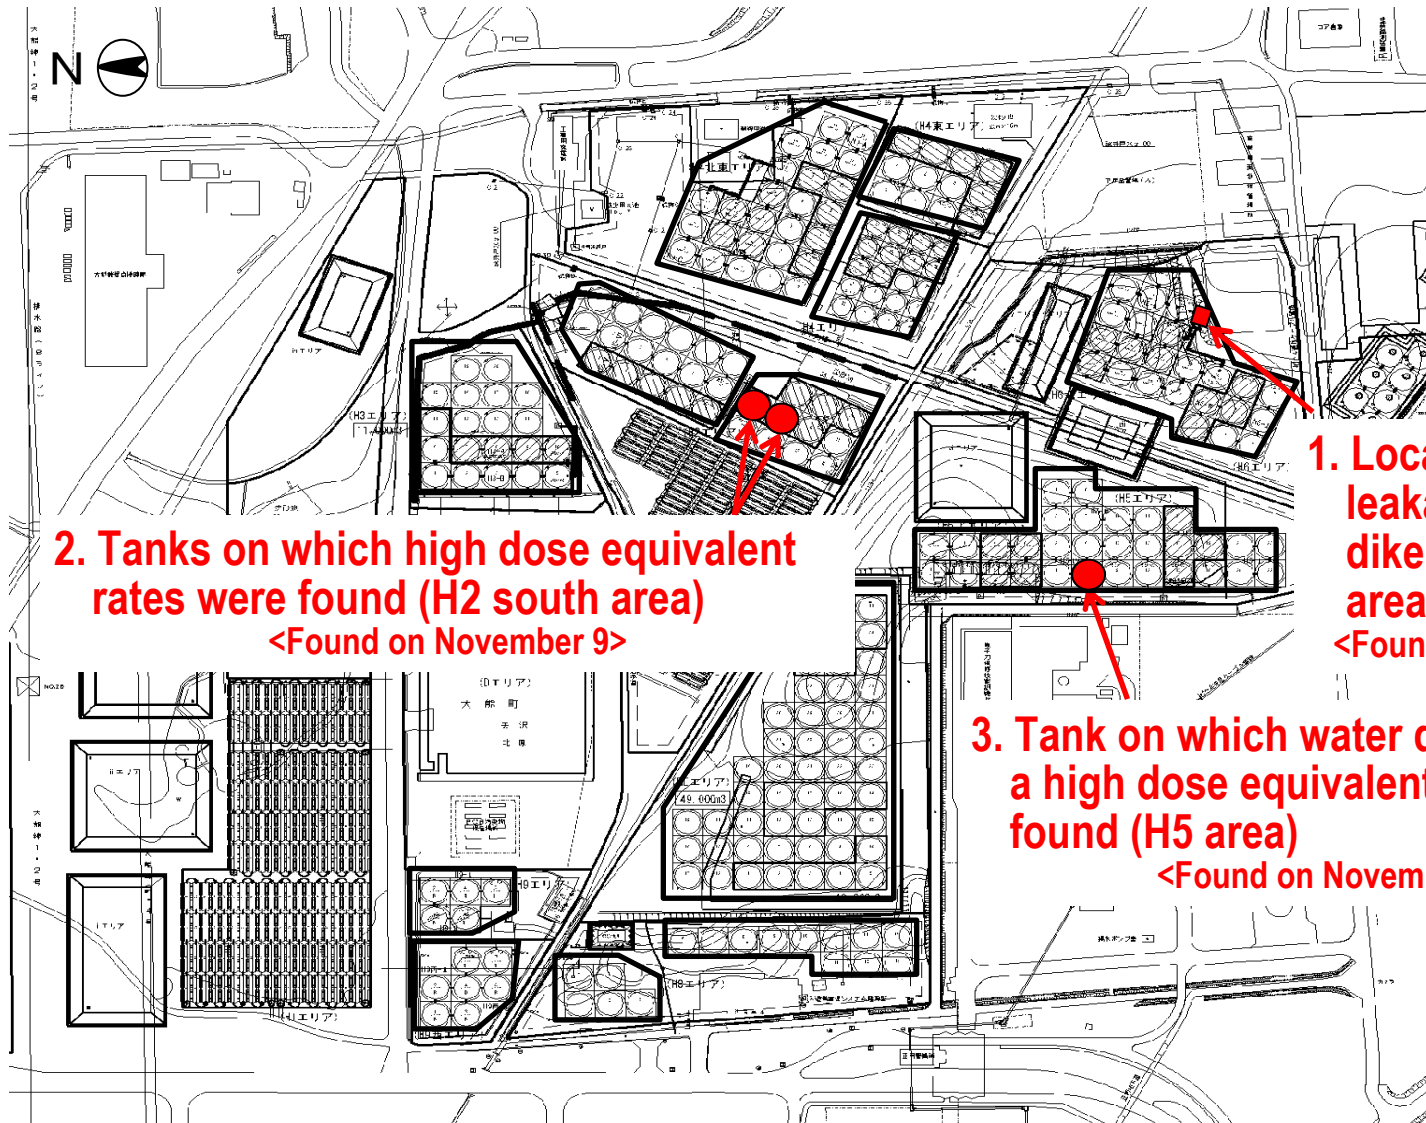
2. Tanks on which high dose equivalent rates were found (H2 south area)
<Found on November 9>

1. Location at which leakage from the dike was found (H6 area)
<Found on November 9>

3. Tank on which water drop traces and a high dose equivalent rate were found (H5 area)
<Found on November 10>

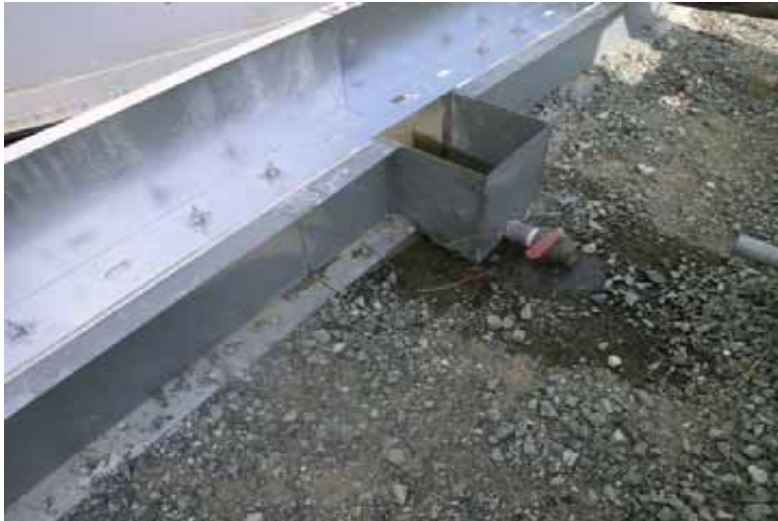
Leakage of water accumulated inside the H6 area dike

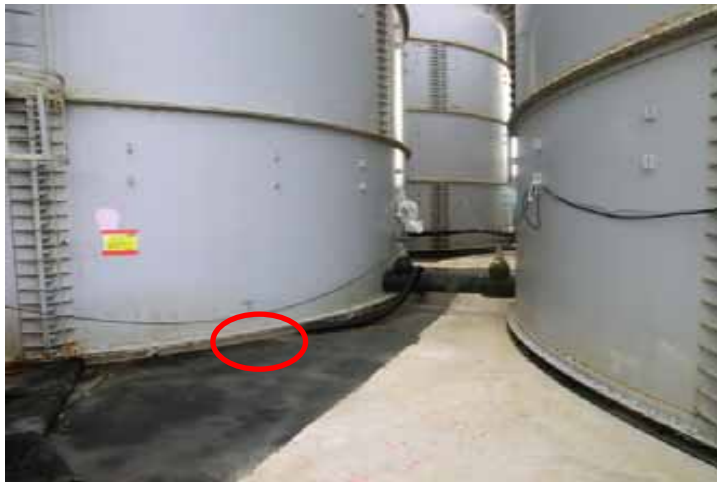
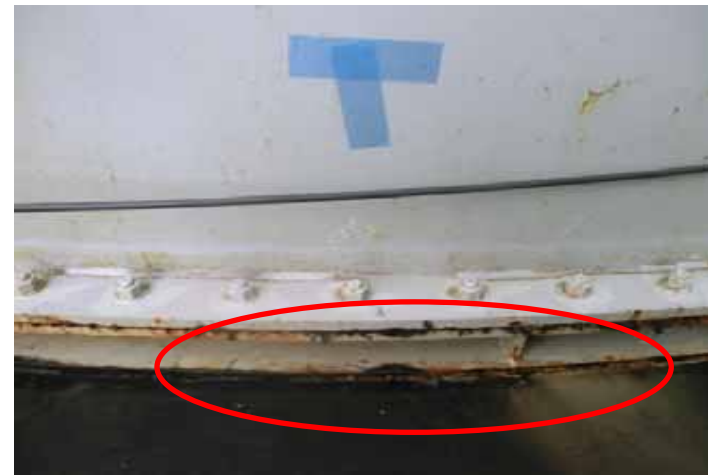
Tank H2-B-No.2

2. One of the tanks in the H2 south area on which high dose equivalent rates were found

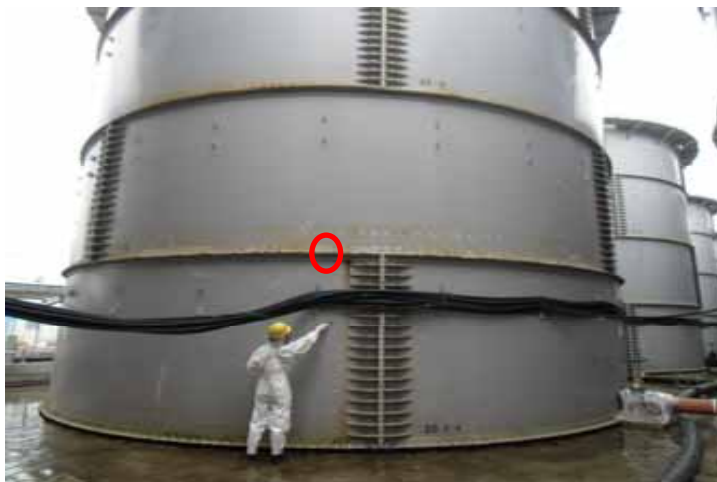
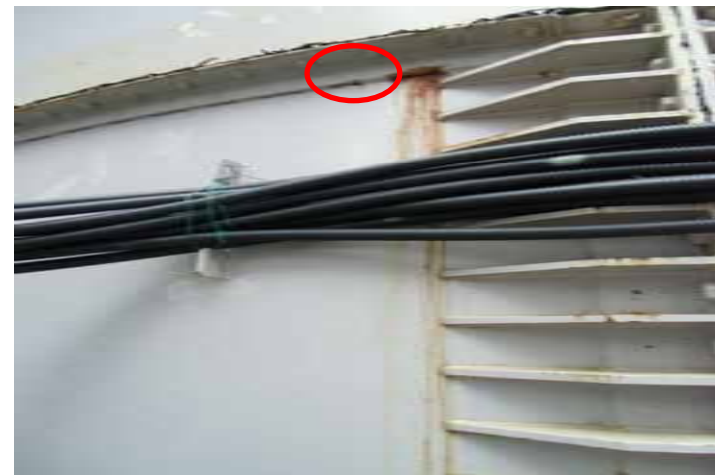
Tank H5-D-No.4

3. The tank in the H5 area on which water drop traces and a high dose equivalent rate were found
