Results of Investigation around Lower Parts of Unit 1 Vent Pipes at Fukushima Daiichi NPS (Second Day)

**November 14, 2013
Tokyo Electric Power Company**

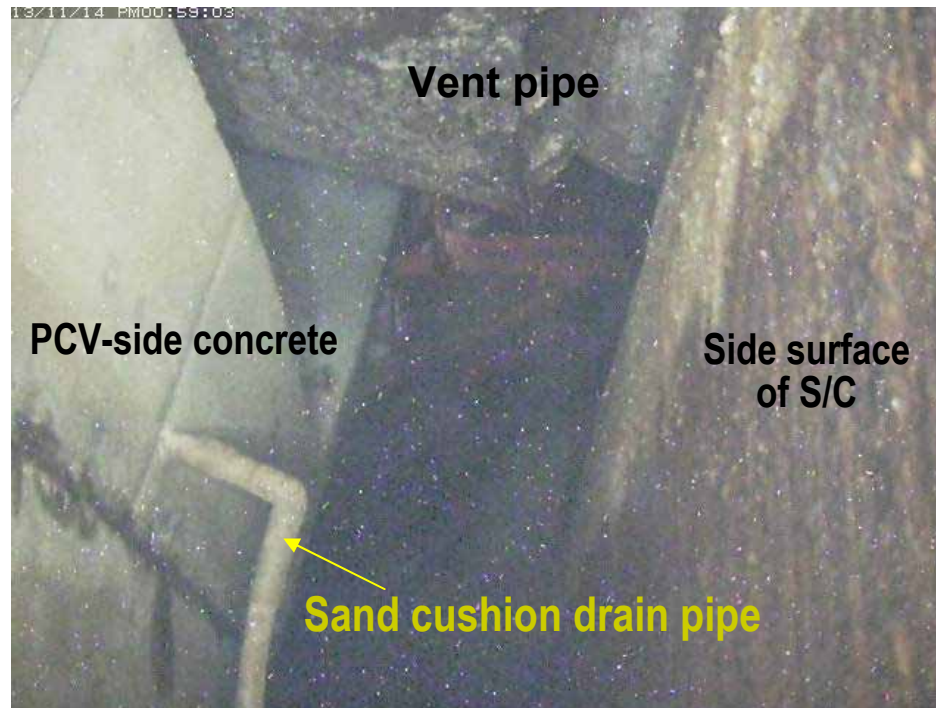
(Representative example)
Condition of the vent pipe at [5]

Investigation results on the lower parts of the vent pipes and the sand cushion drain pipes:
As a result of the investigations of the locations [5] to [8], neither leakage nor damage to the sand cushion drain pipes were found.

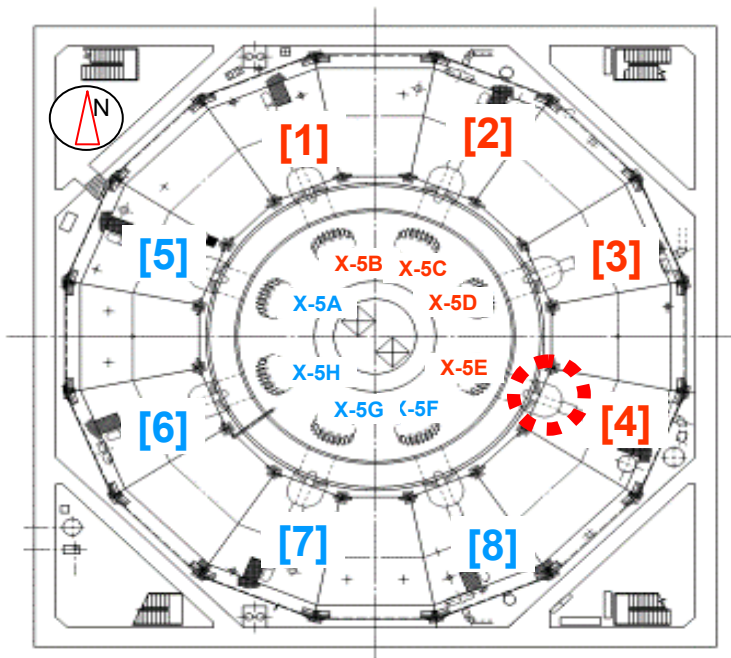
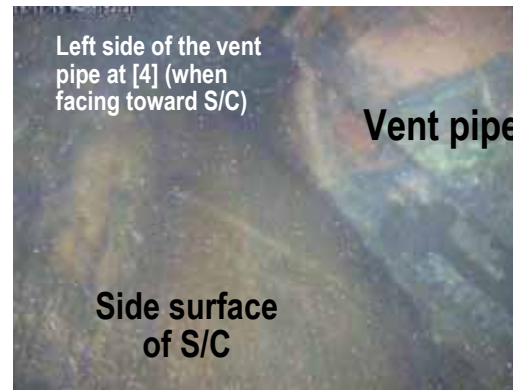
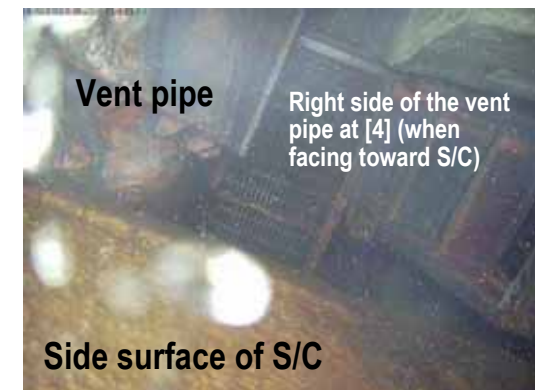
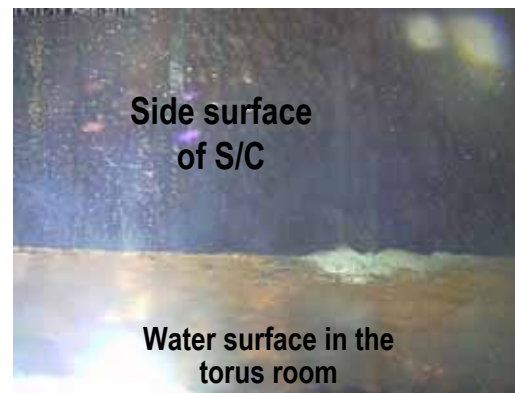
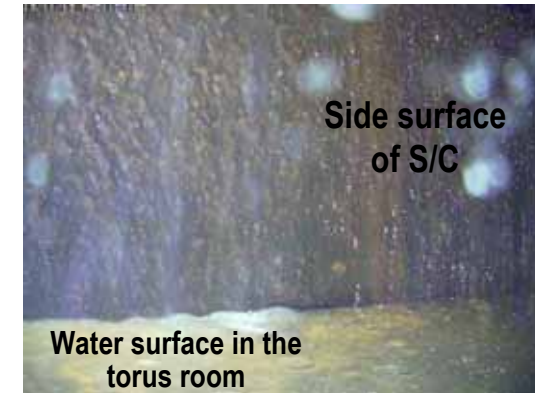
Leakage from the upper part (of the S/C facing side) of the vent pipe at the location [4] was found.

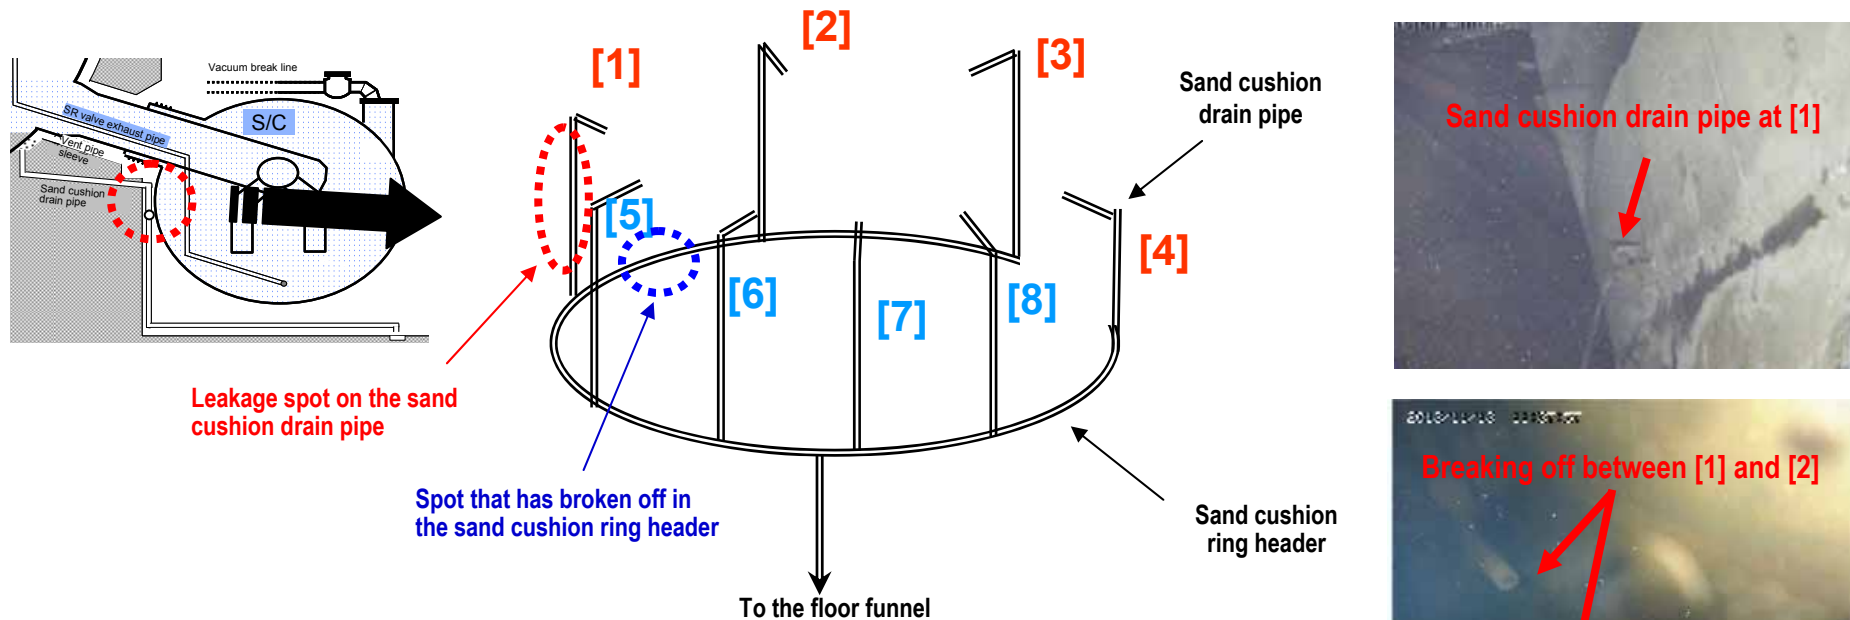
- Damage and leakage were found on the sand cushion drain pipe at [1].
- The sand cushion ring header was found to have been damaged between [1] and [2].

* The sand cushion ring header has a shape of the letter “C”. (The ring is discontinuous and has its ends at the locations [3] and [4].)
