<Reference>  
November 15, 2013  
Tokyo Electric Power Company

# Results for the Effectiveness Confirmation of Corrosion Prevention at the System C in the Multi-Nuclide Removal Equipment

# Inspection points of corrosion prevention effectiveness at System C

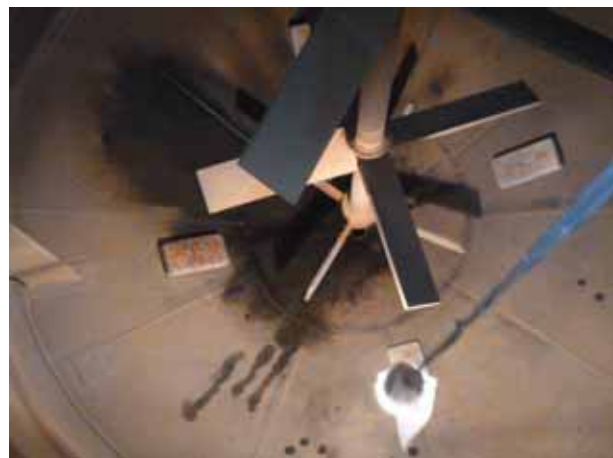
① Batch treatment tank 2C

Inspection point		Result
①	Batch treatment tank (1C and 2C) • Rubber lining (Inner inspection)	<b>No abnormality</b> • No significant damage such as defect and exfoliation with the lining
②	Slurry transfer pump outlet pipe • Flange surface • Pipe weld line	<b>No abnormality</b> • No corrosion on flange surface • No significant abrasion in gasket-type sacrificial positive electrode
③	Circulation tank • Tank weld line (UT confirmation)	<b>No abnormality</b> • No significant echo detected
④	Circulation pump 1 inlet pipe • Flange surface • Pipe weld line	<b>No abnormality</b> • No corrosion on flange surface • No significant abrasion in gasket-type sacrificial positive electrode
⑤	Decant pump outlet pipe • Flange surface • Pipe weld line	<b>No abnormality</b> • No corrosion on flange surface • No significant abrasion in gasket-type sacrificial positive electrode
⑥	Back-pulse pot 1 outlet pipe • Flange surface • Pipe weld line	<b>No abnormality</b> • No corrosion on flange surface • No significant abrasion in gasket-type sacrificial positive electrode

←  
No significant damage such as defect and exfoliation

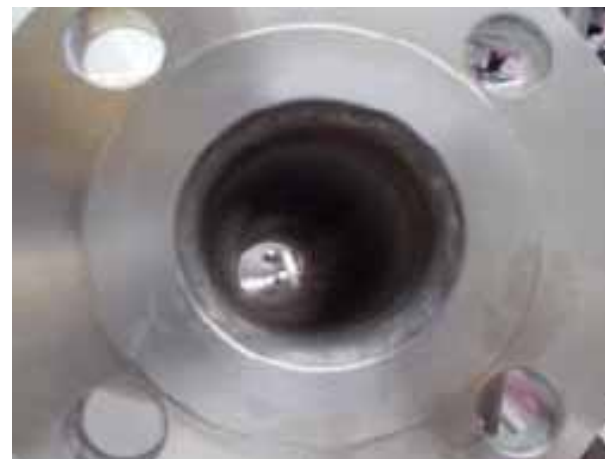
② Slurry transfer pump outlet pipe flange

←  
No corrosion on the flange sheet surface

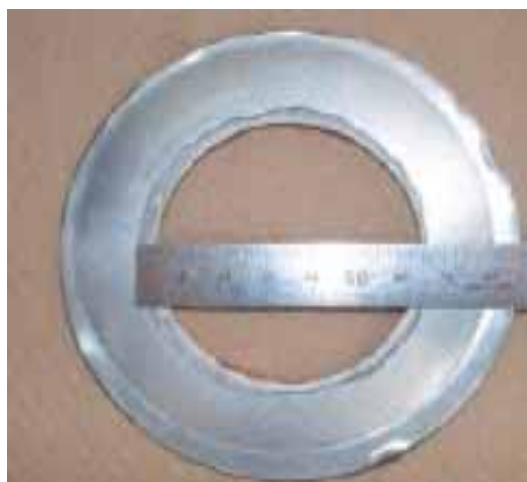
② Slurry transfer pump outlet pipe gasket-type sacrificial positive electrode

←  
A slight abrasion in gasket-type sacrificial positive electrode

( No influence on the sheet function )

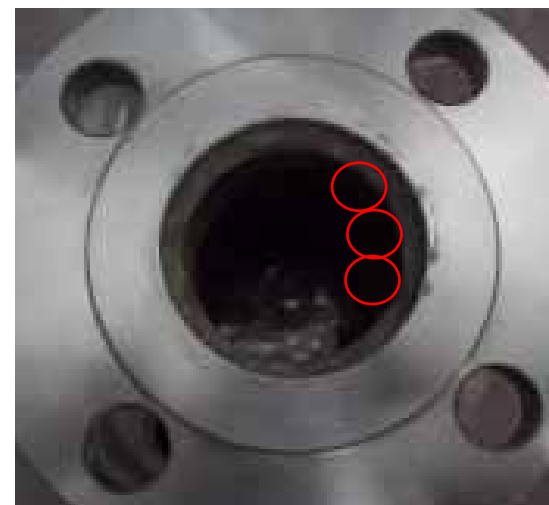
⑦ Supply pump 1 outlet pipe flange

Inspection point		Result
⑦	Supply pump 1 Outlet pipe <ul style="list-style-type: none"> <li>• Flange surface</li> <li>• Pipe weld line</li> </ul>	<b>No abnormality (a remark described below)</b> <ul style="list-style-type: none"> <li>• corrosion-like minute pits on Flange surface</li> <li>• No significant abrasion in gasket-type sacrificial positive electrode</li> </ul>
⑧	Supply pump 2 Outlet pipe <ul style="list-style-type: none"> <li>• Flange surface</li> <li>• Pipe weld line</li> </ul>	<b>No abnormality</b> <ul style="list-style-type: none"> <li>• No corrosion on flange surface</li> <li>• No significant abrasion in gasket-type sacrificial positive electrode</li> </ul>
⑨	Adsorbent tower 2 <ul style="list-style-type: none"> <li>• Inspection hole (closing flange)</li> <li>• Adsorbent tower inner weld line</li> </ul>	<b>No abnormality</b> <ul style="list-style-type: none"> <li>• No corrosion on flange surface</li> <li>• No significant abrasion in gasket-type sacrificial positive electrode</li> </ul>

←  
Three minute pits, which seem corrosion, on the flange-sheet surface

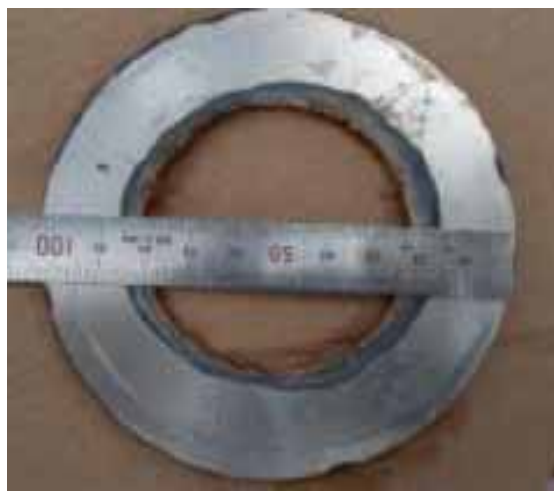
⑦ Supply pump 1 outlet pipe  
Gasket-type sacrificial positive electrode

←  
A slight abrasion in gasket-type sacrificial positive electrode

( No influence on the sheet function )

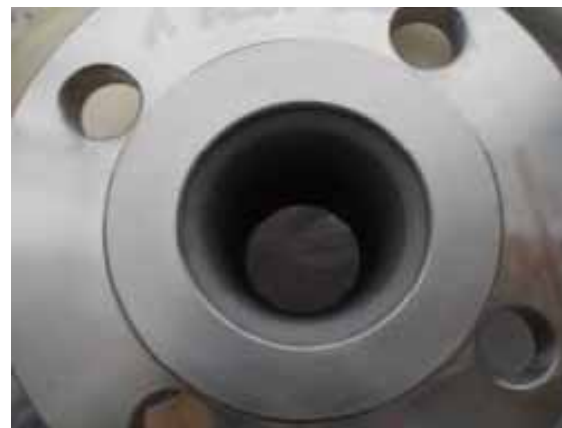
⑧ Supply pump 2 outlet pipe flange

←  
No corrosion on the flange-sheet surface

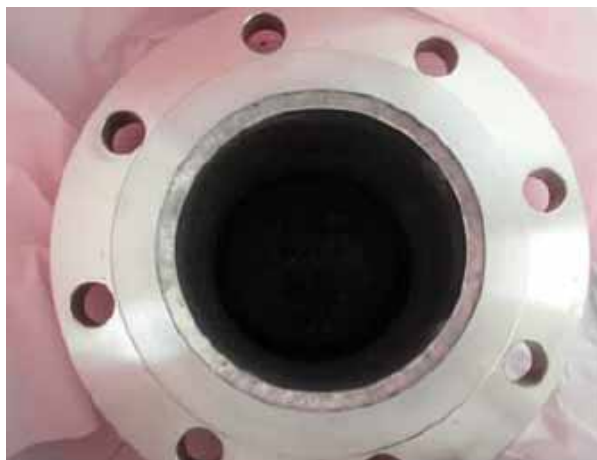
⑨ Adsorbent tower 2C inspection hole

←  
No corrosion on flange-sheet surface

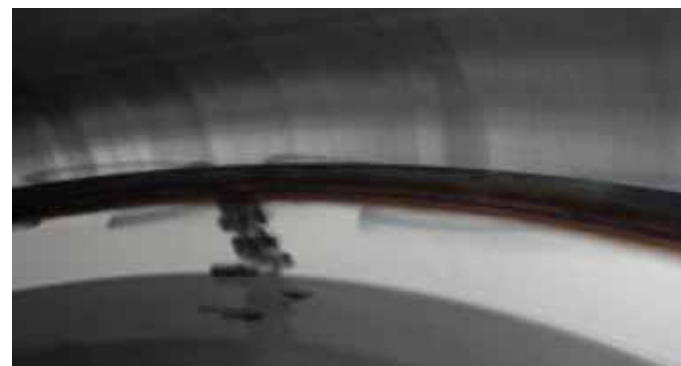
⑨ Adsorbent tower 2C weld line

←  
No corrosion along the weld line

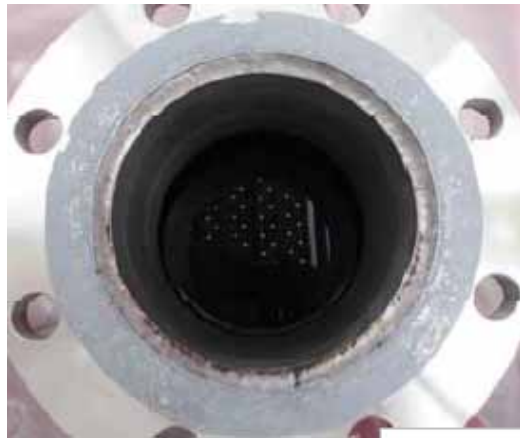
⑩ Adsorbent tower 7C inspection hole

⑩	Adsorbent tower 7 <ul style="list-style-type: none"> <li>• Inspection hole (closing flange)</li> <li>• Adsorbent tower inner weld line</li> </ul>	<b>No abnormality</b> <ul style="list-style-type: none"> <li>• No corrosion on flange surface</li> <li>• No significant abrasion in gasket-type sacrificial positive electrode</li> </ul>
⑪	Adsorbent tower 8 <ul style="list-style-type: none"> <li>• Inspection hole (closing flange)</li> <li>• Adsorbent tower inner weld line</li> </ul>	<b>No abnormality</b> <ul style="list-style-type: none"> <li>• No corrosion on flange surface</li> <li>• No significant abrasion in gasket-type sacrificial positive electrode</li> </ul>
⑫	Treatment column 1 <ul style="list-style-type: none"> <li>• Vent pipe flange</li> </ul>	<b>No abnormality</b> <ul style="list-style-type: none"> <li>• No corrosion on flange surface</li> <li>• No significant abrasion in gasket-type sacrificial positive electrode</li> </ul>

←  
No corrosion  
on flange-  
sheet  
surface

With paste-  
like sacrificial  
positive  
electrodes  
applied

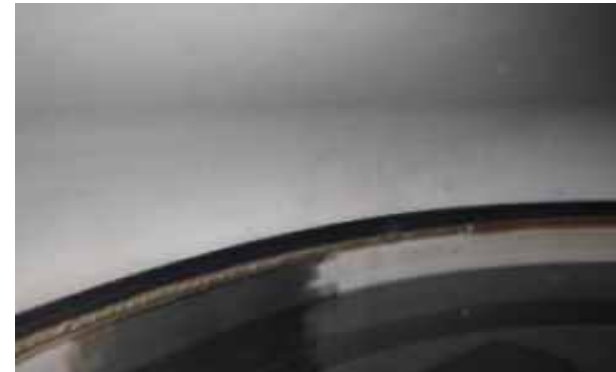
⑩ Adsorbent tower 7C inner weld line

←  
No  
corrosion  
along the  
weld line

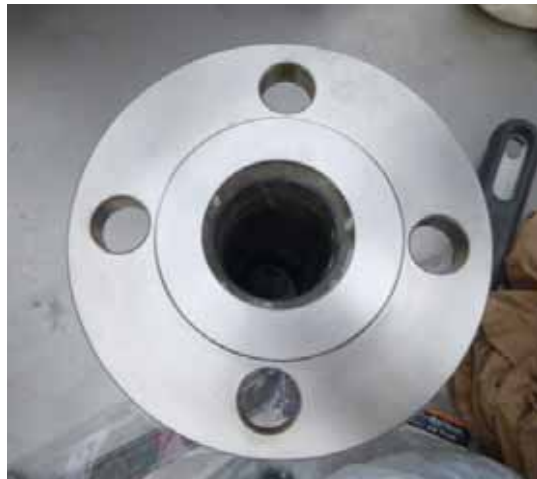
⑫ Treatment column vent pipe flange

←  
No  
corrosion  
on the  
flange

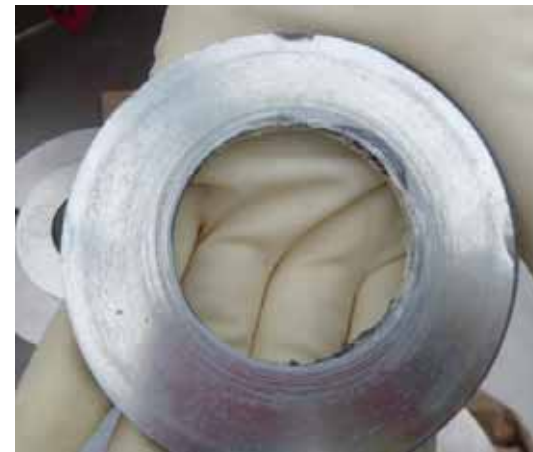
⑫ Treatment column vent pipe  
gasket-type sacrificial positive electrode

←  
A slight  
abrasion in  
gasket-type  
sacrificial  
positive  
electrode

No influence  
on the sheet  
function

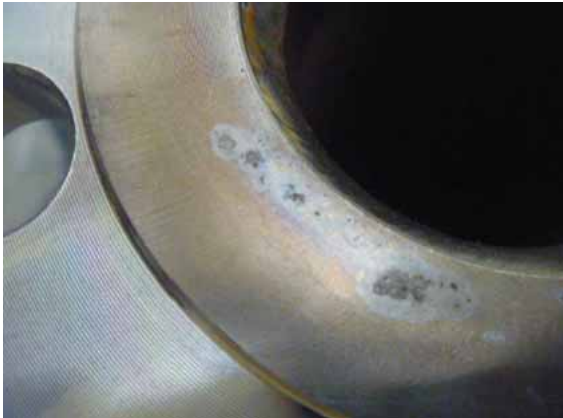
Slurry transfer pump outlet pipe (enlarged)  
with crevice corrosion on flange-sheet surface

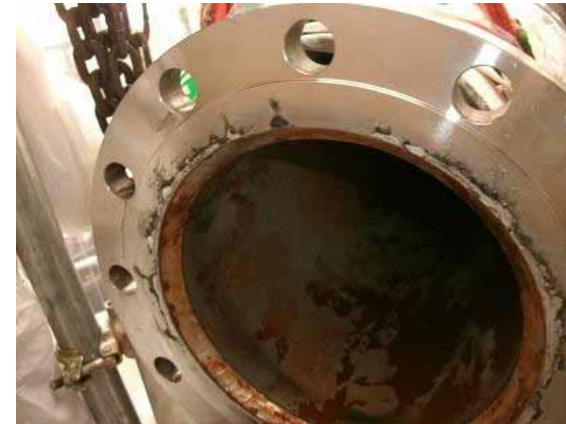
Circulation tank return pipe nozzle  
with crevice corrosion on flange-sheet surface

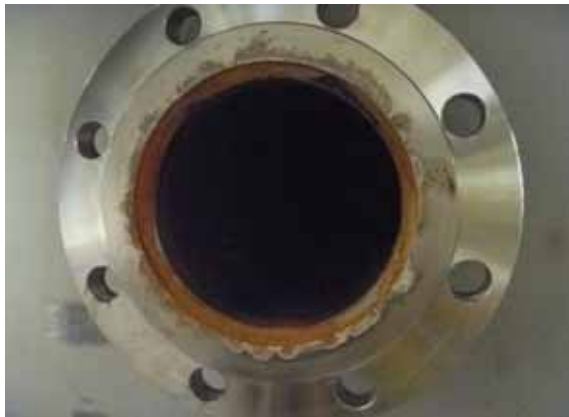
Batch treatment tank 2A decant nozzle  
with crevice corrosion on flange-sheet surface

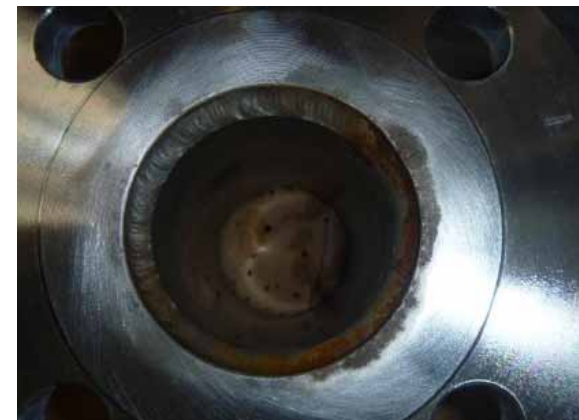
Supply pump 1A outlet pipe  
with crevice corrosion on flange-sheet surface
