## Water Leak From Gland Part of Entrance Valve of Waste Liquid Receiving Tank in Desalination System (Reverse Osmosis Membrane) No.2 at Fukushima Daiichi NPS

# Leakage Location of Desalination System (Reverse Osmosis Membrane) No.2

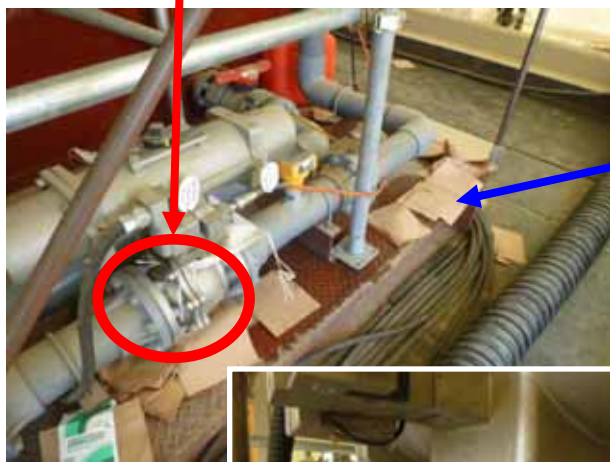
- 9:40 AM A TEPCO employee, who entered the temporary warehouse in order to check the site condition after activation of RO-2, found water leaking at the pace of 1 drop per second from the air controlled valve gland part at the entrance part of a waste liquid receiving tank (entrance valve of RO-2 waste liquid tank).

**Leakage location**  
**(entrance valve of RO-2 waste liquid receiving tank)**

- 9:42 AM RO-2 was suspended by hand.
  - Around 10: 00 AM The leakage was confirmed to be stopped after the gland part of this valve was tightened.
  - Around 11: 58 AM Operation check and leakage check under pressure was performed after this valve was protected, and no problem has been found.

- Estimated cause: Deterioration of gland packing (the packing has been abraded slightly due to secular use of a valve)
- Future correspondence: Similar valves which are being switched ON/OFF repeatedly when desalination system is in operation, will be inspected regularly if they are tightened properly.

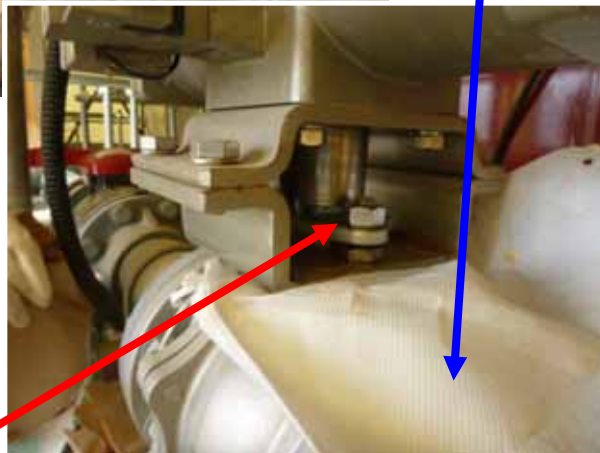
**Leakage location**  
**(gland part at entrance valve of RO-2 waste liquid receiving tank)**
