1. Investigation

We aim to clarify damages of building frames inside Unit 1 reactor building in Fukushima Daiichi NPS.

◆ **Work area** Building frames around the equipment hatch (from 2nd to 4th floors) at Unit 1 Reactor Building

◆ **Date** On December 4 (Wed.) and 5 (Thu.), 2013

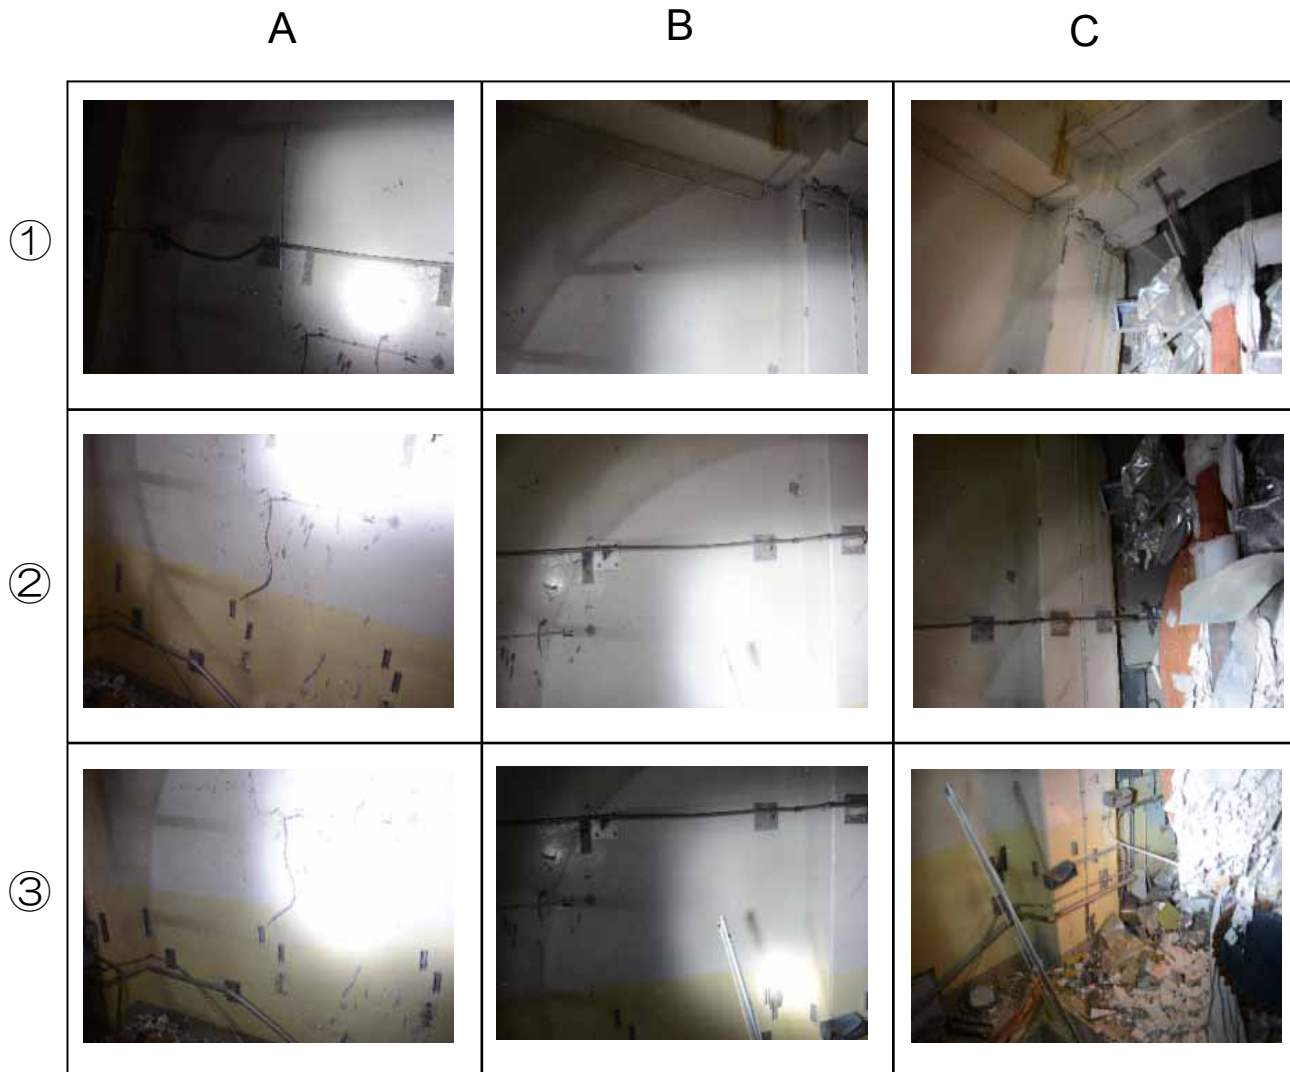
[4th floor equipment hatch walls in the west]

- After taking photos of the walls on each floor, no remarkable damage was found.
- These results will be reflected in the seismic resistance evaluation in future.
